# THE CARE AND FEEDING OF A LONG-TERM INSTITUTIONAL COMMITMENT TO GREEN STORMWATER INFRASTRUCTURE: A CASE STUDY AT THE UNIVERSITY OF CONNECTICUT

Michael E. Dietz<sup>1</sup>, Chester L. Arnold<sup>2</sup>, Katie D. Milardo<sup>3</sup>, Richard A. Miller<sup>4</sup>

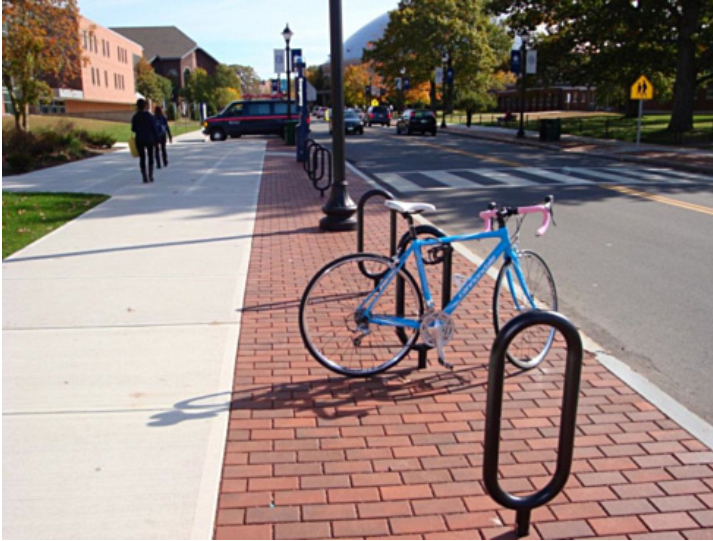
**FIGURE 4:** Pervious pavement in the “snow shelf” between the sidewalk and street, University of Connecticut, Storrs.

However, with the advent of the IC-TMDL, GSI implementation on campus has grown substantially since 2005 (Figure 3), with pervious pavements (Figure 4), bioretention (Figure 5), and green roofs (Figure 6) becoming commonplace on campus. More detailed information about these installations can be seen online through a virtual GSI tour at <http://s.uconn.edu/virtualGSItour>. The initial university response to the TMDL, in the form of a study, technical report and watershed plan, was led by the University of Connecticut's Center for Land Use Education and Research through its longstanding "NEMO" (Nonpoint Education for Municipal Officials, <http://nemo.uconn.edu>) stormwater effort. Documents and information related to the study can be found at <http://clear.uconn.edu/projects/tmdl>. Implementation has been primarily the responsibility of the University of Connecticut Office of Environmental Policy, with input from the Center for Land Use Education and Research, and other University faculty.

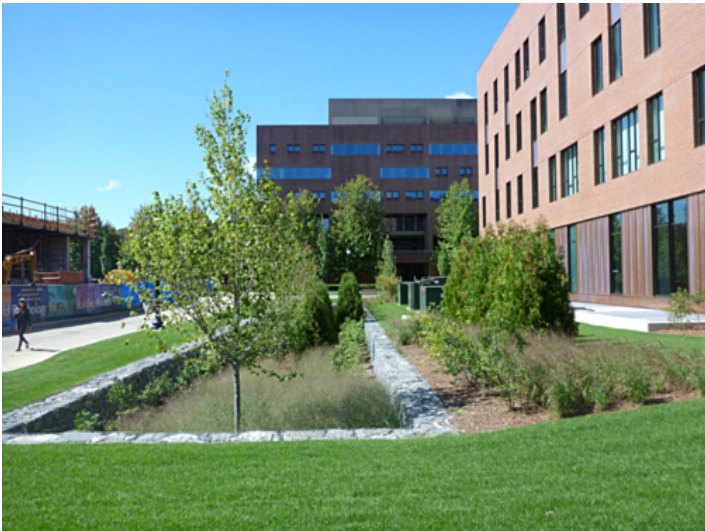
**FIGURE 5:** Bioretention area by Oak Hall, University of Connecticut, Storrs.

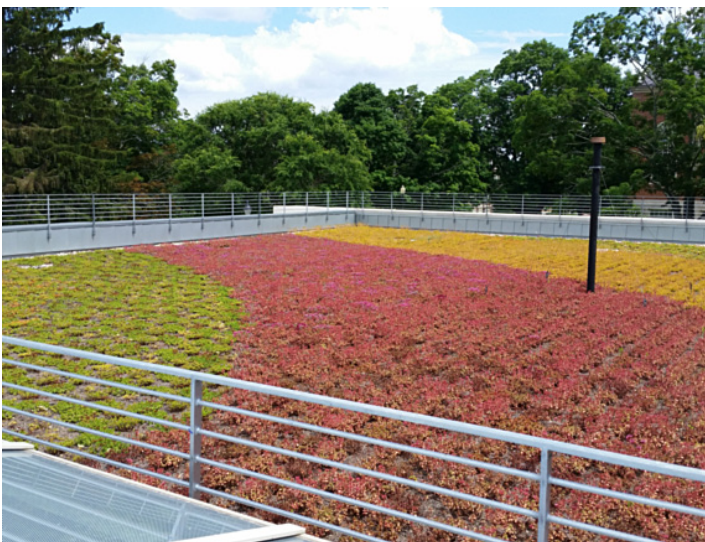
**FIGURE 6:** Green roof on Storrs Hall, University of Connecticut, Storrs.
