## A FIELD STUDY SETUP OF FOUR HOMES HAVING NON-VENTILATED AND SEMI-CONDITIONED SEALED ATTICS

### INTRODUCTION

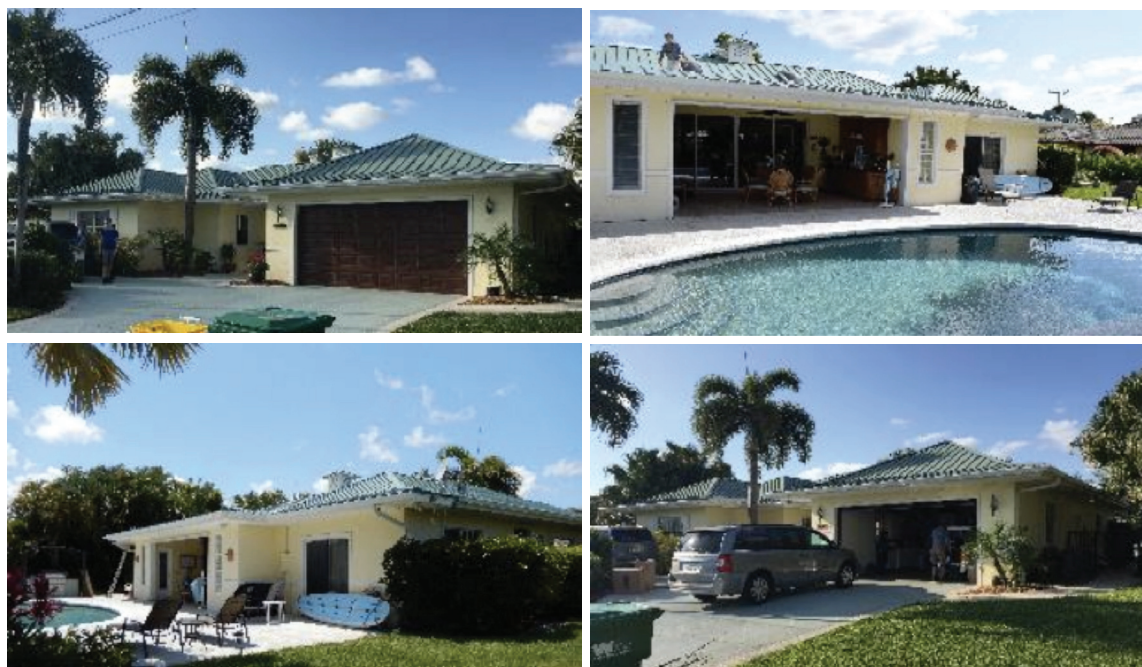
**FIGURE 3:** House 1 in West Palm Beach, FL.

Figure 3 shows images of the residence from different directions. This single-story residence has a sealed attic with hip roofs. The home features a standing seam metal roof.

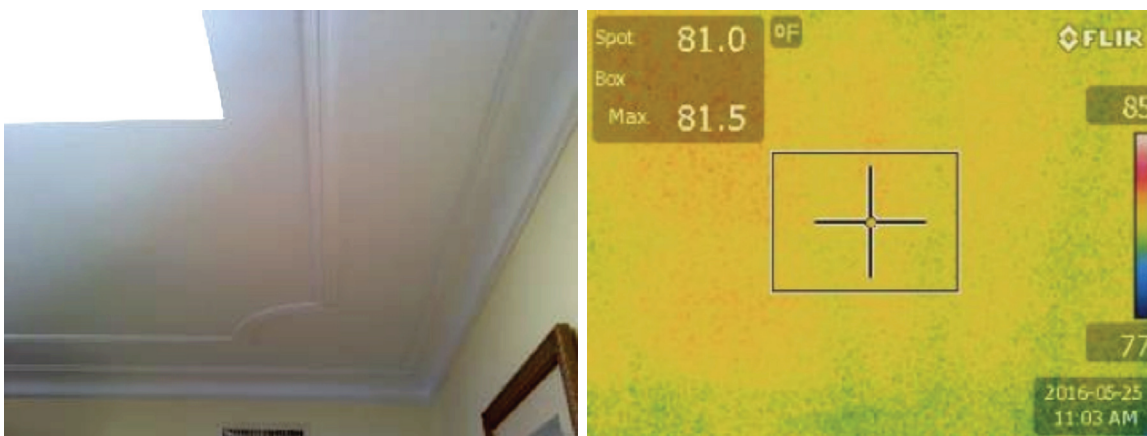
**FIGURE 4:** Digital and Infrared Picture of West-facing Ceiling and Wall.

An infrared image of the ceiling shows the gypsum to have a temperature of about 81°F, Figure 4. The ceiling is not insulated and is only about R-0.45 for ½-in gypsum. Miller et al. (2016) observed that sealing the attic with less than code level of insulation causes the heat flowing through the ceiling to be almost double that crossing the ceiling for an unconditioned,

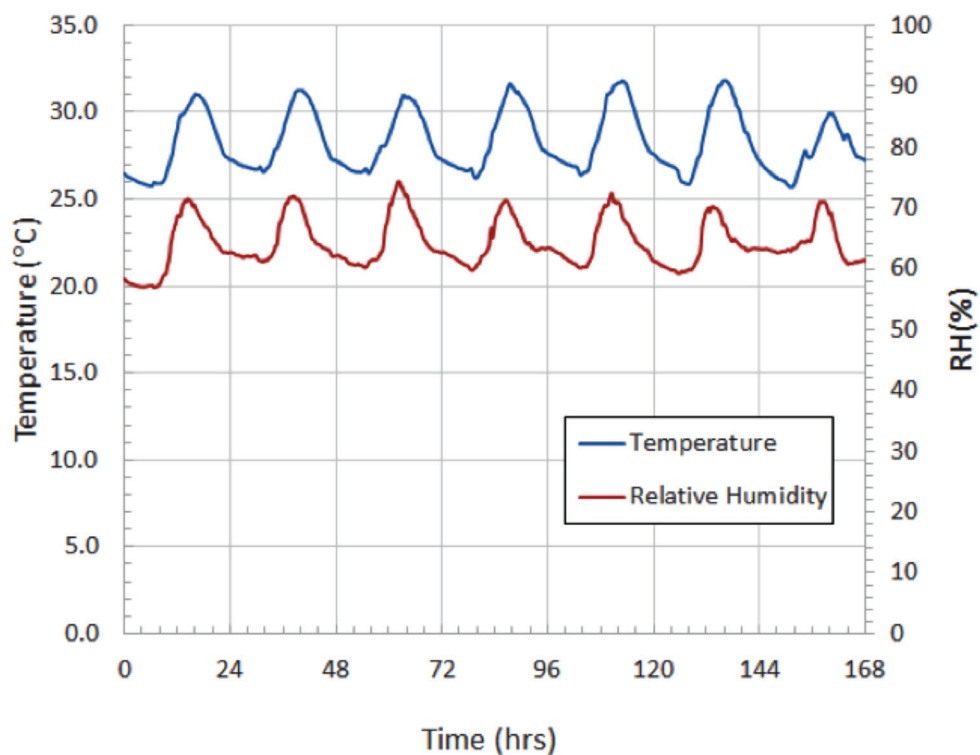
**FIGURE 7:** The attic air temperature and relative humidity for seven contiguous days of data collected for house 1 in West Palm Beach, FL.

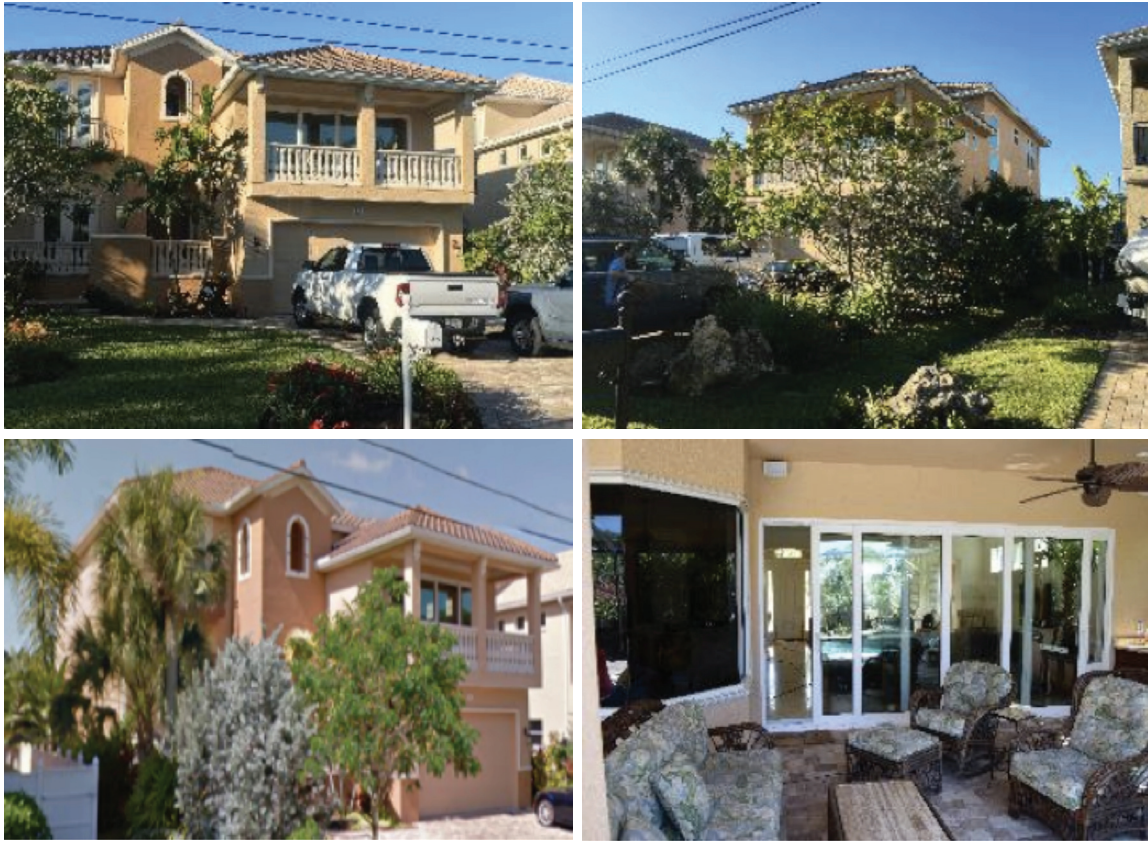
**FIGURE 8:** House 2 in Venice, FL.

House 2 is located in Venice, FL, within Climate Zone 2A, defined as hot-humid by ASHRAE 169 (2006), and Florida Energy Climate Zone (FECZ) 2. The warmest month in Venice is August with an average high temperature of 32.6°C (90.6°F). The hottest day on record was June 29, 1977 when the temperature hit 37.2°C (99.0°F). During January the average over-night temperature drops to 10.7°C (51.2°F) with the lowest temperature of 0° (32.0°F) being recorded on January 4, 2012. The average annual precipitation in Venice is 50.5 inches. Figure 8 shows images of the residence from four different directions.

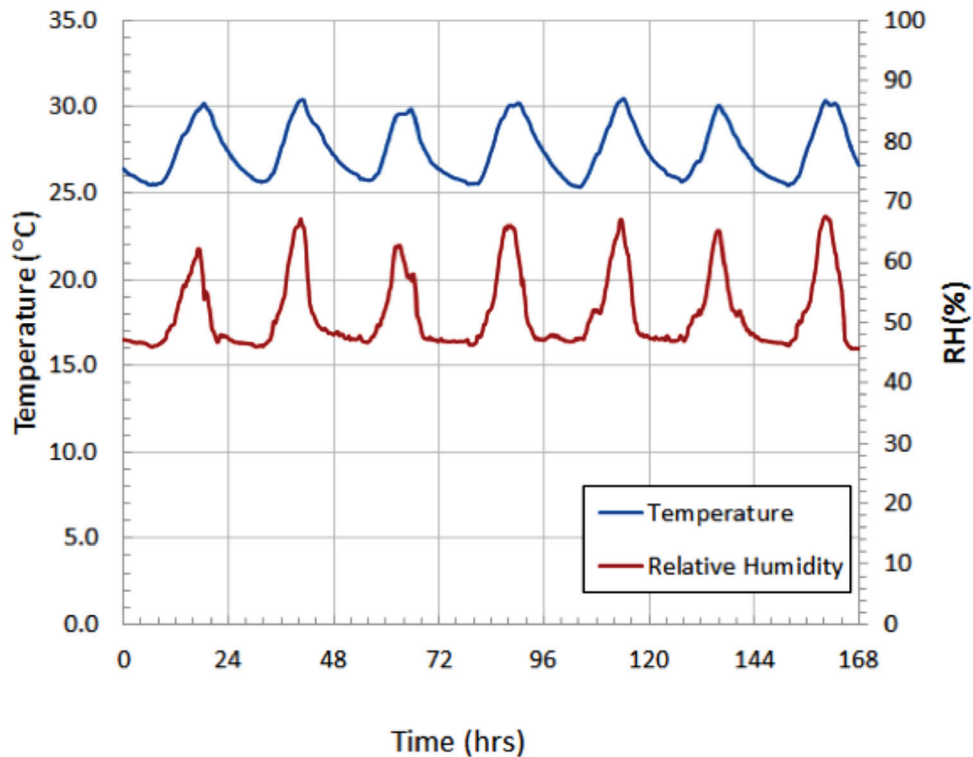
**FIGURE 12:** The attic air temperature and relative humidity for two contiguous days of data collected for house 1 in Venice, FL.

from the roof deck and into the attic during the daylight hours and back into the foam during the cooler evening hours. The temperature and relative humidity of the attic air are both less than that observed for the outdoor ambient and there is nothing unusual observed for air in this sealed attic. The relative humidity in the attic is surprisingly low.

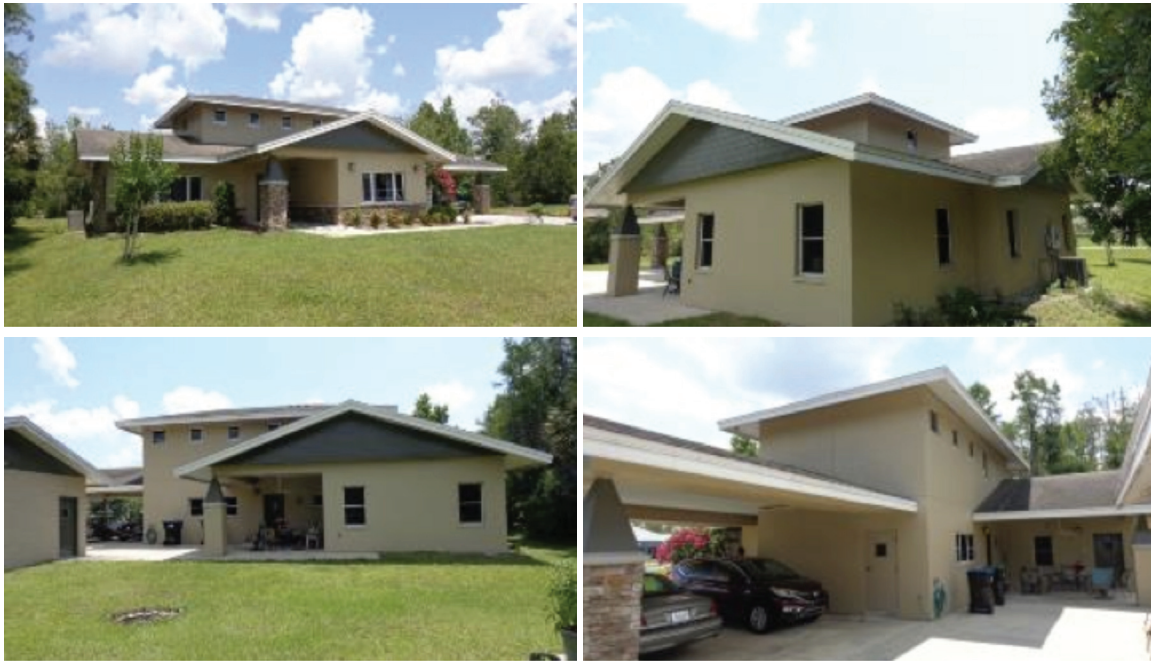
**FIGURE 14:** House 3 in Orlando, FL.

The following images and text are related to House 3 in Orlando, Florida. Figure 14 shows images of the residence from four different directions. The two-story residence has both first- and second-floor attics. Based on accessibility, the attic sensors were located in a sealed, first-floor attic on the northwest part of the house, as shown in Figure 14.

The home is a split-foyer type with separate roofs protecting 1st and 2nd floors. The 2nd floor attic was not accessible because of its low 3/12 pitch. Another roof and attic covered the garage and a 3rd attic section was located on the northwest side of the home. The 3rd section served as the test attic. It did not contain ducts or HVAC. The home was well shaded on the west side of the home therefore the roof did not see much irradiance except around high noon. Two split-system air conditioners cooled the building. One air handler was placed in a closet with ductwork run between the 1st and 2nd floors to air-condition the 1st floor. The second unit was placed in a mud room. Its duct was directed up into the attic on the 2nd floor for supplying conditioned air to the upper floor.

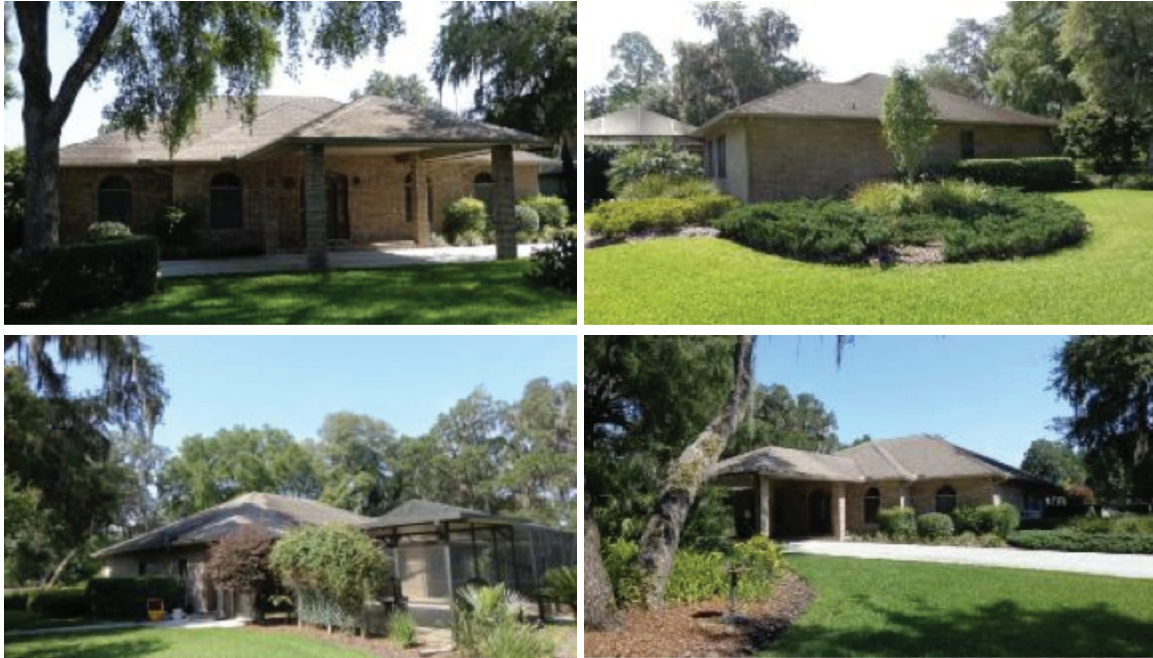
**FIGURE 15:** House 4 in Gainesville.

occurred in 1952 when the temperature hit 40°C (104°F). During January the average overnight temperature drops to 5.6°C (42°F) with the lowest temperature of -12.2°C (10°F) being recorded January, 1985. The average annual precipitation in Gainesville is 47.3 inches. The following images in Figure 15 are for the Gainesville residence from different directions. This single-story residence has a sealed attic with hip roofs.
