SCENIC HUDSON'S LONG DOCK PARK CULTIVATING RESILIENCE: TRANSFORMING A POST-INDUSTRIAL BROWNFIELD INTO A FUNCTIONAL ECOSYSTEM

Chris Moyles¹ and Timothy Craul²

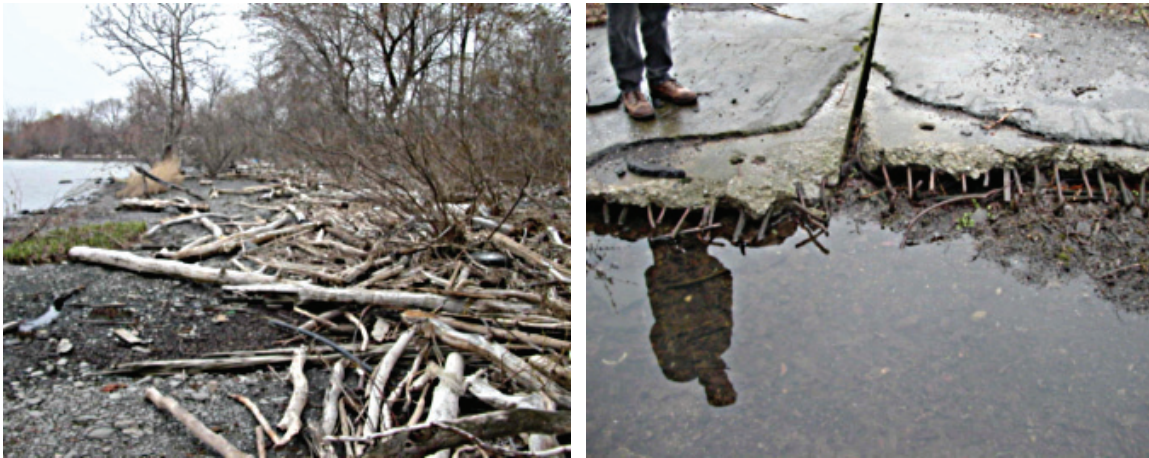
FIGURE 7: Images of existing site conditions; debris from storm surge along south shoreline (left) concrete slabs at Wetland A (right).

The majority of the Beacon Point site had an underlayment, inches below the surface, of concrete decking slabs, approximately 10'0" wide and 12-14'0" long, covered with asphalt on one side. The slabs, debris from the repaving of the Interstate 84 Bridge between Beacon and Newburgh, were brought to the site as salvage. Their placement and distribution served as a de facto stabilization of the point from surges and withdraws. The soils below the slabs were

coarse and very well drained — during rain events the joints between slabs became visible. Because of the thin soils atop of the slabs little if any vegetation was present. In some areas, particularly the south shoreline and the edge of the Quiet Harbor, trees (*Acer negundo* and *Populus* sp.) rooted and established in the joints between slabs.
