3D LASER SCANNING FOR PRESERVATION AND STRUCTURAL MONITORING OF HISTORIC CALIFORNIA ADOBE MISSIONS

H. M. Böttger¹, C. J. Arce Bazán², and N. P. Saarman³

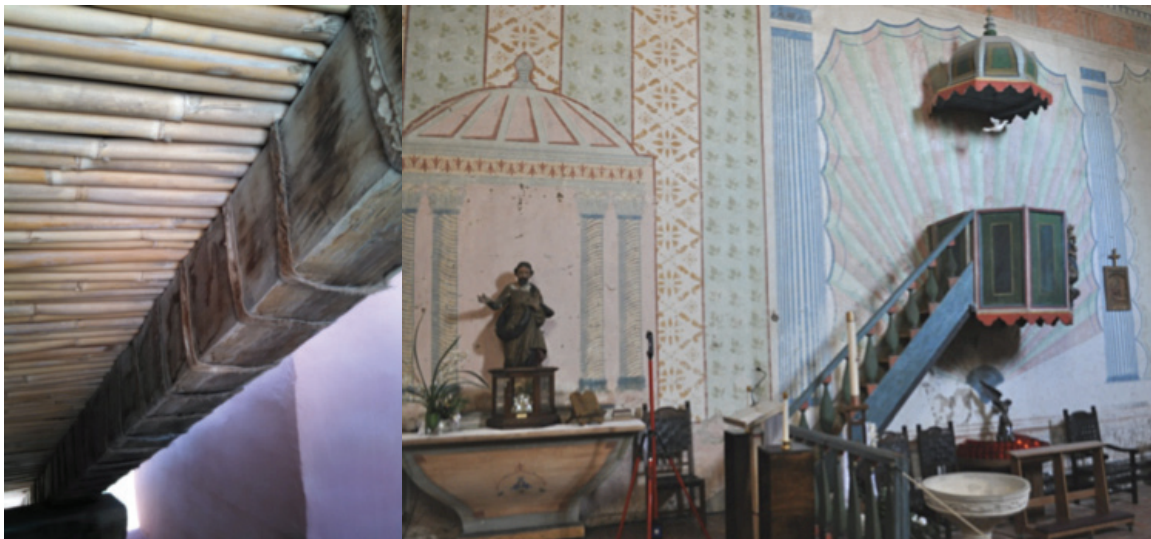
FIGURE 5 AND 6: Fig. 5 (left) – Leather lashing of beams with reed sheathing under eave, photo by author. Fig. 6 (right) – Interior painting, photo by author.

by the Indians with oxen to their destination. They protrude about a foot through the walls where they are keyed with large wooden spikes.” Once roofing began, a common practice of using cowhide leather straps to secure the rafters to the beams was utilized (Fig. 5), due to the scarcity of metal hardware. Hinges and other iron hardware where they occur were hand-forged by the Natives. The adobe church was finally completed in 1818 with a lime plaster exterior finish, and the intricate interior paintings still visible today (Fig. 6) are the only original such paintings remaining among the California missions, hand-painted by Salinan community members in 1820-21 with the direction of the artist, rancher and Spanish diplomat Estéban Carlos Munras of Monterey [9]. Paints were made by vegetable dyes (technique of Native American origin) and ground stone pigments (technique of Spanish/European origin), with binders made on site from the bones of animals killed for consumption [8].

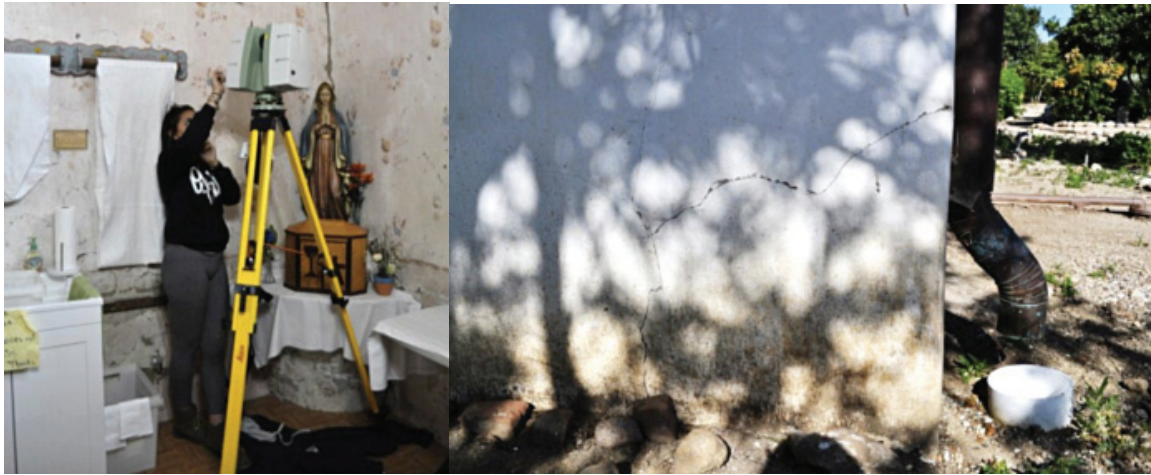
FIGURE 10 AND 11: Fig 10 (left) - Piscina (holy water basin) and sacrarium in northeast corner of Sacristy. Fig 11 (right) - Apparent water damage to wall in area of piscina/sacrarium as seen from exterior.

described below, there are reports and written documentation that seem to support over 100 years of interventions to combat significant deterioration in many areas of the complex. As early as 1901, the outer walls were given a new coat of plaster and cement [8]. A number of studies [11, 12] indicate that non-cement-based plasters provide greater breathability for earthen walls and extend their durability against moisture damage, so it is very possible that this “new” cement plaster has actually contributed to the decay of the walls. In another very specific example, the sacrarium, the drain through which special water used for ceremonies is poured out, is located in the northeast corner of the Sacristy. By Catholic tradition this water must be directed to the ground separately from regular plumbing, but it is clear in the case of Mission San Miguel that a leak or break in this drain line has caused significant damage to this area of the Sacristy foundation, as seen in Fig 11.

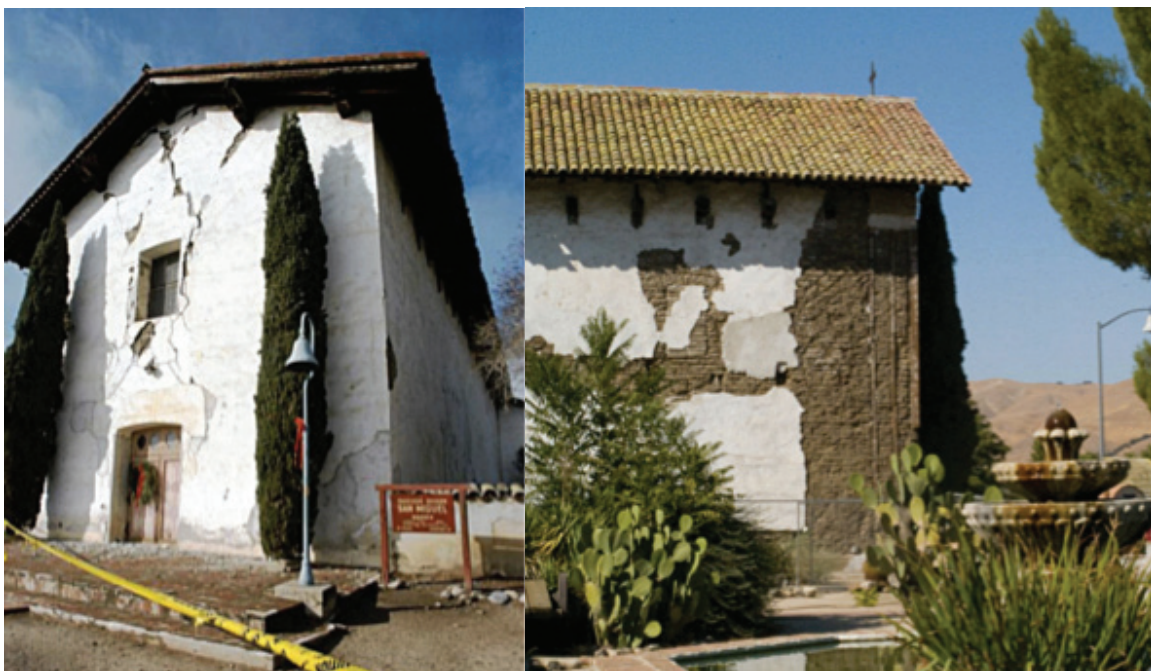
FIGURE 12 AND 13: Fig. 12 (left) – Cracks in façade immediately following 2003 San Simeon earthquake [1]. Fig. 13 (right) – View of main church during restoration, cracks repaired and plaster reapplied [1].

Damage included structural cracking in the unreinforced adobe walls, spalling of large areas of wall and ceiling plaster from substrates and rotation of adobe walls out of plane. Shoring at the north wall of the sacristy, at the windows and doors of the church, and at the east arcade was installed as a temporary measure [13]. Diagonal cracking is clearly visible here, characteristic of unreinforced masonry failure due to significant lateral loads.

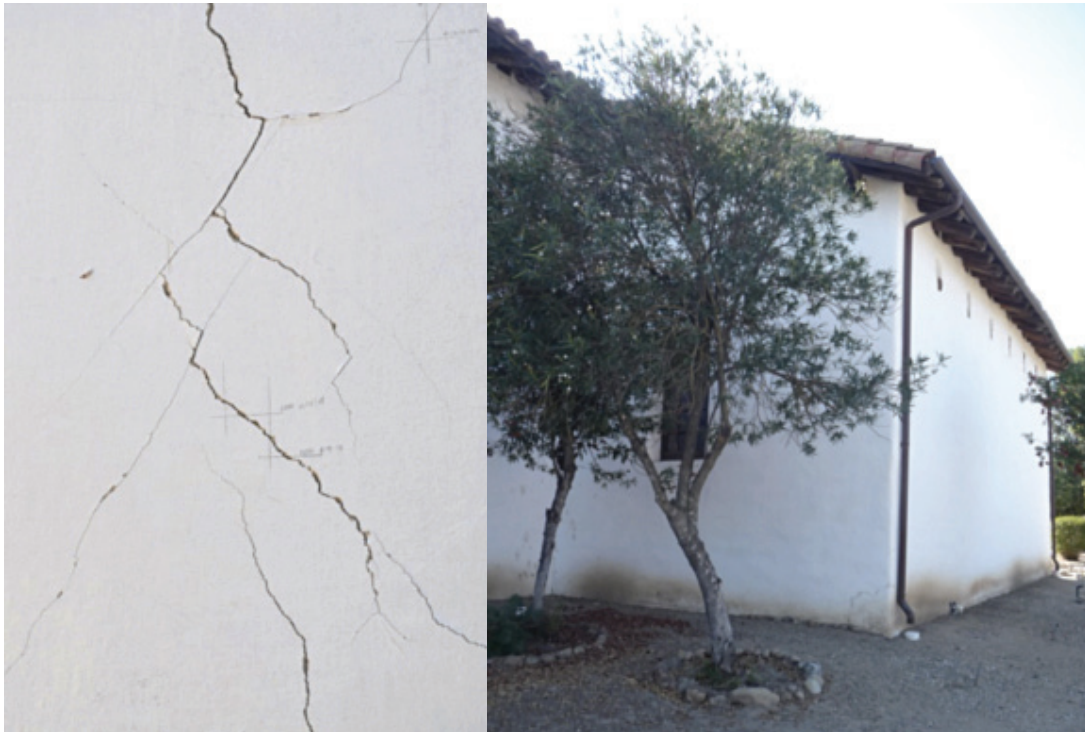
FIGURE 14 AND 15: Fig. 14 (left) – Displacement markings on east Sacristy wall, photo by author. Fig. 15 (right) – Overall view of retrofitted Sacristy looking west, photo by author.

Shortly after the earthquake and closure of the mission complex, structural engineers Dr. Frederick Webster and Nels Roselund were called upon to conduct an assessment of the mission buildings, especially the north wall of the Sacristy which had rotated out-of-plane due to the ground motion, perhaps already begun due to settlement before the earthquake. They noted cracks (Fig. 14) which were forming in the east wall as well, which seemed to accompany the outward leaning of the north wall. Dated horizontal and vertical lines drawn across cracks make visible any displacements in either direction over time. With these observations, they designed and implemented a bond beam retrofit to prevent further rotation of the north wall.

According to Mr. Roselund [14], the bond beams at the tops of each of the three walls consists of two interventions: A) For shear diaphragm to the wall: two layers of 3/4" (1.9 cm) x 8-ft (2.4 m) plywood panels lap-spliced in 1/2" (1.27 cm) half panel lengths, and B) For flexure: a bond beam chord on each side of the wall - on the exterior, a continuous stainless steel strap, with bolted continuity joints, including around corners, and a continuous wood ledger on the interior. The bond beam is connected to the top of the wall with epoxied shear bolts plus periodic anchors that extend deeply into the wall to develop shear friction between the upper adobe courses. This work has been beautifully finished with new plaster and stucco, rendering it invisible from either inside or outside the Sacristy.

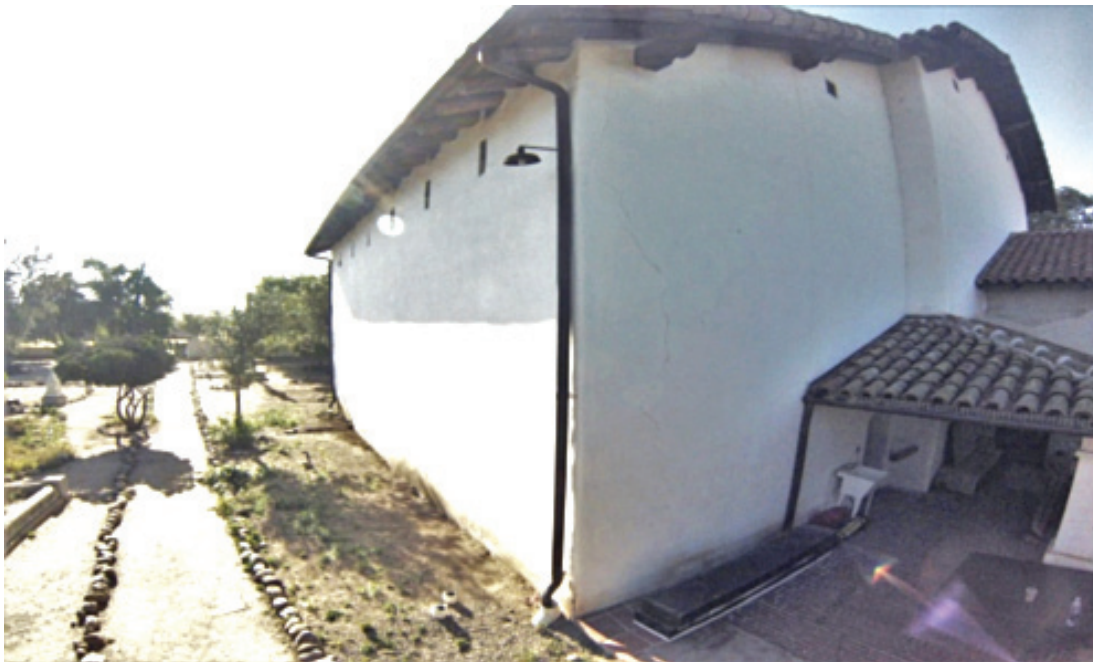
FIGURE 20: Photograph of same area.
