# ASSESSMENT OF EFFECTIVE ENERGY RETROFIT STRATEGIES AND RELATED IMPACT ON INDOOR ENVIRONMENTAL QUALITY

A case study of an elementary school in the State of Maryland

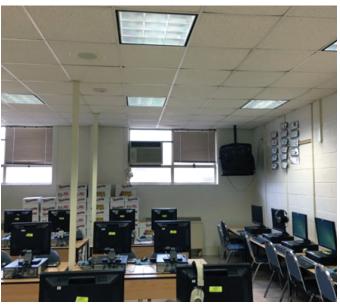
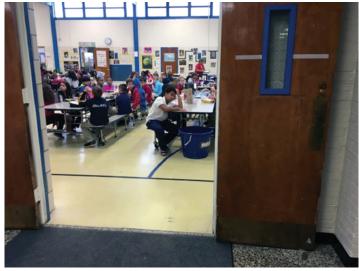
**FIGURE 4.** Existing Interior Condition (lighting and layout).

The lighting system was updated. Currently, most classrooms are equipped with  $1' \times 1'$  fluorescent fixtures with T8 lamps. And the classroom lights are controlled by two toggle switches near the door, and each switch controls one half of the classrooms. Occupancy and daylight sensors are not installed per current AACPS guidelines. In the corridor,  $1' \times 2'$  fluorescent light fixtures with T8 lamps are used and spaced at 2' apart. Currently all corridors must rely on electrical lighting to meet minimum lighting level requirements, which is 30-foot candle per the Illuminating Engineering Society (IES) guidelines, even during sunny days with plenty of daylight. In general, the lighting fixtures used meet current standards. By installing and integrating daylight sensors and occupancy sensors, Quarterfield Elementary school could achieve some energy savings from a smart lighting system.
