## CRACK HEALING UTILISING BACTERIAL SPORES IN CONCRETE

Alan Richardson<sup>1</sup> PhD, Leon Amess<sup>2</sup> BEng, Simon Neville<sup>3</sup> BSc,  
and Christopher Walton<sup>4</sup>, MCE.

### ABSTRACT

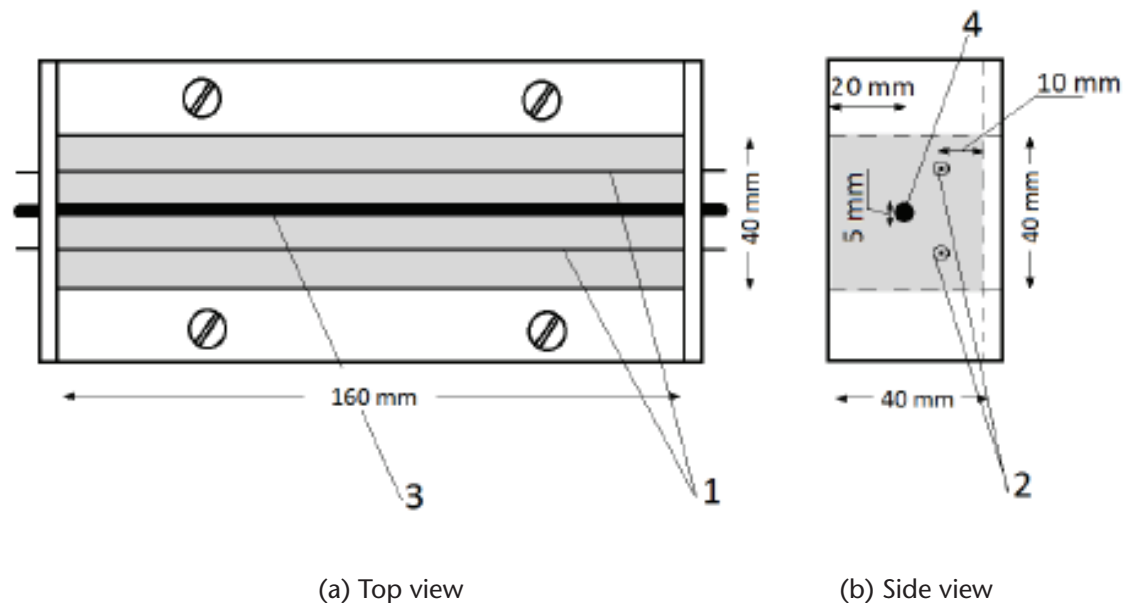
**FIGURE 1.** Specimen mould details (Tziviloglou et al 2016).

1 and 2—Steel wire reinforcement

3 and 4—central hole for testing water flow through the induced crack.

The specimens were manufactured using a mould in accordance with Figure 1.

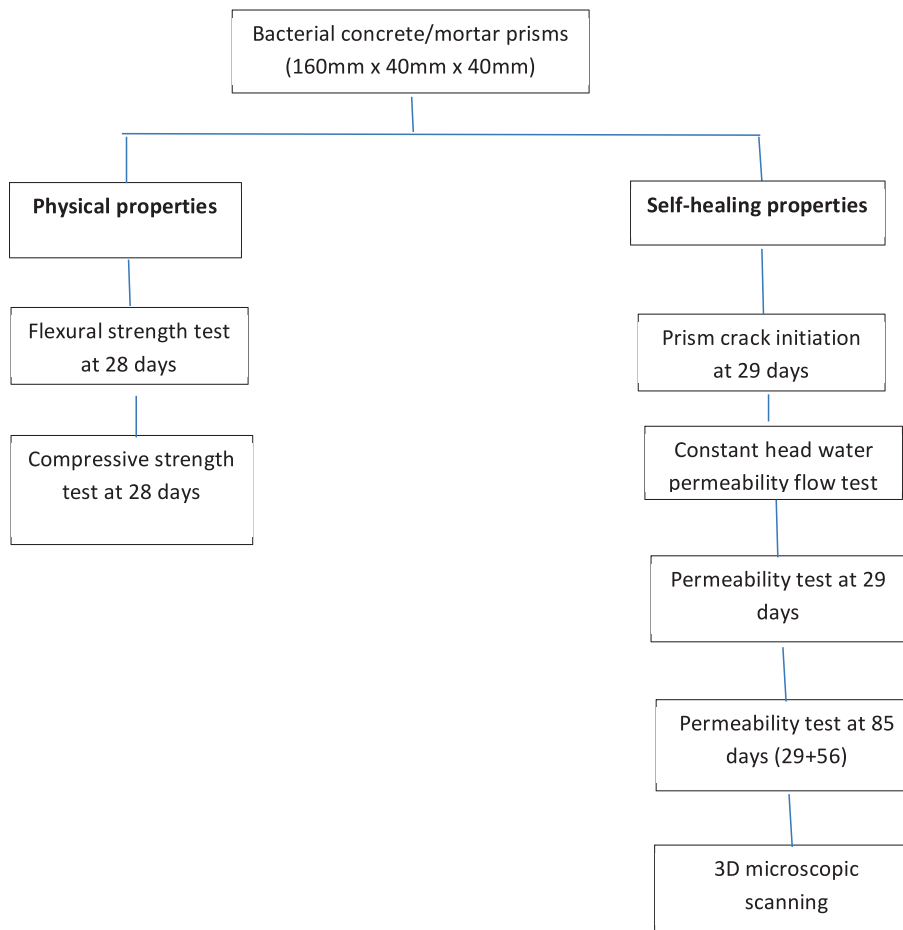
**FIGURE 2.** Flow chart of test programme.

**2.1** *Figure 2 displays the test programme as carried out.*

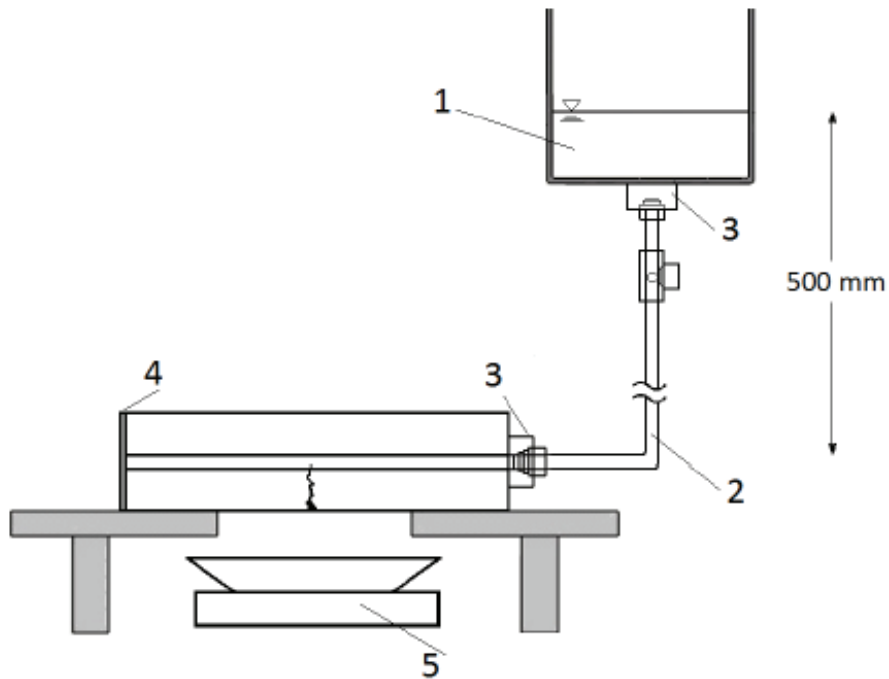
**FIGURE 3.** Water flow test apparatus (Tziviloglou et al 2016a)

Figure 3 displays the schematic arrangement of the water flow test. This test is currently being developed as a new test standard by the RILEM technical committee 253-MCI.

The constant head water supply was fed into the centre of the concrete prism and the water passing through the crack was weighed after a test period of five minutes. The original test specimens were discarded in case the water flow had washed out the bacterial spores and cracked samples were used for the healed water flow test.

- 1—Constant head water container
- 2—Plastic feed tube
- 3—Connector
- 4—Resin seal
- 5—Electronic scale

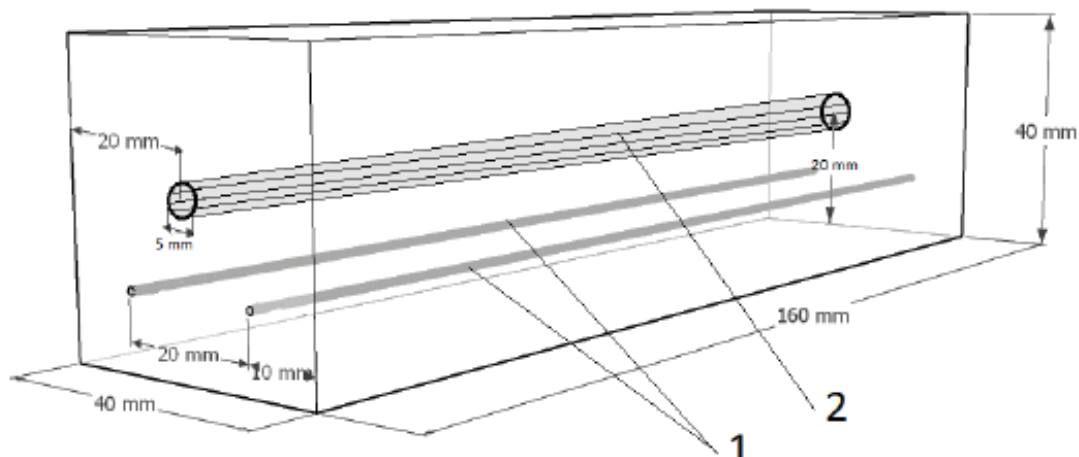
**FIGURE 4.** Test specimen displaying wire reinforcement and a 5mm diameter central hole for water test. (Tziviloglou et al 2016).

The specimens were formed as displayed in Figure 4.

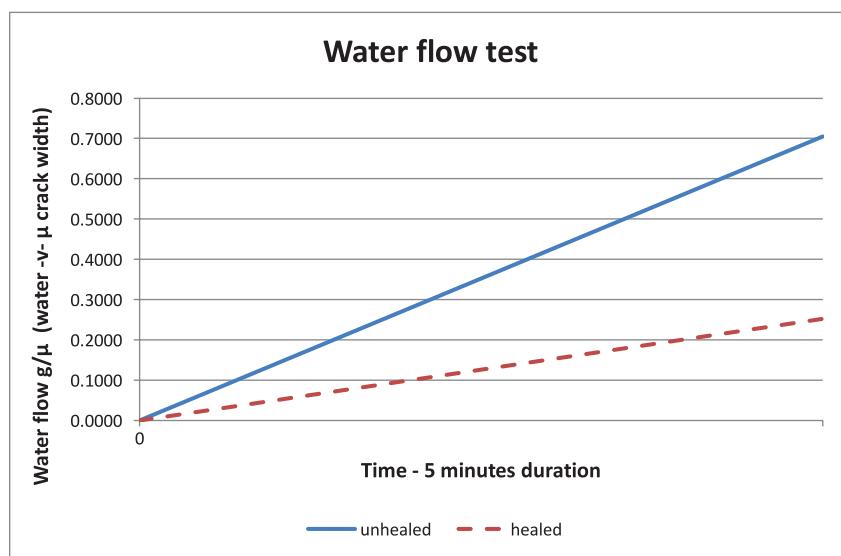
**FIGURE 5.** Paired comparison water flow test using a constant head water supply.

The water flow per micron for each test is 0.7049 g/μ for 29 days and 0.67722 g/μ for 85 days. Taking out the considered outlier of sample 7, the values are 0.7049 g/μ and 0.2515 g/μ respectively. This data is more representative of the observable crack healing and sealing and is displayed in Figure 5.

However, the microscope observations clearly show a large degree of crack sealing/healing has taken place. Specimen 7 displays values which are not in keeping with the surrounding data as for a relatively modest crack width there is a large water flow. If specimen 7 is removed from the results, then the relative crack width and water flow are 46% and 17% reduced. These values are more in keeping with the observable results.

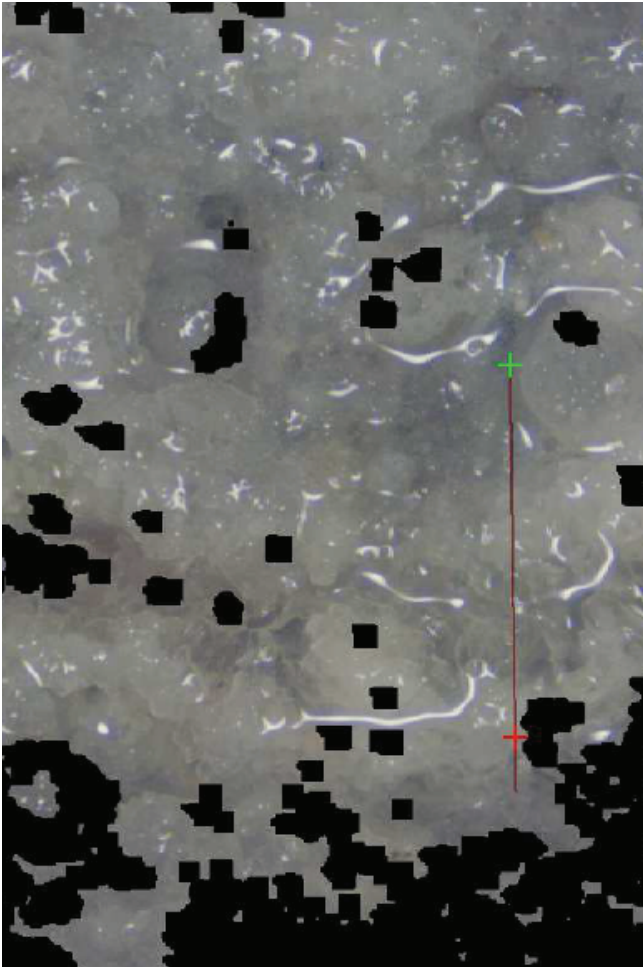
**FIGURE 6.** Displays the healed surface profile of beam 7.

All Figures produced were taken on the Alicona 3D scanning microscope, unless otherwise stated. Figure 6 displays a healed crack on beam 7. The deposition of bacterial formed calcite is self-evident. Section 3.5 relies heavily upon the graphical representation of healed cracks to inform the reader as to the observable effectiveness of the bacterial repair action.

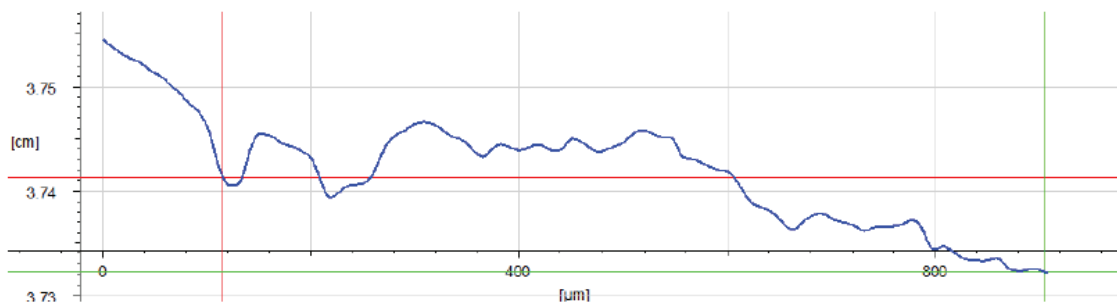
**FIGURE 7.** This figure was prepared by using a crack inspection microscope, and it clearly shows a degree of self-healing has taken place on beam 7 as the crack can be seen to be largely filled with calcite.

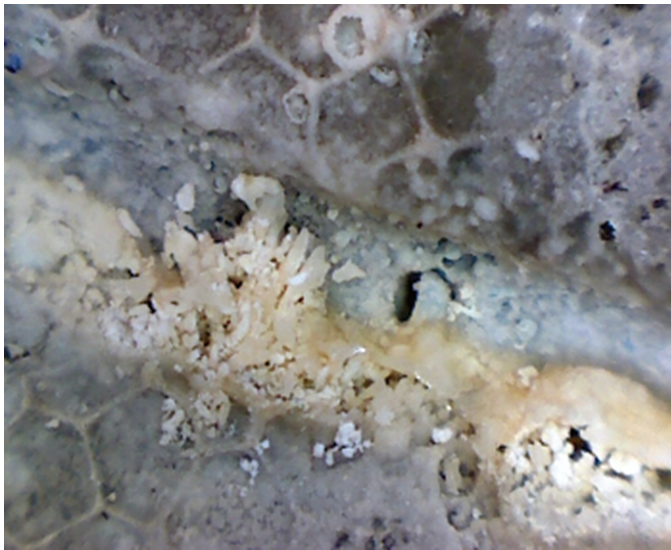
**FIGURE 8.** Healed crack.

Figure 8 displays the healed crack on beam 7 and the 2D and 3D details are taken across the line shown on the plan view of the healed beam

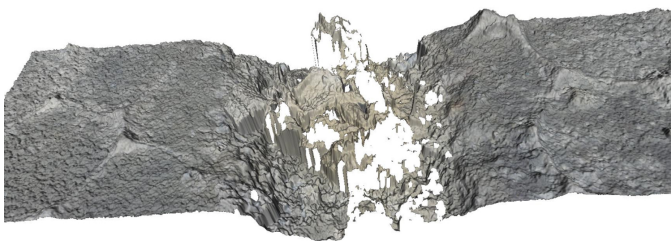
**FIGURE 9.** The 3D build-up of calcite formed from bacterial action.

Figure 9 displays the 3D build-up of calcite formed from bacterial action, filling the cracked beam (8).

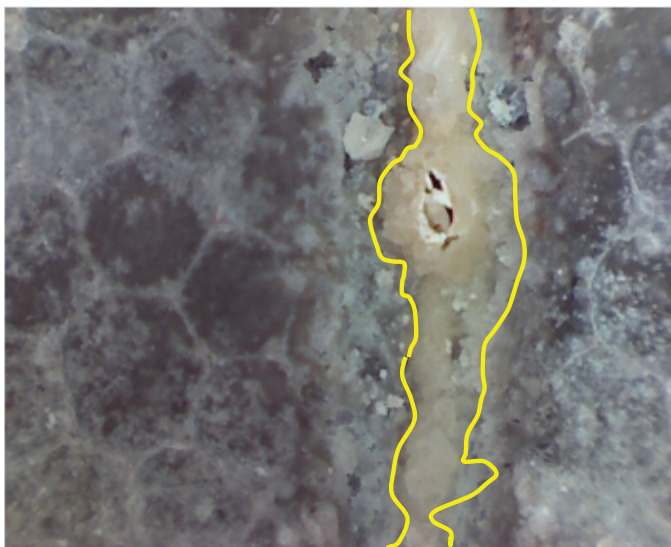
**FIGURE 10.** Displays healed crack on beam 8.

Figure 10 was taken using a crack inspection microscope and it clearly shows a degree of self-healing has taken place on beam 8.

The sealed crack displayed on Figure 10 has been highlighted for ease of identification.

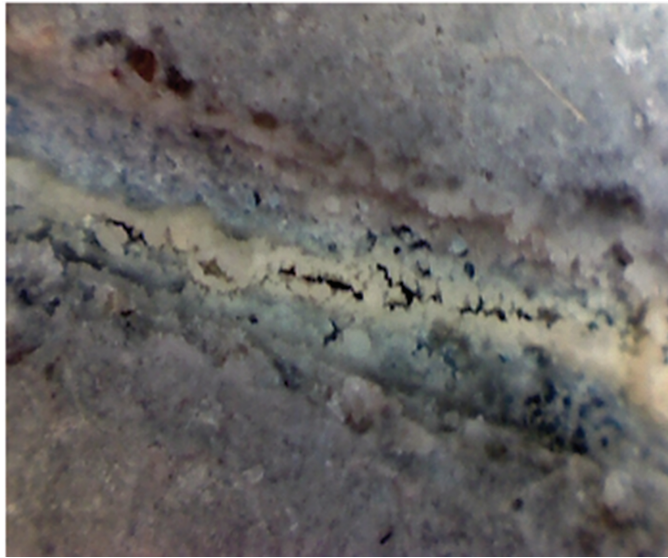
**FIGURE 11.** Partially healed crack.

Figure 11 was taken using a crack inspection microscope and it clearly shows a degree of self-healing having taken place on beam 9, however the healing taken place at the surface is granular in texture and not totally sealed.
