# EVALUATION OF THE MECHANICAL PROPERTIES OF BAMBUSA BAMBOO CULMS WITH METALLIC JOINTS THROUGH DESTRUCTIVE TESTING

Raviduth Ramful<sup>1</sup>

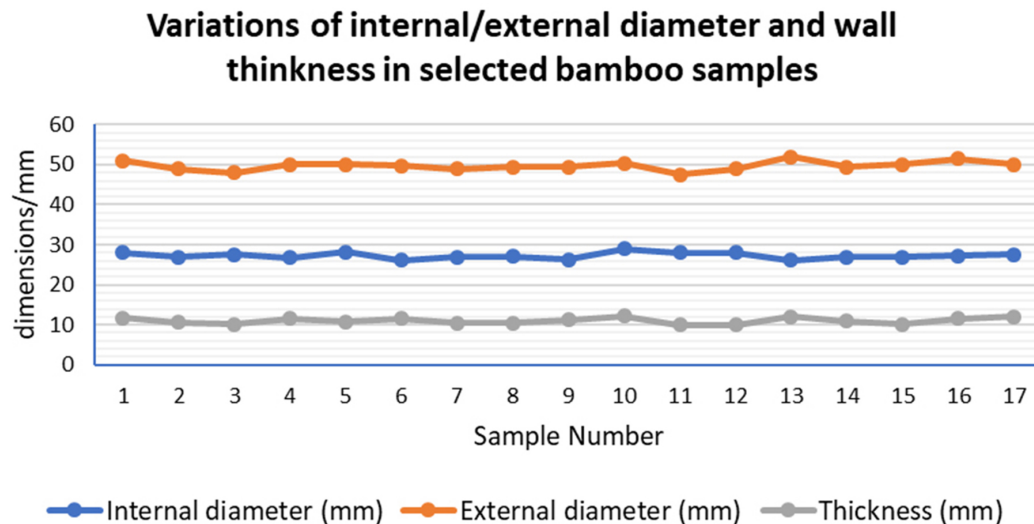
**FIGURE 1.** Variation in culm's internal/external diameter and wall thickness.

In comparison to locally available bamboo species, namely *Phyllostachys* and *Dendrocalamus*, *Bambusa bamboos* were found to grow in abundance in Mauritius' accessible regions. The *Bambusa* species has a smaller diameter ranging from 50 mm to 100 mm and culm length of approximately 12 m to 15 m, making it easier to work with. In order to standardize the test specimens used, variations in culm internal and external diameter and wall thickness were limited to a specific range of about 25 to 29 mm, 48 to 51 mm and 10 to 12 mm respectively as shown in Figure 1. Diameter and thickness tend to decrease with an increase in length from the root section.

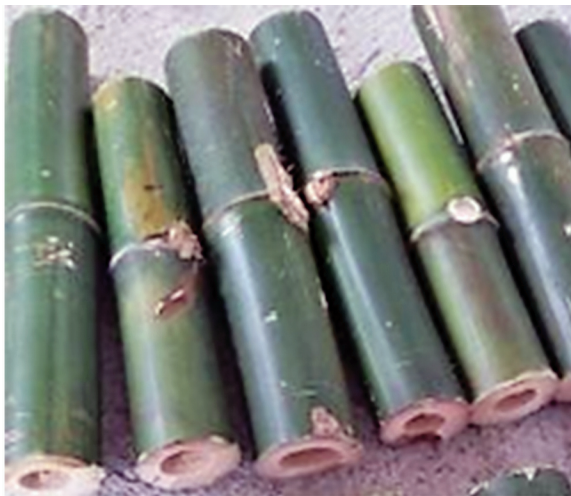
**FIGURE 2.** Sectioning of bamboo specimens.

The maturity of selected bamboo specimens ranged between three and four years. According to Fabiani (2014), the first 1 m from the root section should be discarded due to a non-straight development and the next 6 m of the culm could be used for testing purposes. In order to maintain the wall thickness and diameter specifications within the desired range, culm portions ranging between 1 m above the ground and up to 2 m in height were harvested using a machete. Joints are best implemented at the internode part of the culm as it possesses a good fibrous content for holding loads. Thus, culms used in the design of conceptual joints were divided at the midpoint of internodes as shown in Figure 2.

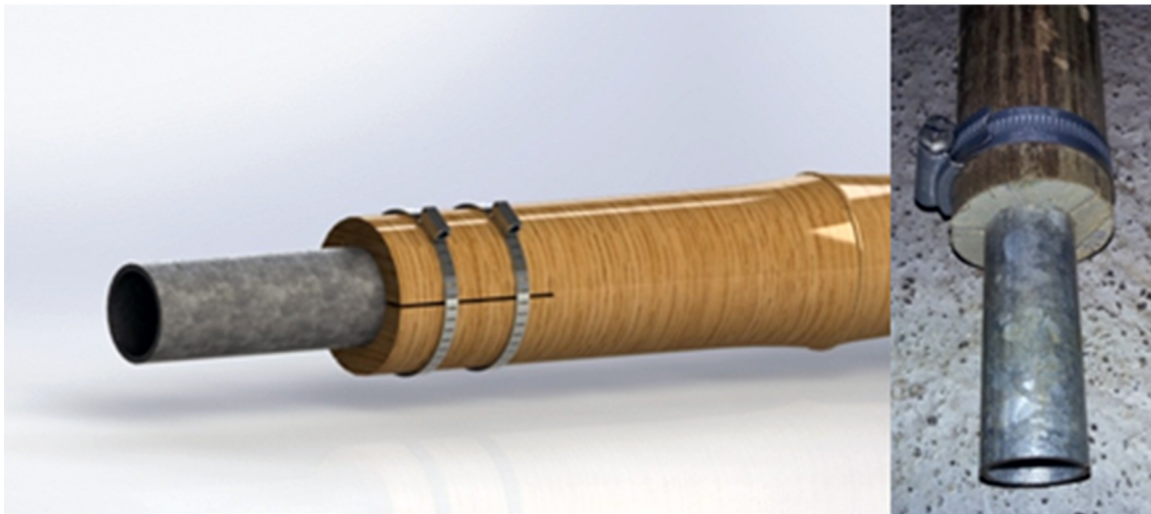
**FIGURE 3.** Concept 1—Tightening ring joint.

As undried bamboo is affected by shrinkage over time, a first concept consisting of tightening rings was devised to address this problem. Bamboo specimens, split along their longitudinal section, were tightened using tightening rings as shown in Figure 3. Mild steel tubes of diameter 2.54 cm and length 15 cm were used and secured into the bamboo specimens using tightening rings. In order to produce a strong joint between the two components, the bamboo was split at three equal sections. Due to the cost of the tightening rings, this conceptual joint was the highest priced one in comparison with other designs.

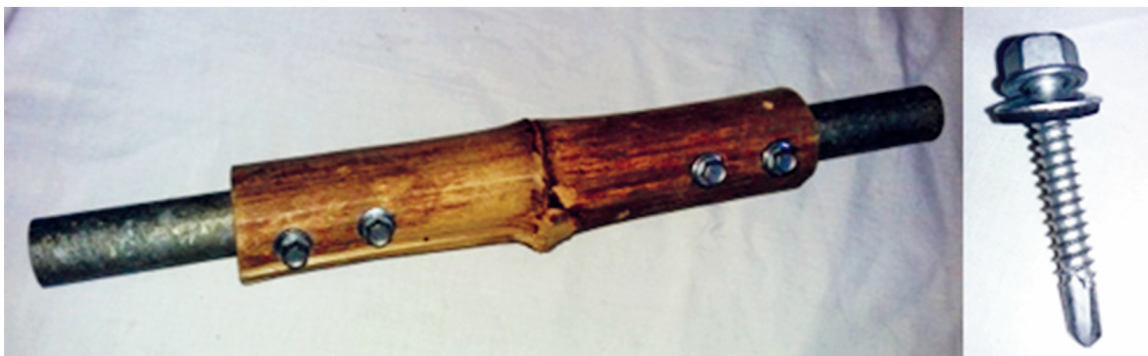
**FIGURE 5.** Concept 3—Self-drilling metal screw joint.

Self-drilling metal screws have good resistance to wearing and can bear high loadings. Their rubber ring provided a tight grip when combined with the curved surface of bamboo. Additionally, the load was uniformly distributed over that surface. Mild steel tubes of diameter 2.54 cm and length 15 cm were used. The number of screws used in the third concept was equivalent to the total number of rivets used in concept 2. The self-drilling metal screws of diameter 10 mm were tightened by the use of a portable drilling machine as shown in Figure 5.

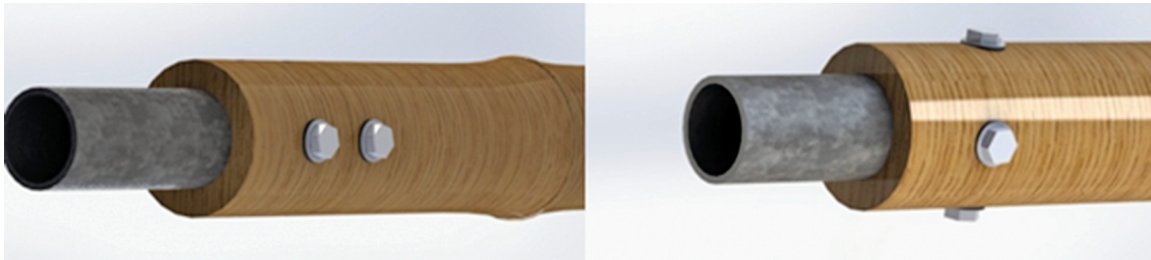
**FIGURE 13.** Initial and improved design of self-drilling metal screw joint.

In order to consolidate the joint design, a further refinement was introduced to the self-drilling metal screw joint. A major alteration in the design was the repositioning of the fasteners

on different portions of the bamboo specimen as shown in Figure 13. The total number of fasteners used remained constant in both joint designs. The new joint samples, which were expected to resist twice the load, were subjected to destructive testing on the Universal Testing Machine.
