# EFFECT OF ALKOXYSILANE-BASED TREATMENT ON THE DURABILITY OF NORTH CYPRUS STONES FOR CONSTRUCTION

#### **ABSTRACT**

chemical treatment, consolidation, treatment efficiency index (TEI), durability, limestone

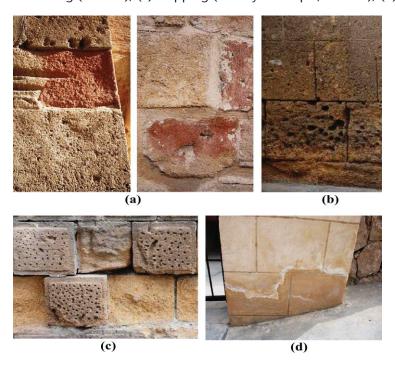
**FIGURE 1.** Decay patterns of Northern Cyprus limestones: (a) staining (Great Inn, Nicosia); (b) crumbling (Nicosia); (c) chipping (Selimiye Mosque, Nicosia); (d) efflorescence (Kyrenia).

the substrate in layers), efflorescence (the surface deposition of soluble salts as moisture in the stone evaporates) and sub-florescence (internal accumulation of soluble salts deposited under the stone surface as moisture in the wall evaporates) (Figure 1).

- Treatments also improve the physical, mechanical and durability properties of the aged stones. Thus, it may be inferred that treatment would yield a benefit to the conservation of historical buildings. Staining, crumbling, chipping, and efflorescence deterioration types seen in the Cyprus stones can be prevented with treatment.

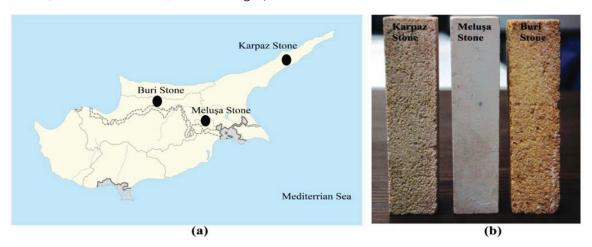
**FIGURE 2.** (a) The regions of the quarried limestones; (b) The samples of the limestones: (KS on the left; MS in the medium; BS on the right).

The laboratory experiments were carried out on three different limestones: Karpaz Stone (KS), Meluşa Stone (MS), and Buri Stone (BS). KS has been quarried from the Karpaz region on the northeast, while MS from the Erdemli region on the southeast, and BS from the Alayköy region on the northwest of Cyprus Island (Figure 2a). Figure 2b shows the stone samples from Meluşa, Karpaz, and Buri.

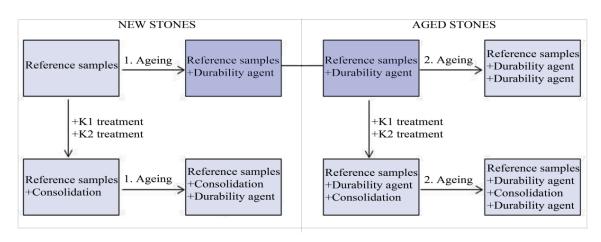
**FIGURE 4.** Experimental process applied to the stones.

Experimental study consists of three stages: (i) Determination of physical and mechanical characteristics of quarried stones; (ii) Determination of durability properties of stones; (iii) Determination of efficiency of the treatments on the durability properties of the new and aged stones (Figure 4). The durability tests on the aged stones were carried out in order to determine whether the treatment would be a benefit to the conservation of historical buildings. Each test result is the average of six samples.

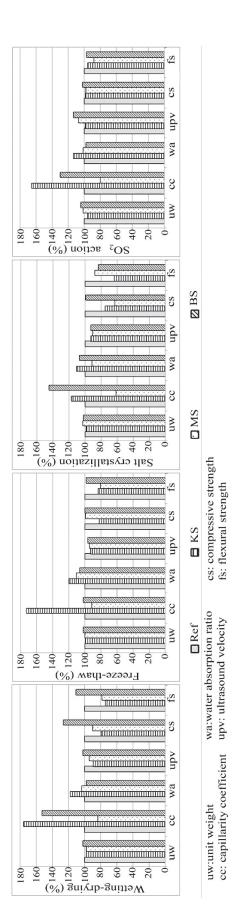
FIGURE 5.

Relative properties of the new stones after durability tests.

Relative properties of the stones after durability tests are given in Figure 5. The apparent rise in the capillarity coefficient of KS and BS after each aging test may be the clue to the new, narrow and interconnected pore development in their fossiliferous structure. Particularly after the wetting-drying test there is an apparent increase in the mechanical properties of BS, which may indicate the soluble compounds clogged in the pores happened by the cycles of wettingdrying. This may be proven by the execution of further microscopic tests. On the other hand, the already low capillary coefficient of the micritic clay structure of MS is decreased further due to the increase of its pore size after aging tests. Indeed, after the 11th cycle of salt crystallization test, MS fragmented (Figure 6). This may be the result of internal pressure that occurred by the crystallization of salts in the drying phase, which are absorbed within the pores. Although KS and BS preserved their integrity, some cracks at the edges of the samples were observed. After the freeze-thaw test, KS and MS could not resist the internal pressure of the ice due to their lower porosity. On the other hand, no significant change is observed in the mechanical properties of BS; this may be attributed to the inherent pore structure of BS that provides enough space to absorb the internal stress of ice expansion. After 21 days of exposure to the water vapor with 5% SO<sub>2</sub> concentration, a slight discoloration of the stones was observed.

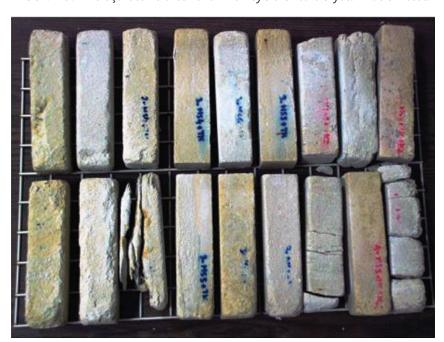
FIGURE 6. Meluşa Stone after the 11th cycle of salt crystallization test.

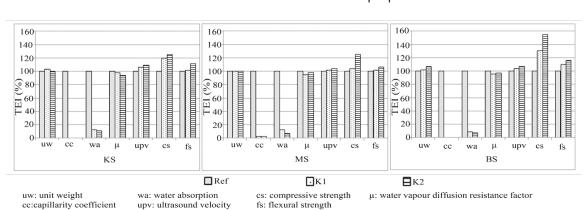
**FIGURE 7.** The influence of the K1 and K2 treatment on the properties of the stones.

K1 and K2 treatment reduced the water absorption ratios by 87–92%, and the capillarity coefficients by 97–99% for all the three types of stones (Figure 7). These results are also consistent with the study, which determined that silane siloxane-based protection decreased the water absorption ratio of the stone by 80–90% [31]. After K1 and K2 treatment, the ( $\mu$ ) factors of the KS, MS and BS stones decreased approximately 6% and 5% and can be accepted as negligible. Indeed, the combination of consolidant and protection treatment, like K2, should decrease the ( $\mu$ ) factor of the original stone 10–25% at most [32].

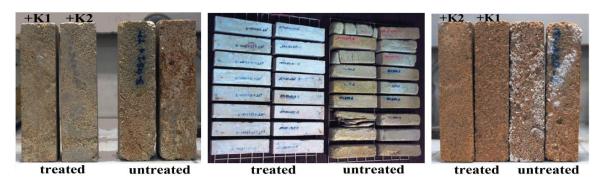
**FIGURE 10.** Influence of the treatment (K1 and K2) on the properties of aged stone: Karpaz, Meluşa and Buri Stones.

The influence of the K1 and K2 treatments on the durability of aged stones is given in Figure 10 after being obtained from the wetting-drying and freeze-thaw tests.

After the wetting-drying test of aged KS, MS and BS, both K1 and K2 treatments lead to a significant decrease in capillarity coefficient (90–100%) and water absorption (80%). This may indicate that chemical treatment filled the open and capillary pores. The development seen in physical properties of the stones are in conformity with the compressive strength results, which give important clues about a material's stability. This shows that the treatments have positive effects on the old stones.

After the freeze-thaw test, water absorption ratios of all stones decreased 85–90% depending on the decrease in capillary pores. The compressive strengths of all stone types increased after treatments. The decrease in the flexural strengths of KS and MS after K1 treatment indicates the brittleness of the stones. TEI of K2 is higher than K1 and BS performed better followed by MS and KS, respectively.

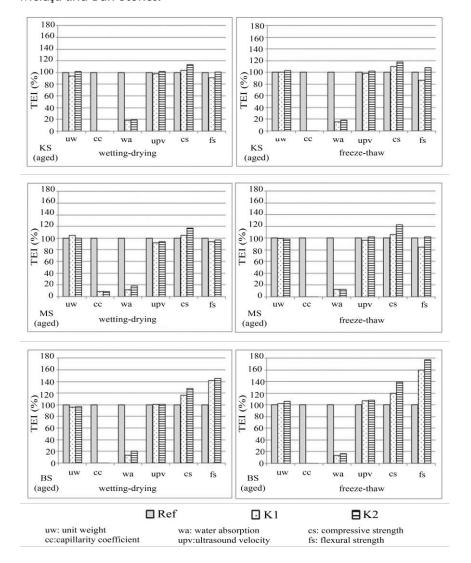
FIGURE 11. TEI of the treatments on the compressive strengths of new and aged stones.

Figure 11 reveals the compressive strengths of new and aged stones before and after the application of chemical treatments K1 and K2. Under both aging agents, treatment efficiency indexes of K1 and K2 for all three types of stones was improved and helped to enhance the strengths, although higher values were obtained with the K2 treatment. The interesting point is that after both aging tests, TEI of the treatments on strengths is gradually decreasing from KS, MS to BS in "new" stones, while there is a gradual increase from KS, MS to BS in "aged" stones. Besides, for all stone types, TEI of the chemical treatments was found to be highest for

the stones having the lowest compressive strength following the aging tests. Hence, the higher the degradation degree under durability tests, the higher the TEI of the treatments (Table 5). Therefore, it can be stated that prior to use of new-quarried limestones in architecture, chemical treatment application is efficient in enhancing the service life of the stones.
