# THERMAL PERFORMANCE OF FELT TYPE VEGETATED FACADE SYSTEMS IN A TEMPERATE CLIMATE DURING HEATING AND COOLING PERIODS

Elif Özer Yüksel<sup>1</sup> and Nil Türkeri<sup>2</sup>

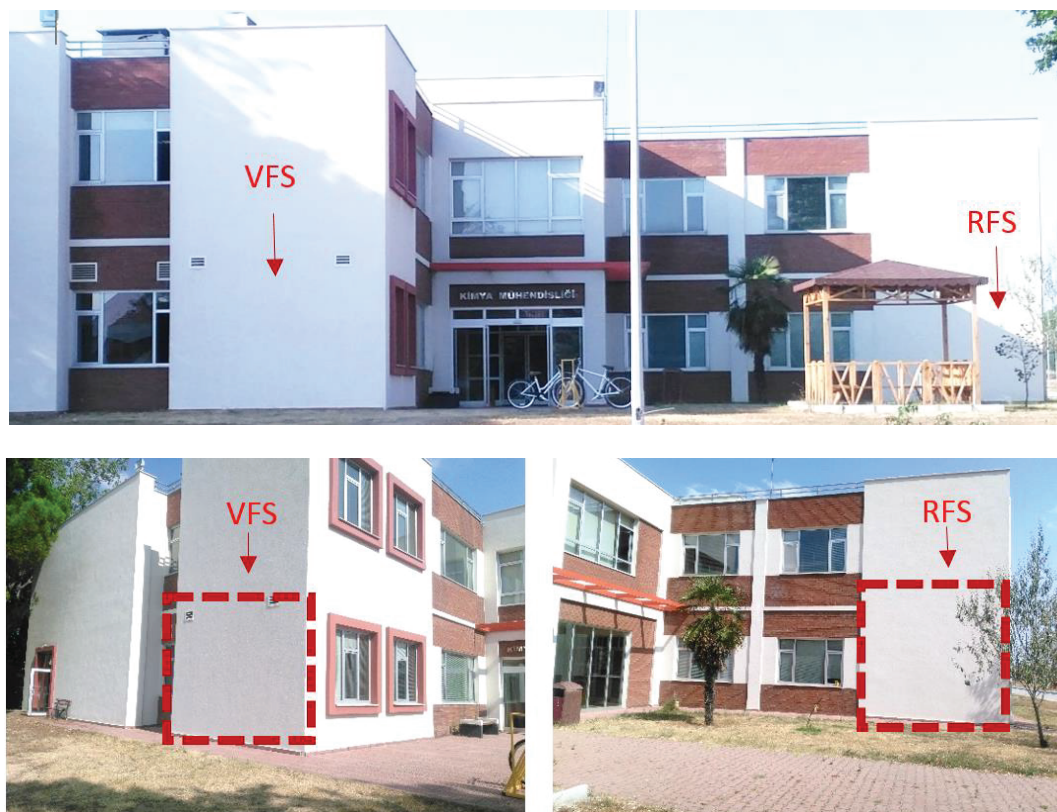
**FIGURE 1.** General views of the experimental building (left: vegetated wall surface, right: reference wall surface).

An existing office building located on the Gebze Technical University campus was chosen as the experimental building; two facade surfaces of the building were used as the vegetated and reference facades (Figure 1). Both facades are oriented to the south. They are exposed to solar radiation for the majority of the day (especially hours when solar radiation reaches high values), and there are no obstructions in front of the facades. Also, there is no opening in the respective walls; both facades are fully opaque. Spaces behind both facades are office rooms. These two rooms have approximately similar conditions. Both of them have the same heating and cooling systems, which is an air conditioning system. It operates between 08:00 and 17:00 during weekdays and doesn't operate during weekends. The window to wall ratios of the east

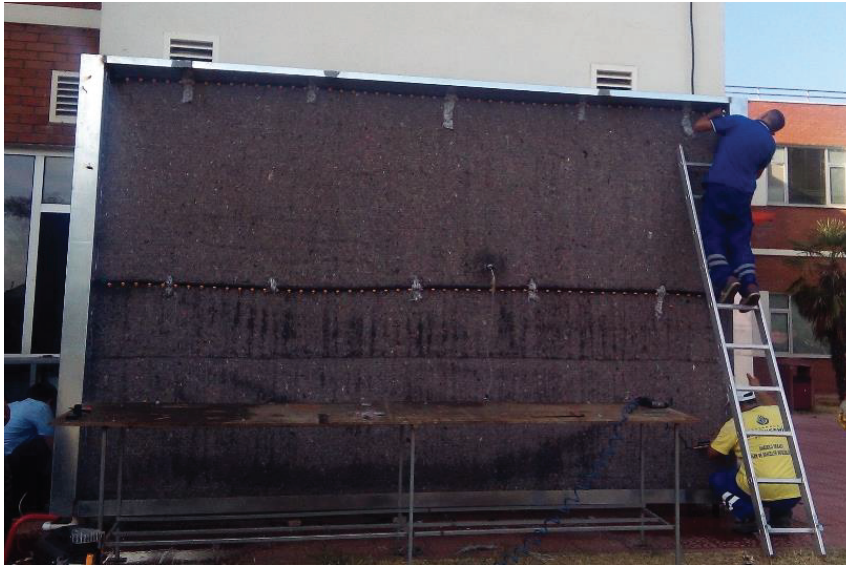
**FIGURE 5.** Geotextile felt material attached on PVC panel and irrigation pipes mounted on the felt layer (image of VFS before plant layer applied).

means of a timer in the summer period to start at 8 am and end at 8 pm and last for 8 minutes per hour. In the winter period, they run from 9 am to 5 pm and last for 5 minutes per hour. Excess water is collected in a drainage channel and discharged into the garden near the building through drainage pipes. Images of all components of VFS are presented in Figures 4 and 5.

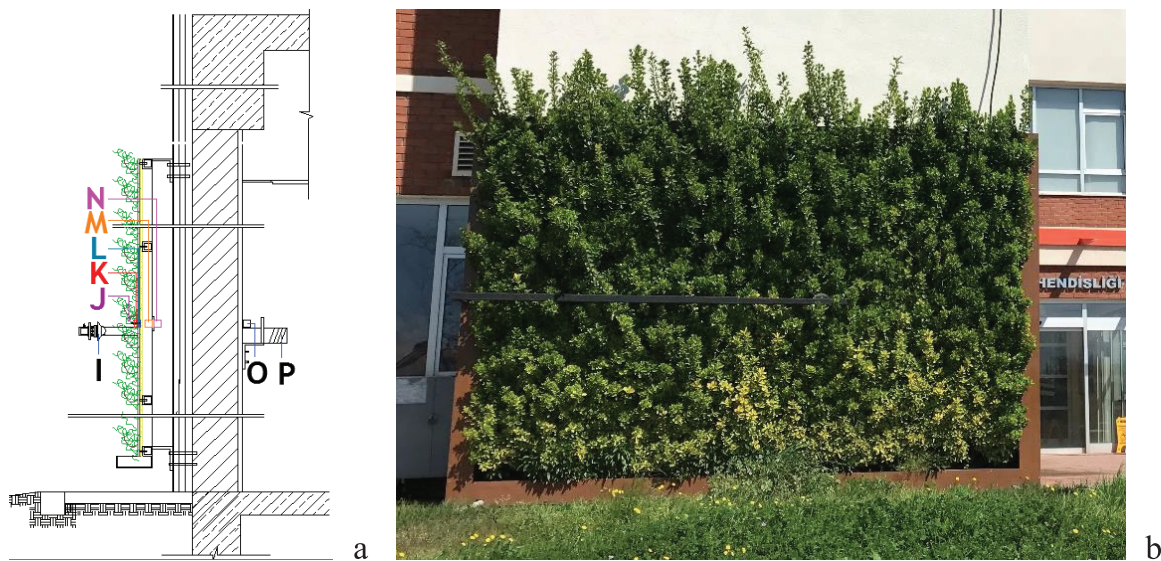
**FIGURE 9A, B.** Section of vegetated facade test assembly(left) and image of vegetated facade system (right).

Three pyranometers were used to measure solar radiation incident and solar reflectance. A pyranometer (“I” in Fig. 9, Table 1) was installed vertically in front of the vegetated facade to measure solar irradiance reflected from the vegetated facade. Two pyranometers were installed in front of the reference facade vertically and mounted back-to-back symmetrically. One of these pyranometers, (“D” in Figure 8a, Table 1) was used to measure solar radiation incident on reference and vegetated facades and the other (“E” in Figure 8, Table 1) measures solar irradiance reflected from the reference facade. Only one pyranometer was decided on to measure incident solar radiation since solar radiation values reaching each of the facades are accepted as identical. Infrared non-contact thermometers were used to measure surface temperatures of the exterior wall of the reference facade (“F” in Figure 8a, Table 1), exterior wall of the vegetated facade (“N” in Figure 9a Table 1), back (“M” in Figure 9a, Table 1) and front (“L” in Figure 9a, Table 1) side of the PVC panel, second layer of felt (“K” in Figure 9a, Table 1). Contact thermometers were used to measure surface temperatures of the interior walls of reference (“G” in Figure

8a, Table 1) and vegetated (“O” in Figure 9a, Table 1) facades. Also, indoor temperature and humidity sensors were placed 20 cm in front of the interior wall surface of the reference (“H” in Figure 8a, Table 1) and vegetated (“P” in Figure 9a, Table 1) facades in order to measure indoor air temperature of the rooms behind the vegetated and reference walls. Additionally, a temperature sensor (“J” in Figure 9a, Table 1) was placed inside the leaves to measure the air temperature among leaves [24]. Location of the sensors are decided according to ISO 10211-1:1995 Standard [33]. All the air and surface temperature sensors and pyranometers are placed about 175 and 180 cm away from ground level and columns in order to avoid thermal bridging caused by any material difference. Surface temperature sensors and pyranometers regarding VFS and RFS can be seen in Figure 10.

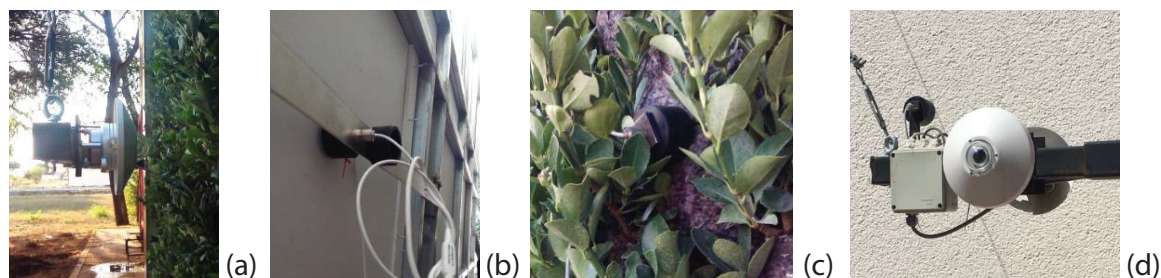
**FIGURE 10.** Images and location of the sensors: (a) pyranometer in front of VFS, (b) infrared sensors measuring exterior surface temperature of vegetated wall and back side of PVC panel, (c) infrared sensor measuring surface temperature of geotextile felt, and (d) pyranometers in front of RFS
