HYBRID VENTILATION IN THE HARM A. WEBER ACADEMIC CENTER: A LATE-SUMMER CASE STUDY

Dianne Ahmann^{1,2} and Lee Durston²

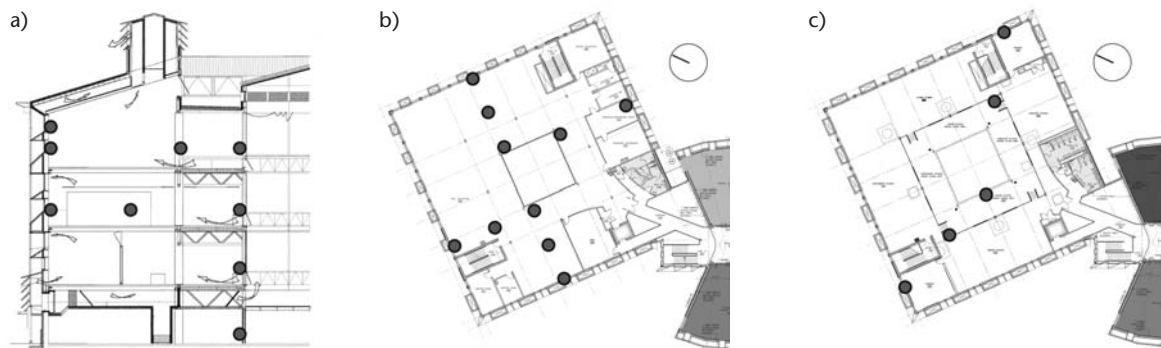
Figure 3. Positions of Hobo dataloggers projected in section (a) and in plan on Levels 3 (b) and 4 (c).

To record thermal comfort parameters, Hobo dataloggers were deployed at 17 positions throughout Levels 3 and 4 and single positions near the lightwell on Levels 1 and 2, as well as externally (Figure 3). Airspeeds were measured by anemometer, and mean radiant temperatures were estimated by globe thermometer at 8:00 a.m., 12:00 noon, and 4:00 p.m. each day. Examination of these data for three points of interest showed that conditions fell consistently outside the comfort zone, but only slightly so (Figure 4). At 8:00 a.m. on 8/23, outside temperatures were equal to the lowest observed at that hour (see Figure 12 for full thermal data). Level 1 was within the comfort zone, while all locations on Levels 2–4 fell above the zone; some were both too warm and too humid, but some, especially on Levels 2 and 4, were only too humid. External conditions were much more humid than internal positions, but not substantially warmer (Figure 4a). By 12:00 noon on the same day, external conditions became much warmer, but internal conditions remained steady or cooled somewhat, especially on Level 3, while humidities remained above the comfort zone. Level 1 conditions reached the comfort zone boundary, suggesting that the floor plenum air was conditioned only minimally. (Figure 4b). An unusually severe thunderstorm cooled the area dramatically later that afternoon (see Figure 13), causing data from the previous afternoon (4:00 p.m. 8/22) to represent conditions more representatively. At this time, external conditions were the warmest and most humid of the set, yet Levels 1 and 2 became cooler and drier,

Level 4 is ventilated independently of Levels 1–3 by means of ceiling grilles high on the vaulted ceiling, just below the lightwell openings (Figure 3a), at 4 locations (20). Level 4 possesses a double-door entrance to the bowtie like that of Level 3, in addition

to two stairwell openings, two seminar rooms with thermostats and mechanical air conditioning grilles, and an unsealed glass door opening to the greenhouse at the top of the lightwell (Figure 3b).

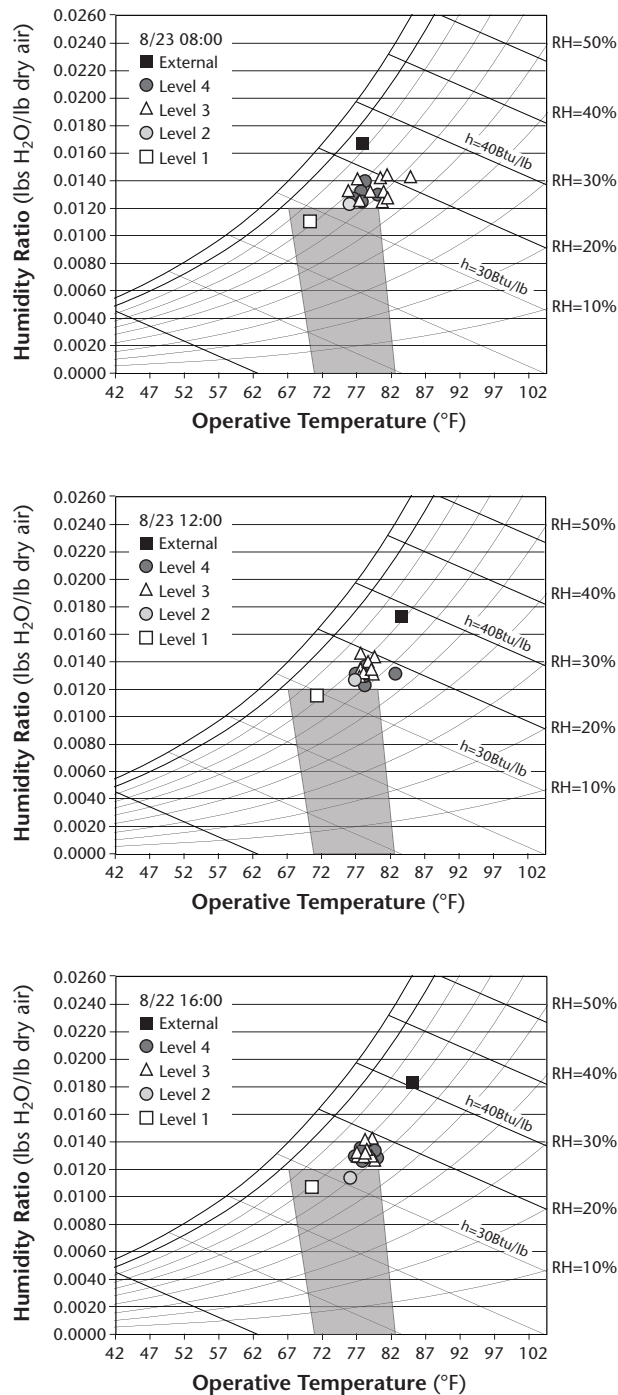
FIGURE 4. Thermal Comfort. Thermal comfort parameters of (a) 8:00 a.m. 8/23, (b) 12:00 noon 8/23, and (c) 4:00 p.m. 8/22 compared to the ASHRAE 55-2004 thermal comfort zone (shaded) show that internal conditions remained within or near the zone on Levels 1 and 2, while Levels 3 and 4 fell slightly outside the zone due to high humidity rather than temperature, during hot humid weather.

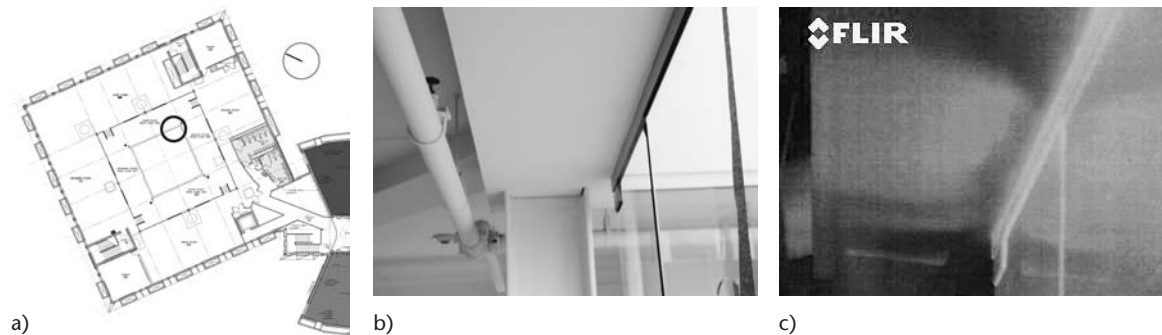
The glass door to the greenhouse (Figure 11a, b) was similarly found to admit abundant warm air to the studios (Figure 11c). This door was unsealed and opened directly from the platform onto the thermal buffer between the glazed lightwell roof and the ventilatory chamber of the lightwell. While the greenhouse was both shaded (Figure 13) and ventilated by clerestory windows, the internal temperature nevertheless reached nearly 90°F during late afternoons, and warm air was found flowing into the platform space consistently throughout the week.

FIGURE 11. Greenhouse Door. The greenhouse on Level 4 possessed an unsealed glass door on the northwest side (a, b), allowing warm air to enter, as viewed against the adjacent soffit (b, c). Airspeed mode: 140fpm; maximum: >400fpm; entry air temperature: 87.2°F; ambient air temperature: 74.5°F. (8/21/07, 11:36 a.m.).

As indicated above (Figure 11), the greenhouse contributed warm air to Level 4 through an unsealed glass door. It appeared to contribute radiant heat as well, however, as evidenced by infrared photography (Figure 14), potentially affecting not only the dry bulb temperature but also the mean radiant temperature of the space.

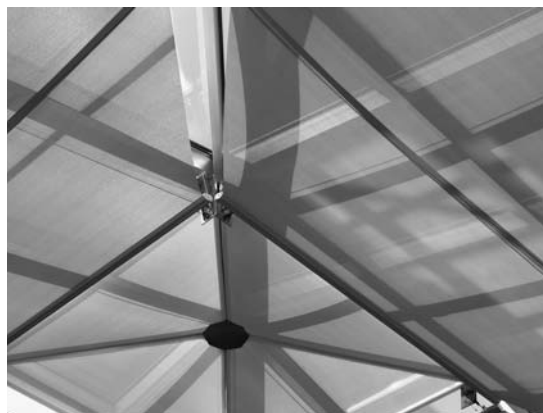
In possible anticipation of heat gain issues, the greenhouse was designed as a thermal barrier between the exterior environment and the top of the lightwell (10); it therefore possesses a glass floor at the height of the Level 4 platform. The greenhouse also has clerestory louvers around its perimeter that opened each afternoon of the study, presumably to mitigate overheating of the internal air, as well as internal retractable shade cloths (Figure 13). The latter were fully deployed or deployed on all but the NW quadrant throughout the study.

FIGURE 13. Greenhouse Shading. The greenhouse, at the top of the lightwell, was equipped with retractable shade cloths that were deployed on all, or all but the NW quadrant, throughout the study.

The greenhouse and lightwell were important thermal contributors on Levels 3 and 4, as shown by the persistence of greenhouse- and lightwell-induced thermal gradients despite counteracting influences of mechanical conditioning and unintended airflows through windows, offices, and stairwells. On Level 3, the dominant pattern was a north-to-south gradient, with the north side warmest, both because it was able to receive southern sunlight through the lightwell glazing, and because cool air was entering the south corner from the bowtie. On Level 4, the dominant pattern was a radial thermal gradient, warmest at the center. While interior shade cloths were drawn across the greenhouse roof, these were apparently insufficient, and external shading for the greenhouse should be a top priority in future work.

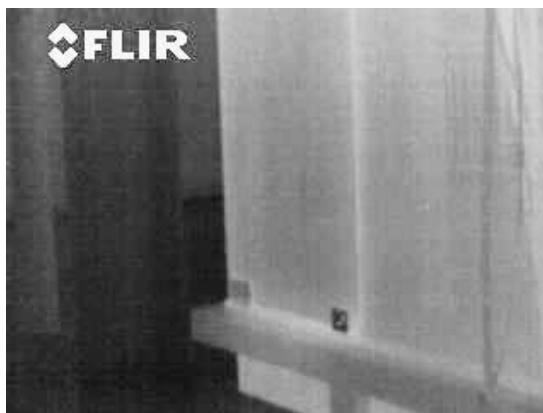
FIGURE 14. Greenhouse Radiance. Infrared photography shows the warmth of greenhouse glass as viewed from the Level 4 platform; warmer temperatures are lighter in color.

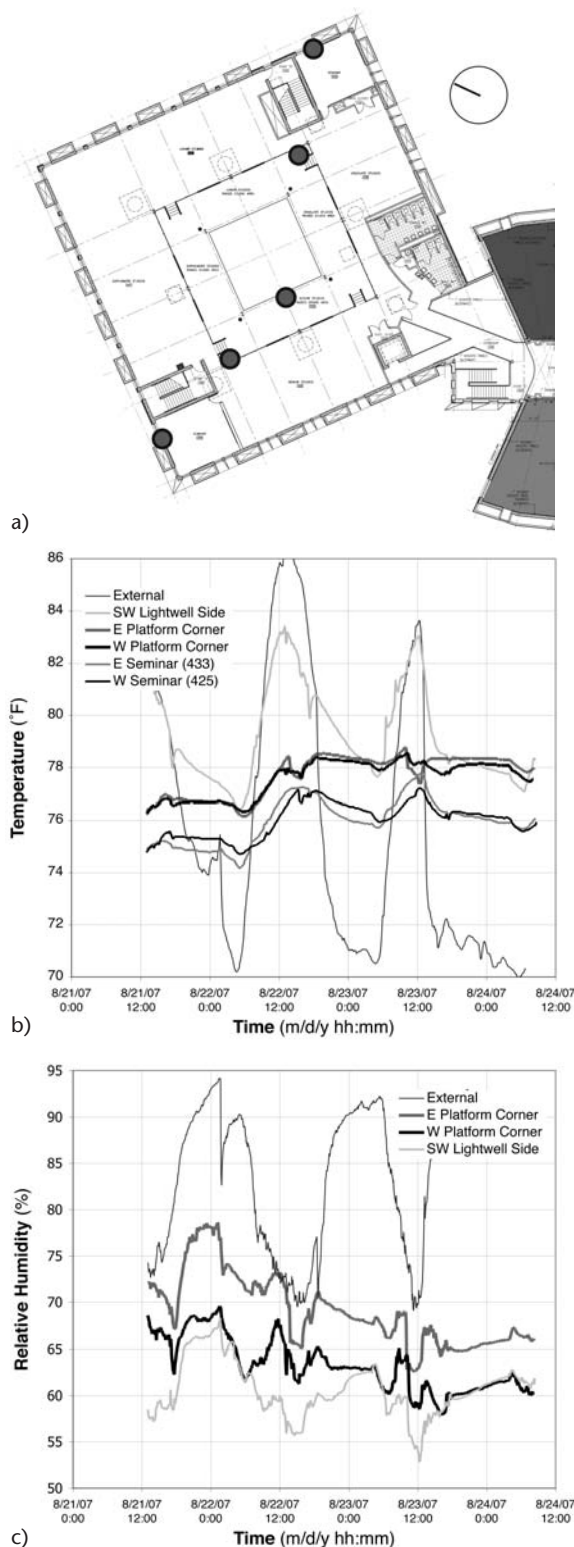
From the lightwell outward to the seminar rooms, temperatures dropped noticeably (Figure 15b). This radial thermal gradient was expected, because the seminar rooms were conditioned, even if modestly. The similarity in temperatures of the E and W platform corners was not expected, however, given the minimal conditioning of the studio space and the exposure of the E platform corner to considerable outside air via the NE open window described above. Relative humidity measurements among the three central positions confirmed that the E platform corner experienced a noticeably greater proportion of humid outside air than the others (Figure 15c). Given its air supply, its temperature was also expected to be greater than that of the W platform corner. The fact that it was not emphasized the thermal role of the greenhouse in warming the studio spaces during the study.

FIGURE 15. Lightwell Heat Gain: Level 4. Hobo dataloggers were deployed at the working plane in an E-W transect across Level 4 (a). Dry-bulb temperatures (b) showed diminishing warmth with distance from the greenhouse, while relative humidities (c) showed the contribution of humid outside air from the open window to the east platform corner.

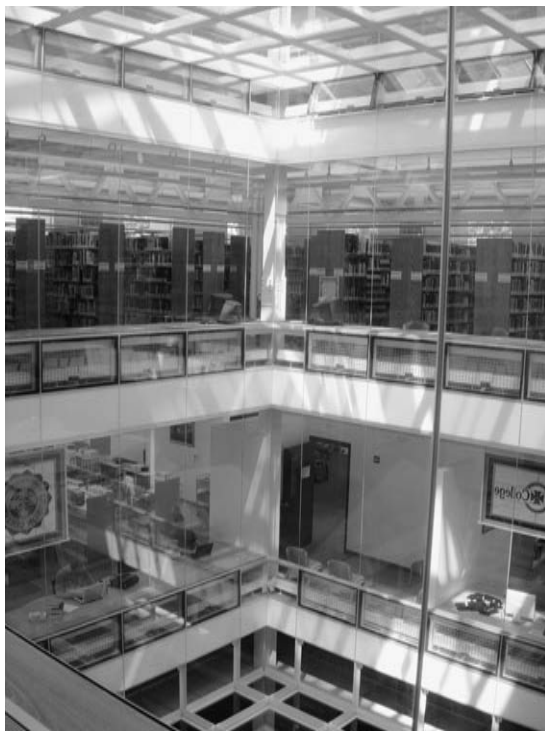
FIGURE 17. Lightwell Direct Sunlight. Direct sunlight from the lightwell is shown illuminating the north glazed surfaces of the lightwell; Levels 3 and 2 of the library are visible beyond.
