BEHAVIOUR OF PLASTERED STRAW-BALE ASSEMBLIES SUBJECTED TO THREE-POINT BENDING

Michael Rakowski, M.Sc.¹ and Colin MacDougall, PhD, P.Eng.²

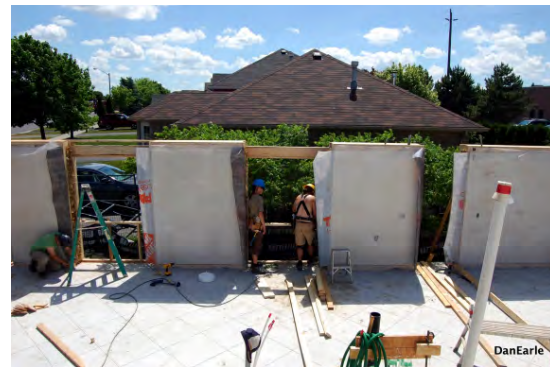
FIGURE 3. Prefabricated straw bale panels used for residential construction.

years. The period since the early 1990s has seen a revival in interest in straw-bale construction. Thousands of straw-bale buildings have been constructed, from self-built homes to larger public buildings. Pre-fabricated straw-bale panels have been successfully integrated into conventional timber and concrete frames as well (Figure 3).

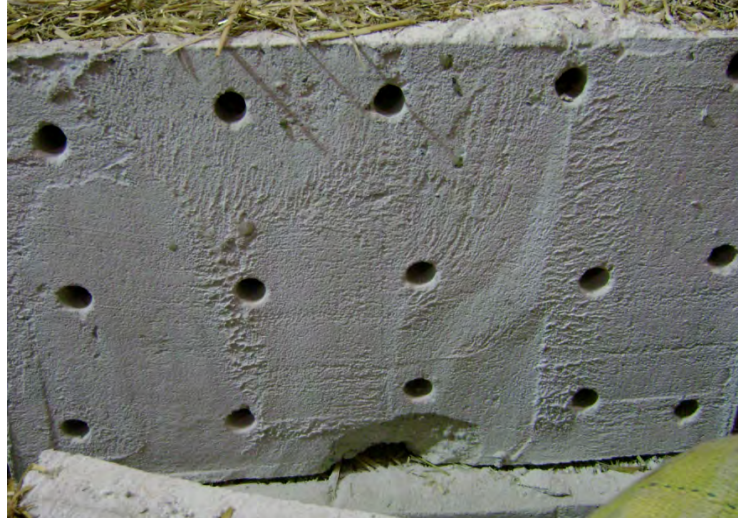
FIGURE 10. Holes drilled in the plaster skin after the completion of each test to permit measurements of the plaster thickness.

The panels were tested in stroke-control at a rate of 0.1 mm/min. The test proceeded until a few minutes after the ultimate load was reached to record the pre- and post-failure behaviors. Upon completion of each test, 15 holes were drilled in each of the two plaster skins of the straw-bale and the depths were recorded to approximate the skin thickness at various locations. The plaster cubes and cylinders were tested following the procedures in ASTM C109 and C39, respectively.

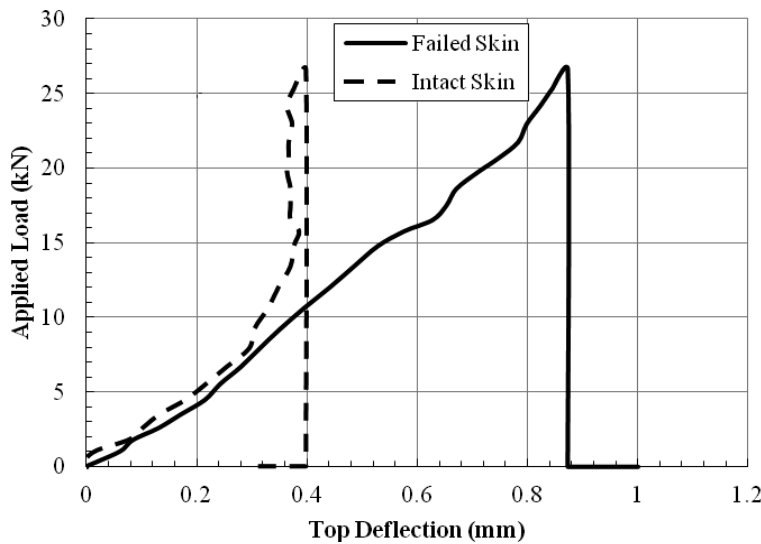
FIGURE 11. Load-deflection curve for Specimen 6.

A typical load-deflection curve for a specimen with $H/L < 1$ is shown in Figure 11 (Specimen 6). The ‘Top Deflection’ values on the x-axis represent the vertical deflection of the top bearing pads. The curve’s general shape was typical and represents all the characteristics of the

The dotted line in Figure 11 represents the load vs. vertical deflection curve of the intact skin while the solid line shows that of the failed skin. Initially, the deflection in both skins was similar. This indicates that the top beam was loading each skin equally. At about 15% of the ultimate load, the curves for each skin began to diverge. The deflection of the intact skin increased at a much slower rate than the failed skin (note that at this point, neither skin has

failed). This indicates that the top beam was rotating. At failure, there was about a 0.5 mm difference in the vertical deflection of the intact and failed skins. This is equivalent to a top beam rotation of 0.05 degrees. This divergence in deflections could be related to the difference in strength and stiffness of the plaster composing each skin. As loading increased, the weaker skin would begin to develop microcracks, leading to a reduction in stiffness and increased deflections on that side.

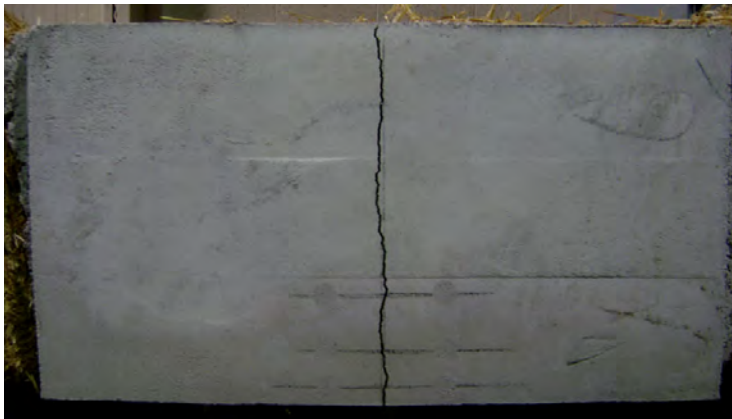
FIGURE 12. Plastered straw bale panel, failed by vertical tensile cracking.

Each of the six specimens with $H/L < 1$ failed when one plaster skin experienced failure by cracking (referred to as the “failed skin”) while the other (referred to as the “intact skin”) remained intact, showing no signs of failure. A large crack initiated at the bottom edge of the plaster skin halfway between the two reaction points and was approximately 5 mm in width. The crack immediately propagated upwards vertically, penetrating the top edge of the plaster skin and leaving only the straw to resist the load. The integrity of the bearing points remained, and no crushing of the plaster beneath the bearing pads was observed. Figure 12 shows a failure of this type.

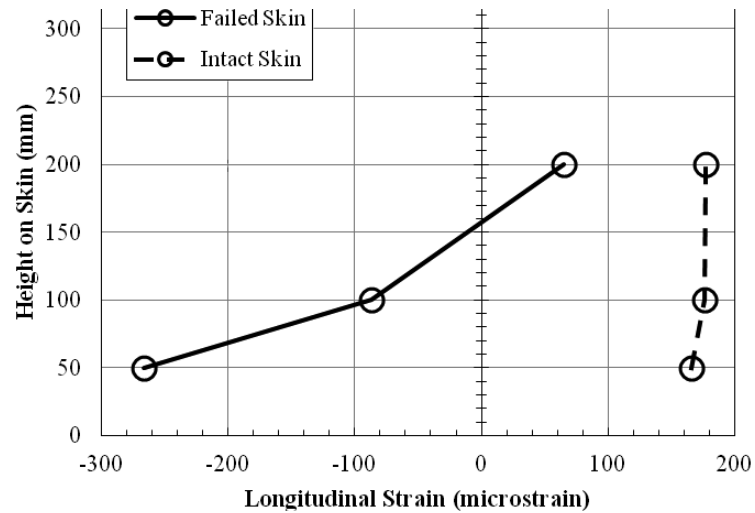
FIGURE 13. Strain distribution of plaster skins at the ultimate load of Specimen 6.

The strain distributions of the two plaster skins at the ultimate load of the panel are shown in Figure 13. Negative values of strain are in tension. At a height of 50 mm from the bottom of the failed skin, a longitudinal strain of -267 microstrain was recorded at the ultimate load. The extreme tensile strain was consistent with the observation of a tensile crack forming at failure. The tensile strain decreased with height and was approximately linear. The size of the tensile zone was approximately 150 mm from the bottom, or 46% of the plaster skin height. The strains measured on the intact skin were all compressive. Tensile strains may have occurred at a level lower than that at which Pi gauges were mounted. Nevertheless, the Pi gauge data indicates that the two plaster skins were not bending equally.

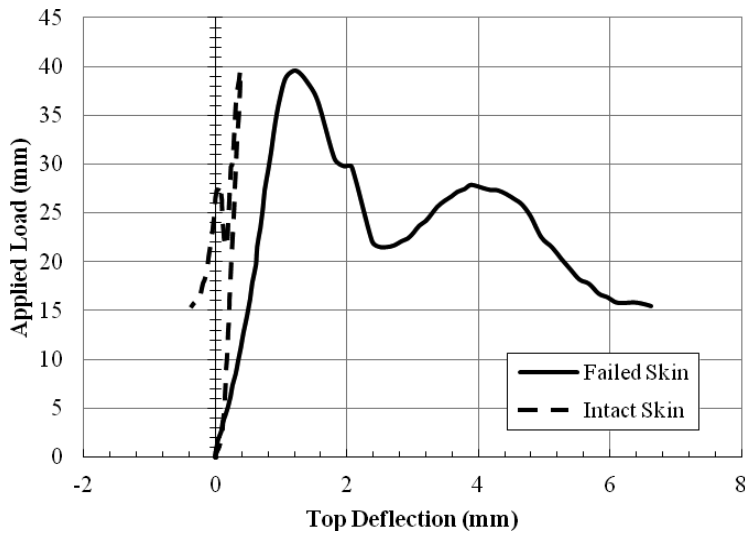
FIGURE 14. Load-deflection curve for Specimen 8.

As the H/L ratio increased, the failure mode was observed to change from vertical tensile cracking at mid-panel to bearing failure at the loading point. The load-deflection curve for Specimen 8 is shown in Figure 14. The curve's general trend of the response is typical for unreinforced bales with span lengths of 200 mm, 250 mm, and 300 mm. At the ultimate load, one plaster skin experienced failure by crushing of the plaster beneath the top pad, while the other skin remained intact.

Up to 15% of the ultimate load, the load-deflection response of each plaster skin was identical. At this point, the curves began to diverge. Unlike the bales with 400 and 500 mm span lengths, the failure was not accompanied by a total loss of load capacity. After the ultimate load was reached, the top bearing pad continued to crush the plaster beneath it. At this point, the residual strength of the straw-bale assembly was 40 to 60% of the ultimate strength.

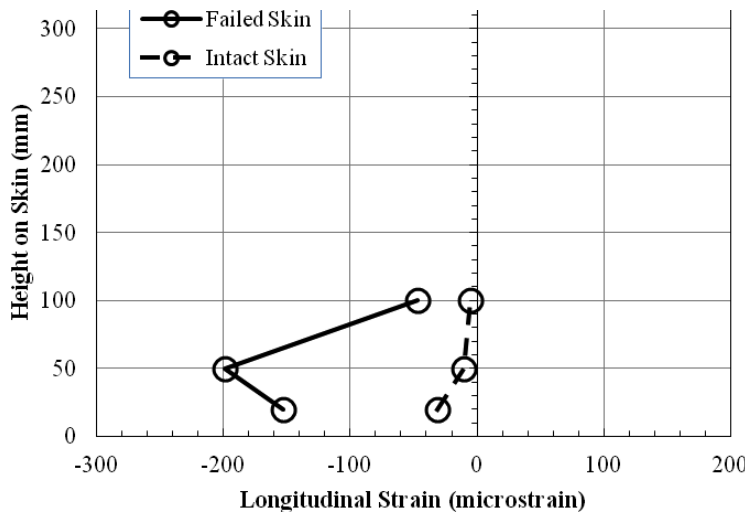
FIGURE 15. Strain distribution of plaster skins at the ultimate load of Specimen 8.

The strain distribution at the ultimate load for Specimen 8 (Figure 15) indicates that the tensile strains that were developed in the failed skin were less than those measured for the tests with $H/L > 1$ (Figure 13). Note the Pi gauges were shifted towards the bottom

edge of the plaster skin for these tests. The strain measured by the Pi gauge located 20 mm from the bottom ($-150 \mu\epsilon$) is less than that measured by the gauge 50 mm from the bottom ($-200 \mu\epsilon$), which is not expected. However, the difference is within the precision of the Pi gauges ($\pm 100 \mu\epsilon$). The strains in the intact skin were significantly less than those in the failed skin at the ultimate load, again indicated that the two skins were not being loaded evenly. The strain distribution, if extrapolated for both skins, suggests that the neutral axis is located between a height of 100 mm to 150 mm.

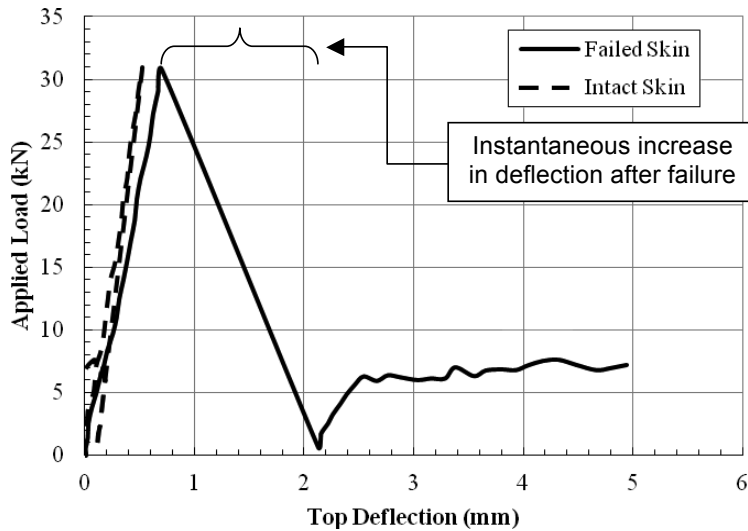
FIGURE 17. Load-deflection curve, Specimen 11.

The reinforced specimens (Specimens 10, 11, and 12) were tested with a 400 mm span, and failed in the same manner as the unreinforced panels with 400 and 500mm support spacing; that is, at the ultimate load, a vertical tensile crack developed in one of the plaster skins while the other remained intact. The load-deflection curve for Specimen 11 is shown in Figure 17. Like the unreinforced bales, the behaviour of the two skins was similar up to 15% of the ultimate load. At that point, the deflections in the failed skin increased faster than the intact skin. At the ultimate load, sudden vertical cracking of the bottom plaster edge at mid-panel led to a rapid loss of strength. The crack immediately propagated upwards, penetrating to the top edge of the plaster skin. Unlike the unreinforced specimens of 400 and 500mm spacing, residual strength was present after the maximum load. The integrity of the bearing points remained and no crushing of the plaster beneath the bearing pads was observed. No rupture of the steel reinforcement was observed at failure. Instead, the plaster and diamond lath became debonded and the geometry of diamond shaped openings became skewed slightly.

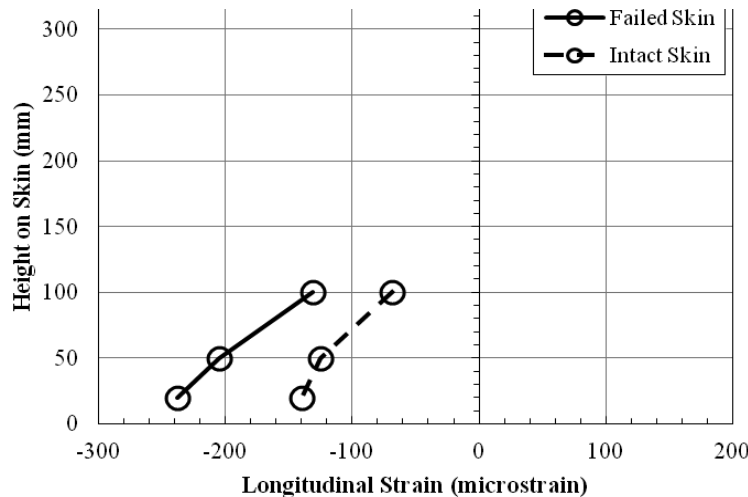
FIGURE 18. Strain distribution of plaster skins at the ultimate load of Specimen 11.

The strains measured at failure for Specimen 11 are shown in Figure 18. As observed in the other tests, the tensile strains in the failed skin were higher than those in the intact skin. Extrapolating the data, the location of the neutral axis can be estimated as 30% and 60% of the height of the panel and the ultimate tensile strain in the plaster can be estimated to be between 250 and 300 microstrain.
