SUSTAINABLE STRATEGIES FOR THE REHABILITATION OF AN HISTORIC STATE OFFICE BUILDING

Robert C. Burns, AIA, LEED AP¹

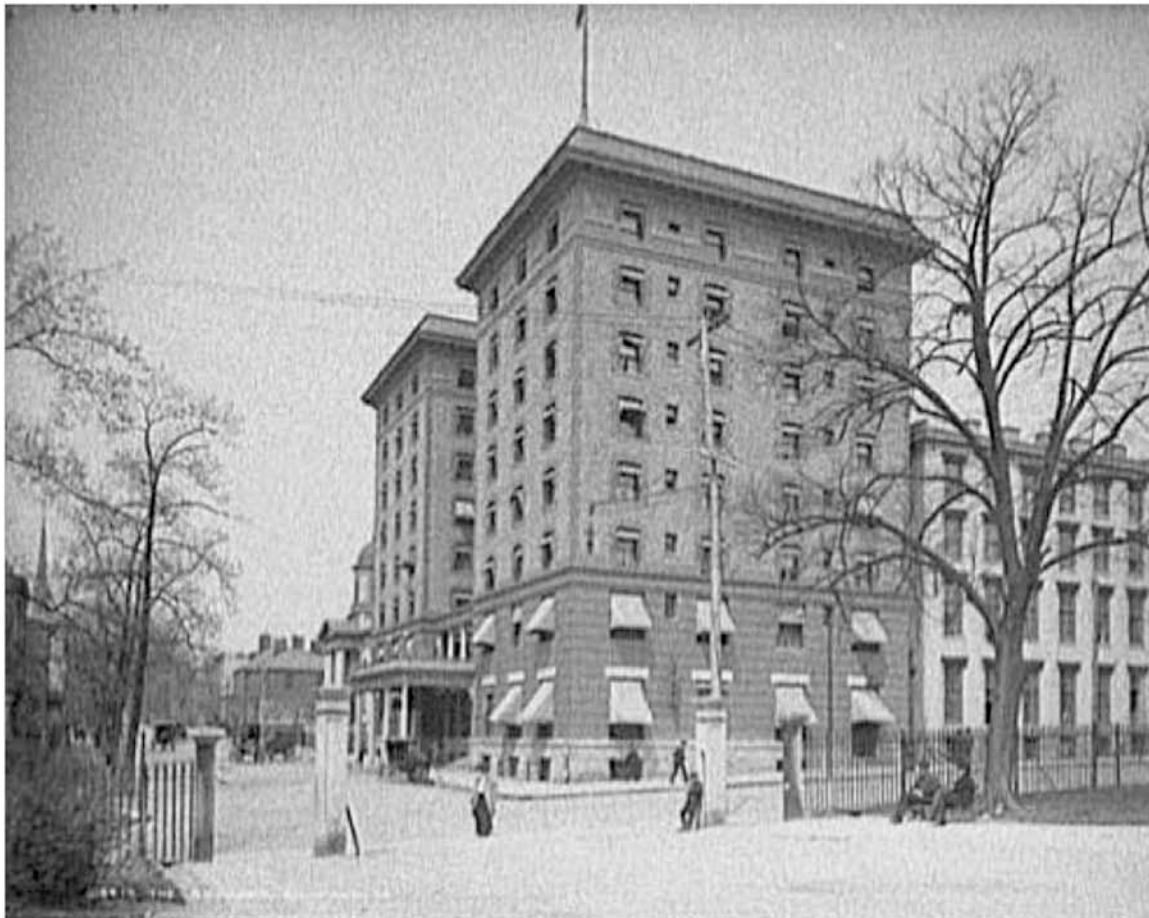
FIGURE 2. Original 1904 configuration of the Hotel Richmond.

The architecture of the Hotel Richmond is as distinctive as its social history. The original eight-story 1904 Albright work is an elegant brick Italianate structure, featuring a dressed ashlar foundation and rusticated first and second stories, and formed a perfect basis for the

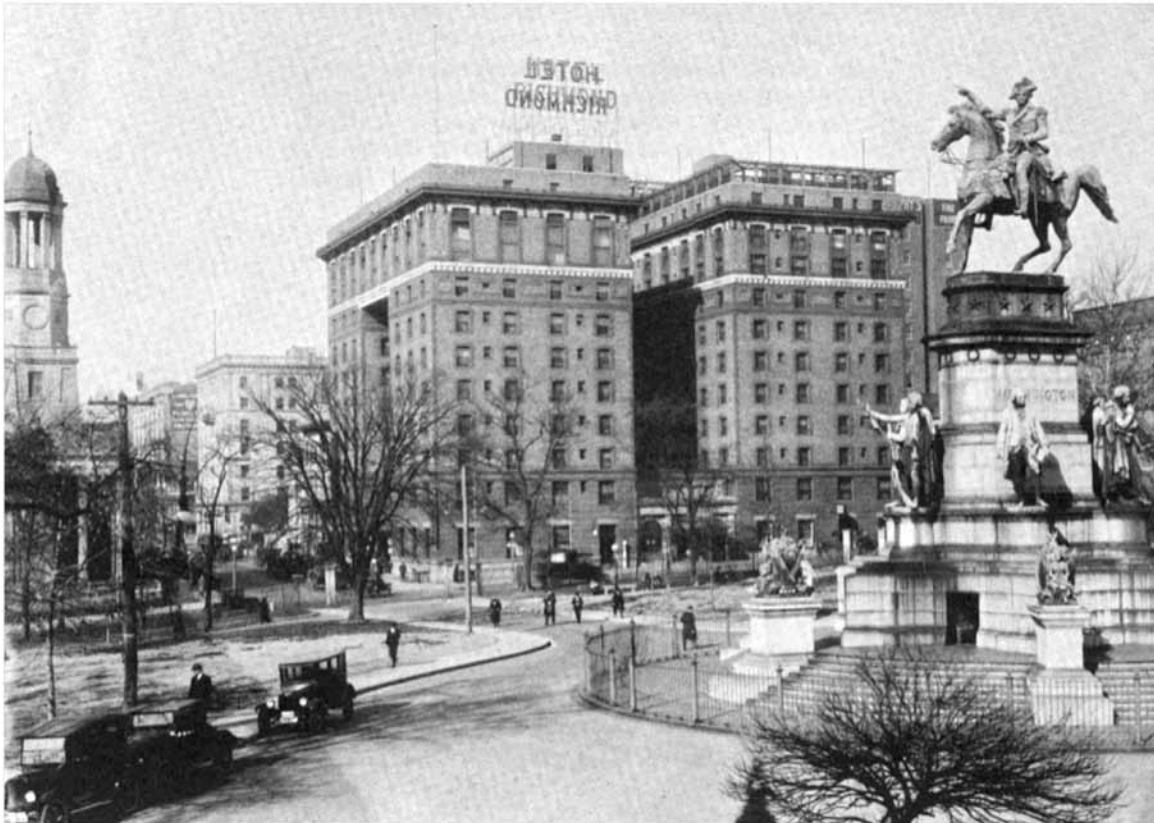
FIGURE 3. Post-1911 configuration of the Hotel Richmond, photo c. mid-1920s.

Peebles' design for the Hotel Richmond created a complete and fine example of the Neoclassical, high-rise hotel prevalent in the early 20th-century United States. Through the use of such elements as contrasting brick, stone and terra cotta masonry, and highly detailed copper cornice work, Peebles created a striking and distinctive architectural composition, while his interior elements, including the grand double-height Ninth Street Grand Entrance Lobby and the Ninth Floor Ballroom "Winter Garden" provided both monumental and welcoming public spaces. Original construction drawings and photographs from the building's history clearly document the high quality of the Hotel Richmond's interior and exterior spaces during their heyday, and much of this detail survives in the existing Ninth Street Office Building today.

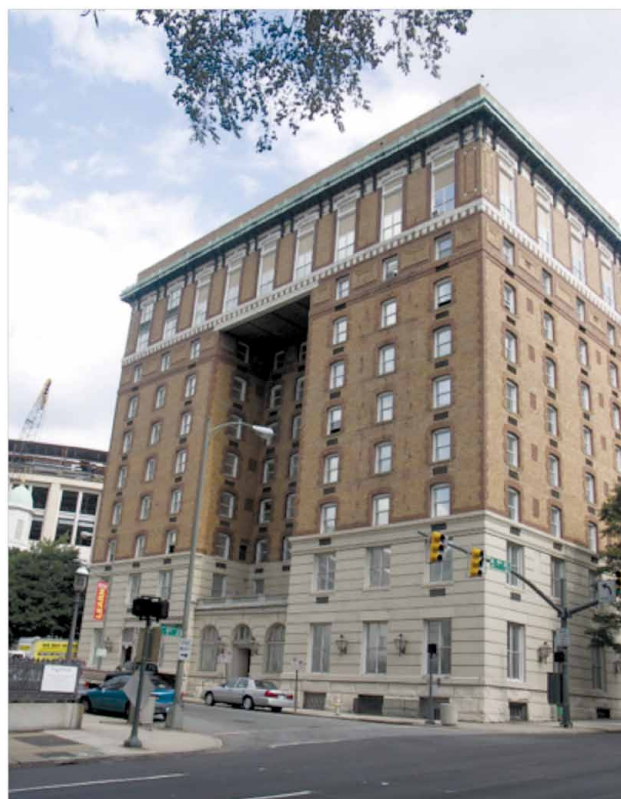
FIGURE 4. Ninth & Grace Street Corner showing Pre-Project Existing Conditions, 2006. Note painted stone and brick masonry base floors and through-wall fan coil units under deteriorated aluminum replacement windows.

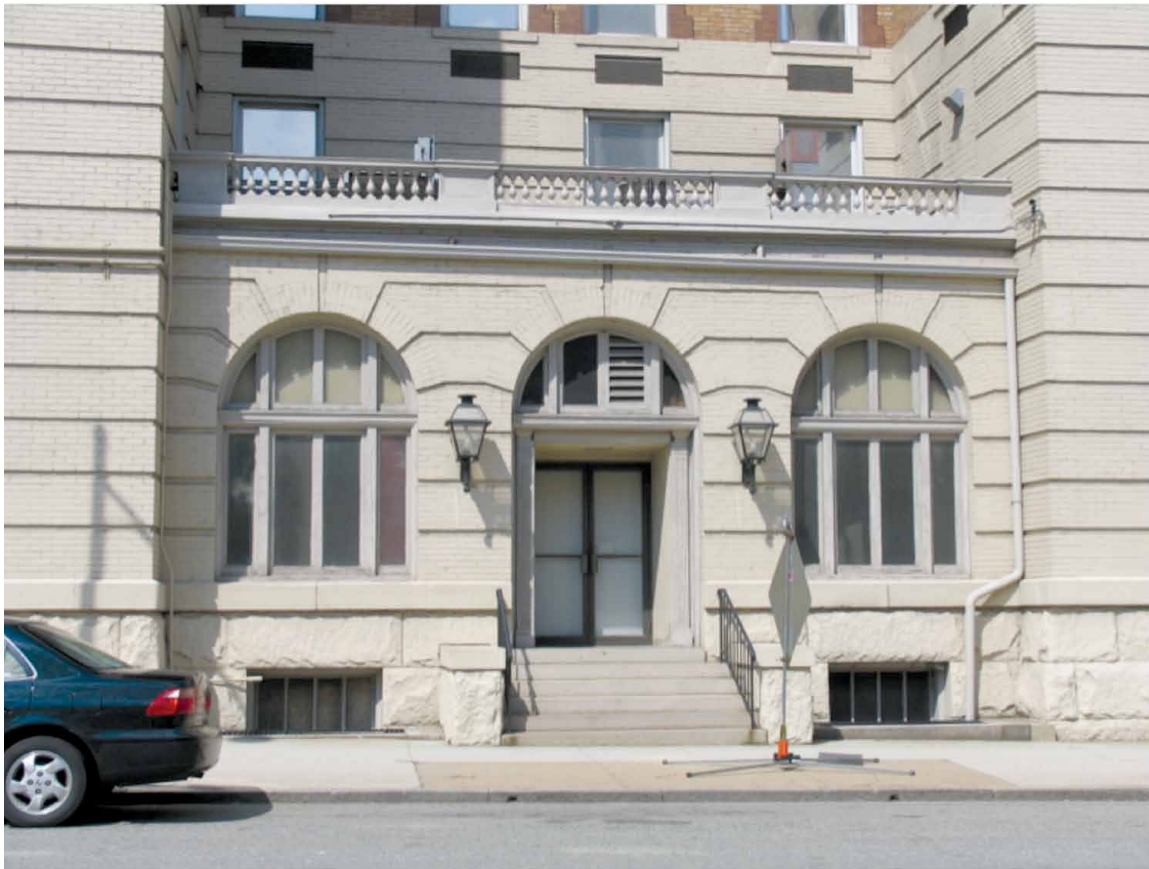
FIGURE 5. Grace Street Entrance showing Pre-Project Existing Conditions, 2006. Note painted stone and brick masonry at lower base floors and deteriorated wood and aluminum windows.

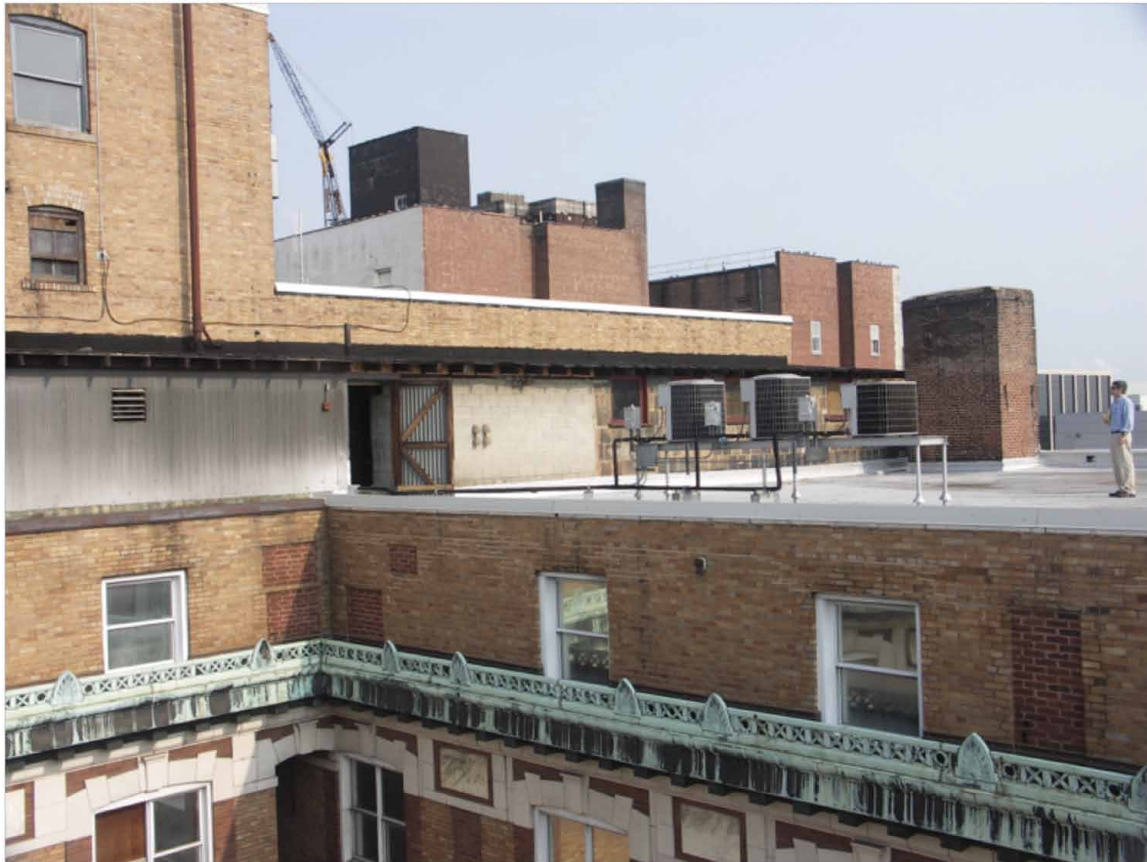
FIGURE 6. Ninth Street Courtyard Upper Floors and Rooftop showing Pre-Project Existing Conditions, 2006. Note deteriorated brick masonry joints, mismatched masonry infill, outdated rooftop mechanical equipment, deteriorated aluminum replacement windows, and incompatible rooftop structures to be removed.

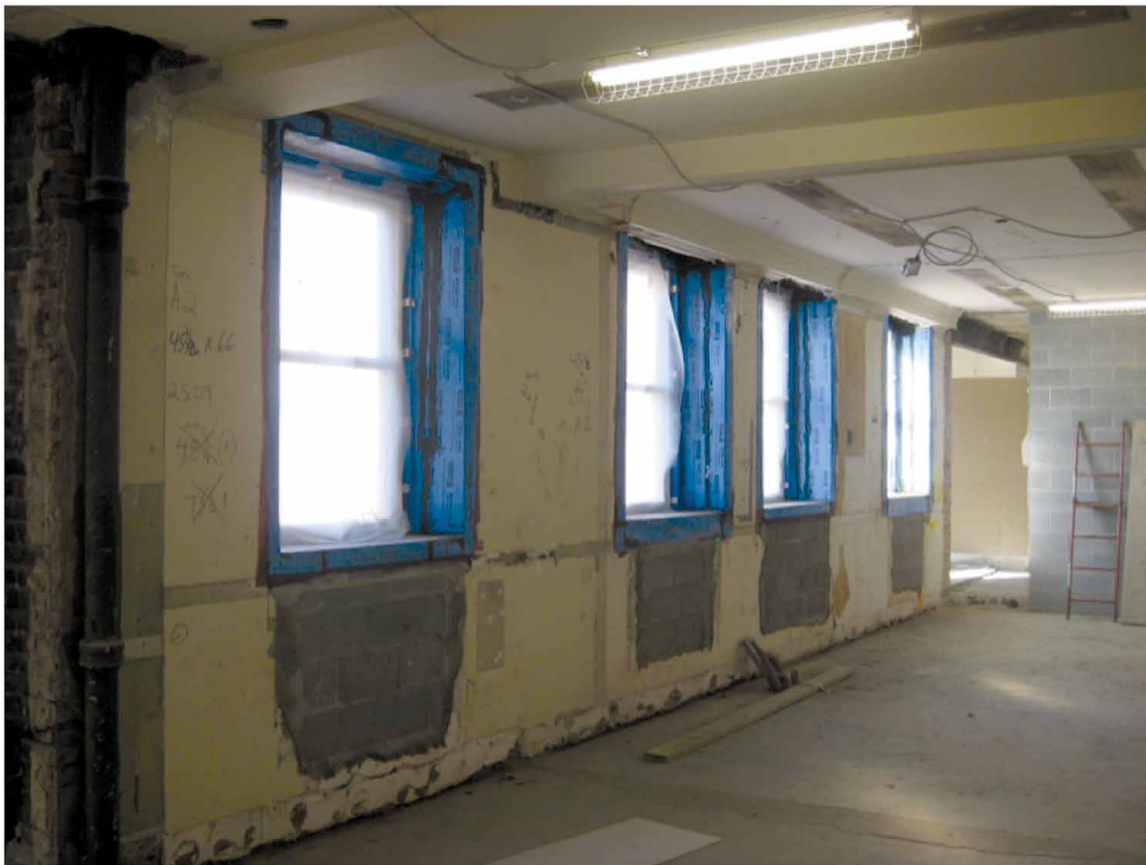
FIGURE 9. Repair of existing exterior enclosure work in progress. Note CMU infill at former through-wall HVAC unit locations, installation of new replacement insulated window units and associated window flashings, and water barrier.

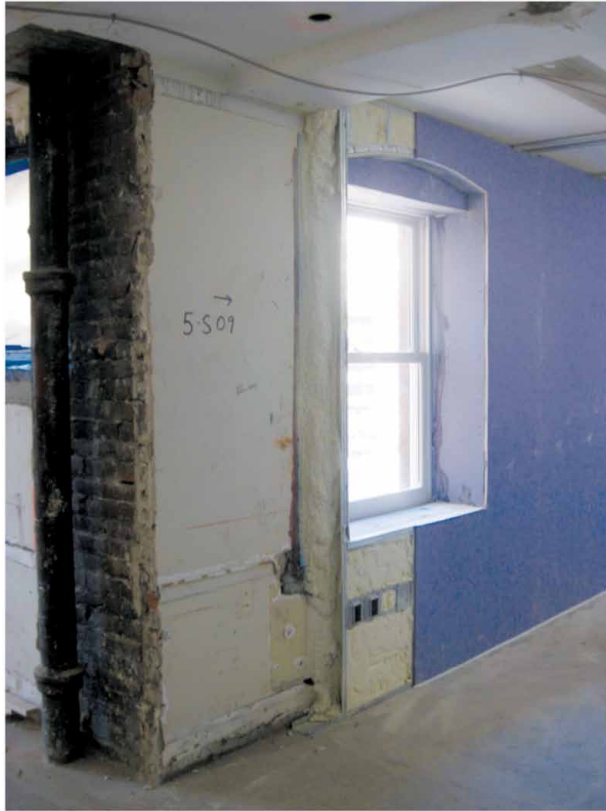
FIGURE 10. Insulation of exterior enclosure work in progress. Note existing plaster and brick masonry wall condition at left, metal stud cavity with spray foam insulation at new window, and purple moisture resistant gypsum board at right.

On the Ninth Street Office Building, the existing building envelope offers great opportunities for sustainable upgrades. As discussed above, the existing masonry exterior construction is one of the primary historic character defining systems of the building and so removal and replacement of the exterior masonry is neither desirable nor practical. The condition of the existing brick and terra cotta masonry and mortar was carefully evaluated and repointed where necessary, resulting in an improved exterior skin. The problem of how to improve the thermal resistance of the envelope was solved through the use of additional thermal insulation at the interior of the enclosure. Since the existing interior plaster walls were deteriorated beyond repair and required replacement in any case, a new metal stud furring cavity was added to the interior of the solid brick masonry exterior wall

and closed-cell polyurethane foam insulation was sprayed into the cavity. By this method, a total minimum R-value of 21 was achieved for the exterior wall. The spray-on applied insulation also provides a far superior air and moisture barrier for the interior space than the original historic solid masonry and interior plaster construction. New high quality aluminum clad wood insulated window units (U value = 0.4) were installed to replace the existing 1970's retrofit aluminum windows to complete the thermal wall enclosure and provide an improved historic appearance to replicate the original (long gone) historic wood windows. The existing black single-ply membrane roof was at the end of its useful life, so the addition of new polyisocyanurate rigid insulation (R value = 30) under a new light colored, reflective, thermoplastic polyolefin (TPO) membrane roof was an easy task.

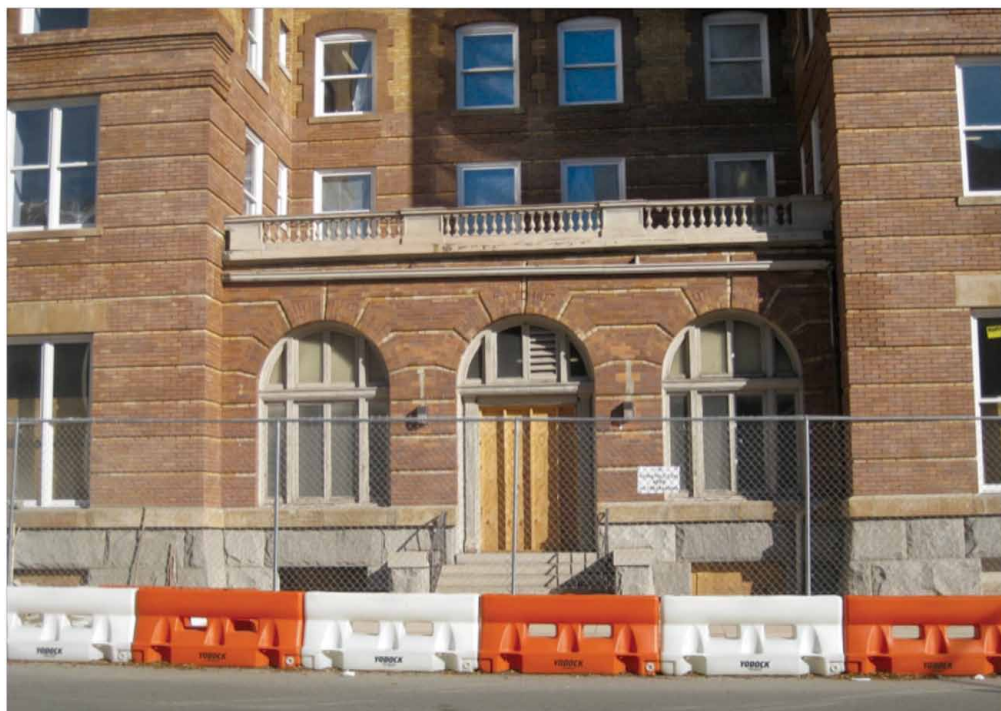
FIGURE 11. Grace Street Entrance showing rehabilitated condition, 2014. Compare with pre-construction photo above. Note paint coatings removed from stone and brick masonry at lower floors, along with restored brick masonry. Deteriorated historic wood windows have not yet been restored.

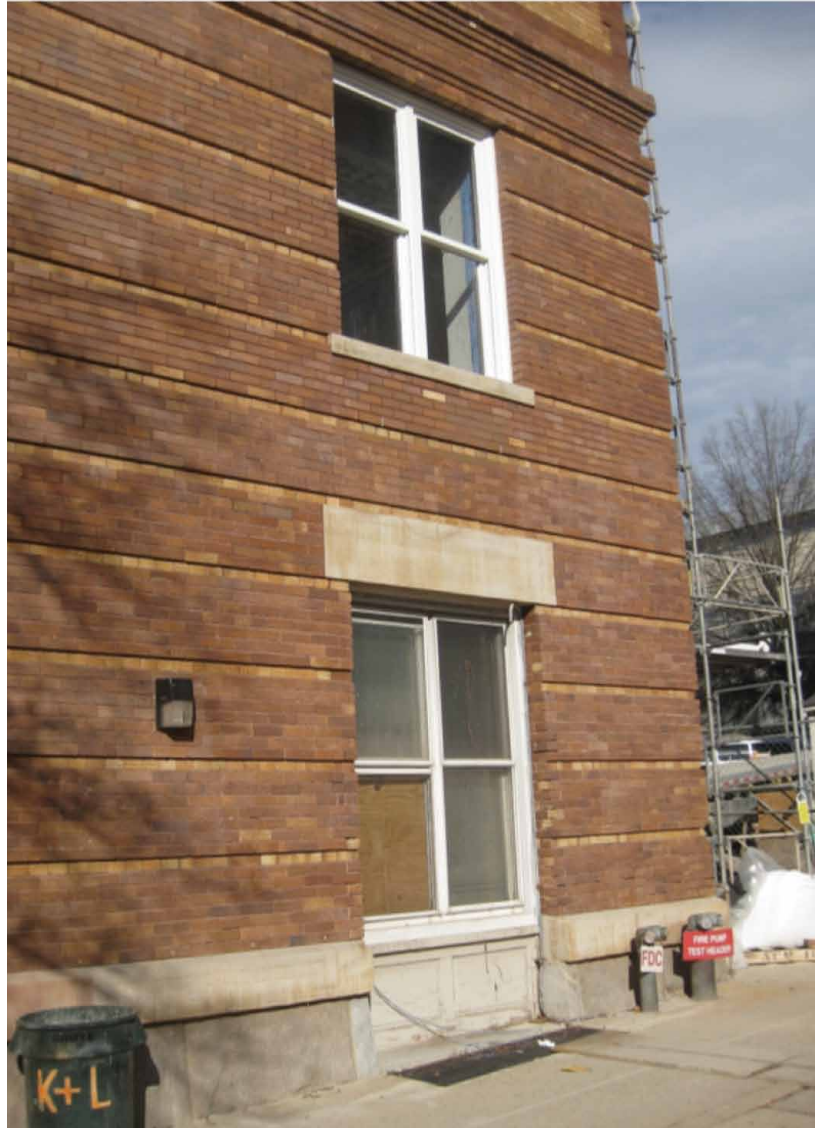
FIGURE 12. Northeast corner of the Ninth Street Façade showing restored brick and stone masonry and new replacement window at Second Floor. The First Floor window is a pre-existing deteriorated aluminum window that has yet to be replaced. The light fixture on the wall is a temporary construction fixture.

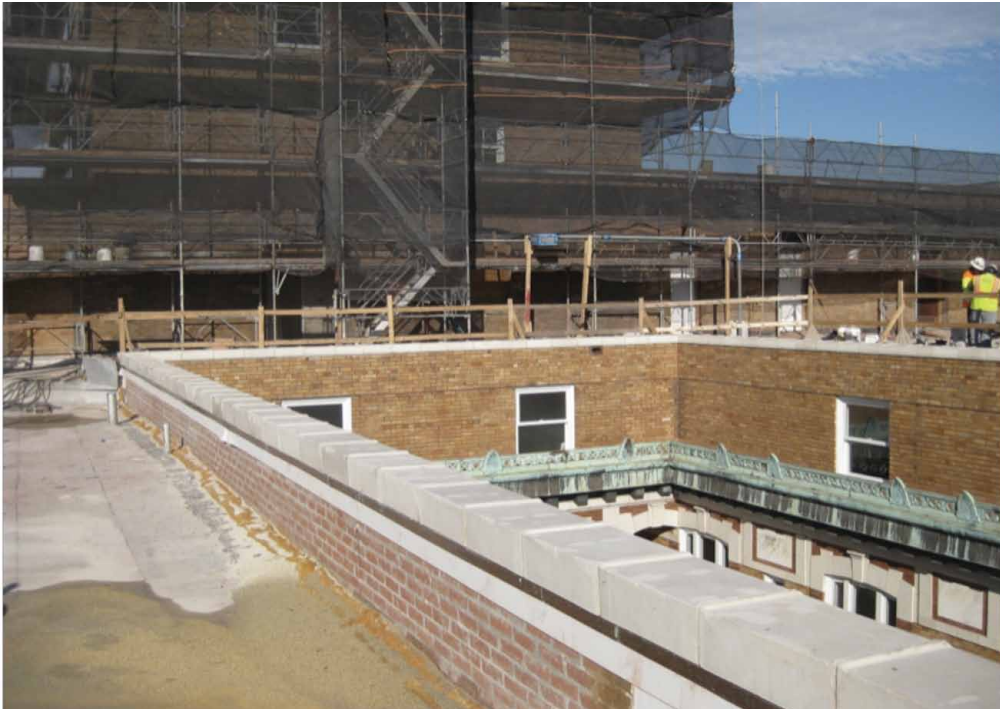
FIGURE 13. Ninth Street Courtyard Upper Floors showing rehabilitated condition. Compare with 2006 pre-construction photo above. Note replacement of mismatched masonry infill, removal of outdated rooftop mechanical equipment and corrugated metal addition, installation of new replacement windows and restored parapet coping stones.

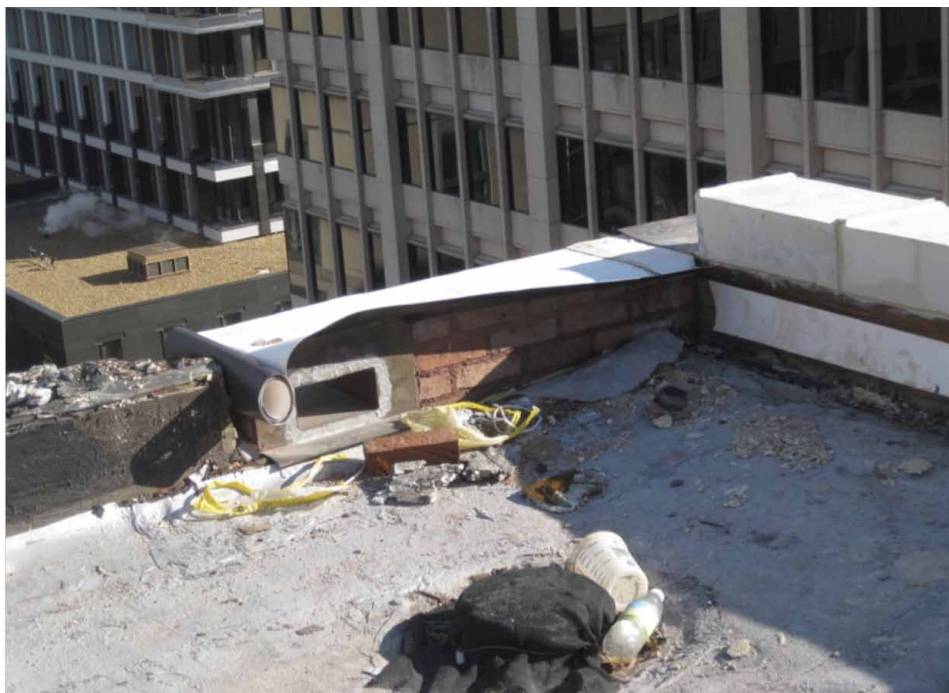
FIGURE 14. Reconstruction of masonry parapet in progress. TPO flashing is being installed in preparation for new roofing and masonry work. Note newly restored and reinstalled terra cotta capstones at right.

In addition, we were able to take advantage of the poor condition of some of the rooftop parapets where full reconstruction of the parapet was required. This existing condition allowed the construction team to remove the damaged brick masonry, repair the underlying water barriers, and reinstall the original brick in the reconstructed parapet. This allowed the project to take full advantage of LEED credits for minimizing construction waste/reuse of existing features materials and other related credits.

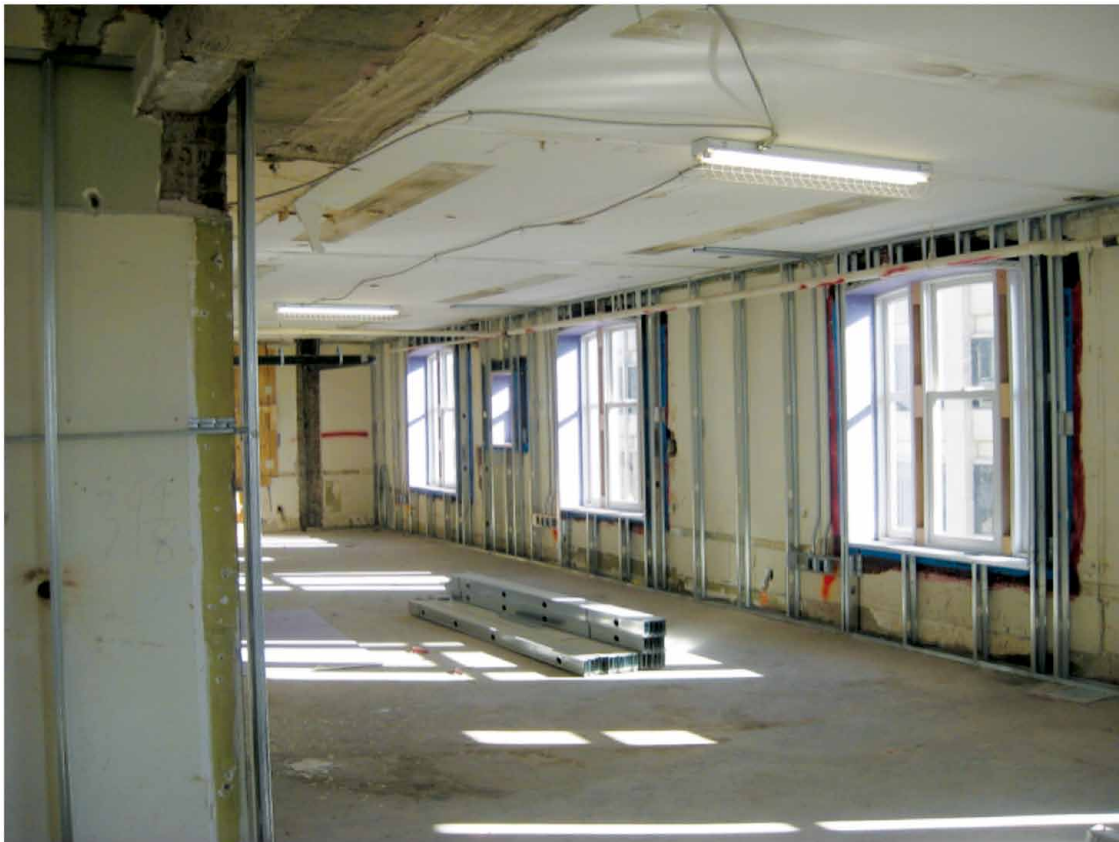
FIGURE 15. Daylight at Typical Office Floors. Full glass front walls (to be designed and built as part of the tenant interior phase) will define individual offices and the shallow floor plates will allow daylight and views to penetrate deep into the interior of the floors.

Here again, the Ninth Street Office Building rehabilitation was able to blend historic rehabilitation criteria with modern sustainable principles as the new clad wood historic replica windows not only provide improved insulation value but also offer the same operability as the original double hung wood units from the early 20th century. The narrow floor plates for each of the building office wings, in combination with the interior programmatic requirements of the tenant, suggested an innovative floor plan arrangement where the private offices arranged at the perimeter of the building include full glass interior partitions. By taking this approach, despite the programmatic requirement for a very high proportion of private offices, daylight from the oversized perimeter windows is allowed to penetrate deep into the floor plate.

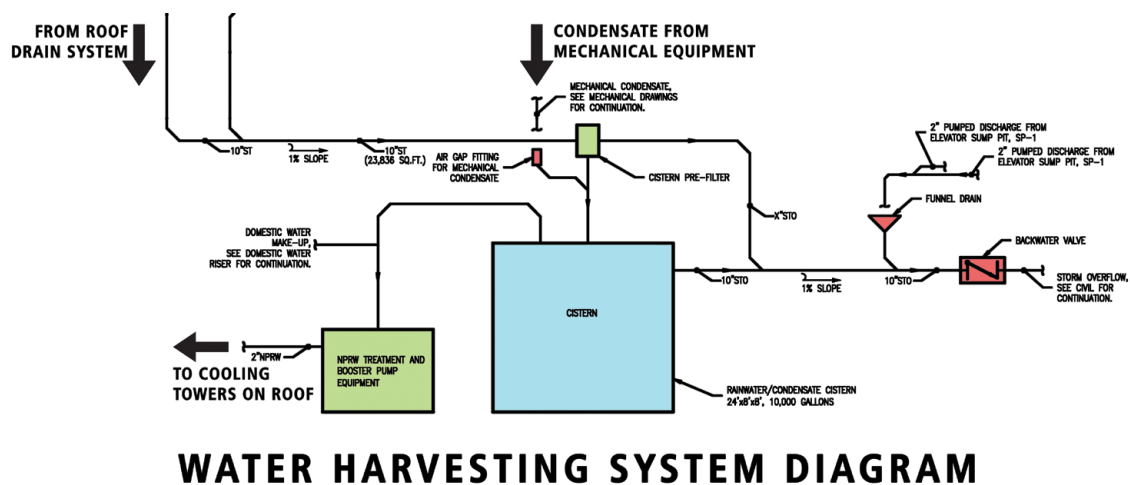
FIGURE 18. Water Harvesting System Diagram. Rainwater from roof drains is diverted through a pre-filter into the 10,000 gallon water storage cistern located below the basement floor. Condensate is also collected from the mechanical equipment throughout the building. When called for, water is pumped out of the cistern through a water treatment/booster pump system to provide make-up water for the cooling towers on the roof.

Through the use of water savings strategies, such as low flow water fixtures and the use of diversion of rainwater and HVAC condensate drainage into a water collection cistern below our building's basement to provide make-up water for the rooftop cooling tower, it is anticipated that the Ninth Street project can enjoy 20% to 40% water savings per year.

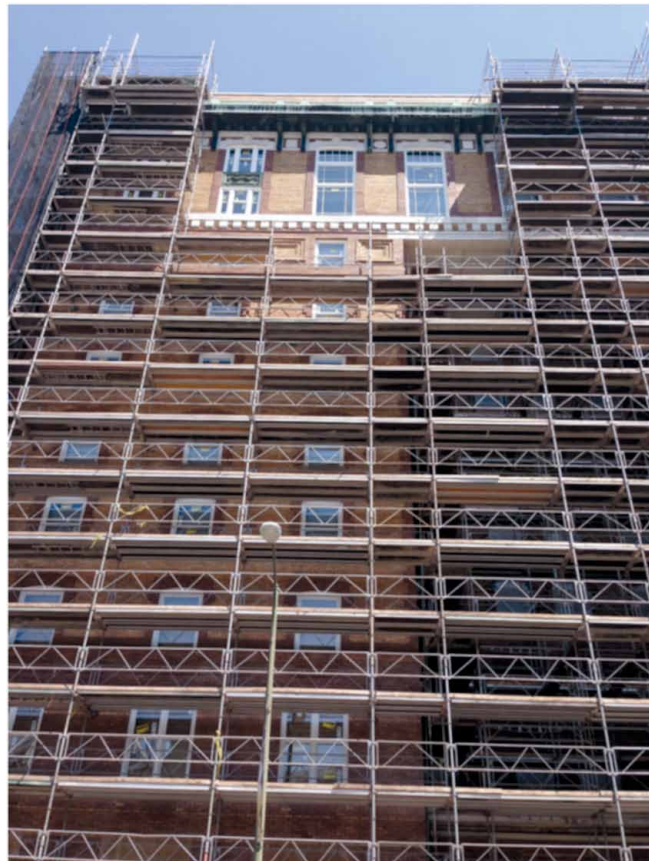
FIGURE 19. Scaffolding along Grace Street coming down to reveal the restored historic façade.
