THE DESIGN AND CONSTRUCTION OF THE 4C'S BUILDING

Stephen Vardy,¹ Colin MacDougall,² Chris Magwood,³ Anthony Spick⁴

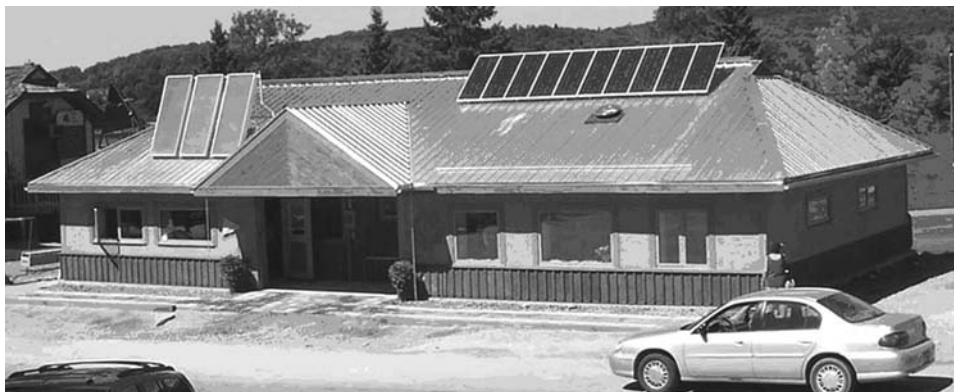
FIGURE 1.
Haliburton 4C's
thrift store and
food bank.

The Haliburton 4C's Food Bank and Thrift Store building, shown in Figure 1, was designed and built in June through August 2005. The structure combines an impressive variety of sustainable design options, while meeting specific functional and financial goals. The vision for the building was for it to serve as a working food bank and thrift store, while being a demonstration of the applicability of various alternative building materials and design options for a public building located in a very "traditional" neighbourhood.

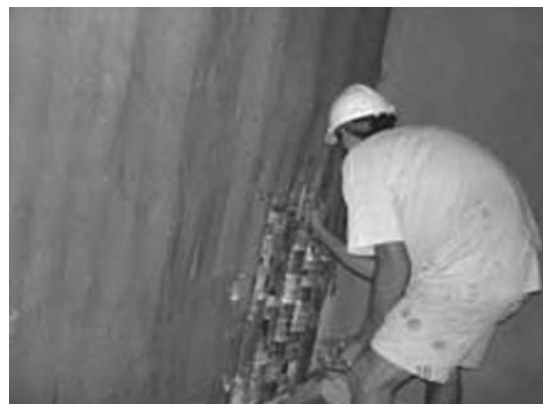
FIGURE 4. Pop bottle infill wall.

The interior walls were a combination of compressed straw panels and timber stud walls with a variety of infill materials. The compressed straw panels consist of straw which has been compressed at high heat to create a solid panel segment. The infill walls were constructed by placing the infill in the wall and plastering over with an earthen plaster. Plastic bottles, as shown in Figure 4, and hempcrete, which consists of lime, chopped hemp fibres, and water, were used as infill materials.

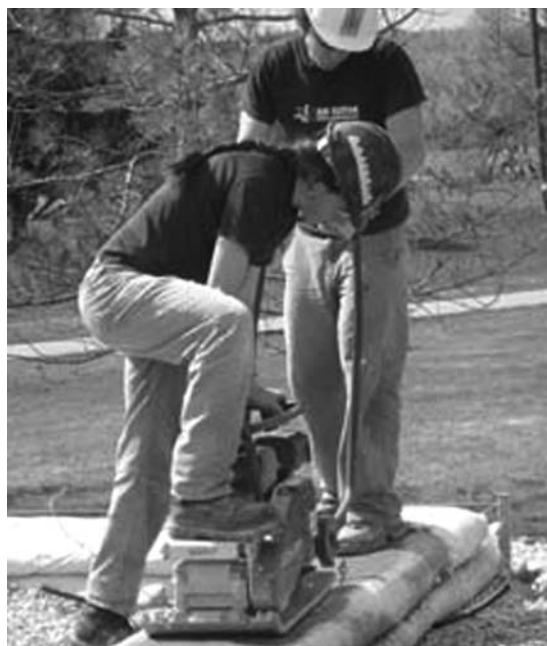
FIGURE 5. Placement and tamping of foundation.

Figure 3 shows the rubble trench foundation with rammed earthbag stacked footing. The rubble trench foundation was constructed by excavating the soil over the entire footprint of the site and filling the trench with compacted gravel. The rubble trench provided adequate structural stability, and drainage for the structure. Figure 5 shows the earthbags that were placed over the gravel around the perimeter of

the footprint to provide support for the load-bearing exterior walls. The earthbags were constructed by filling 60 mm diameter continuous polypropylene bags with a mixture of granular “B” gravel, water, and Portland cement for most of the perimeter. Rammed earth was used in the earthbags for the framed alcove area on the south side of the building. Once the first course was laid, the bag was tamped to ensure adequate consolidation of the mixture. The second course was also tamped for consolidation and leveling. An issue that arose with the earthbag design was a lack of confidence from the engineer in the ability of the earthbag to withstand the appropriate loads with minimal deformation. Thus, it was required that experimentation be conducted at Queen’s University to quantify the amount of deformation that may be expected under the anticipated loading. This experiment is discussed in greater detail below.

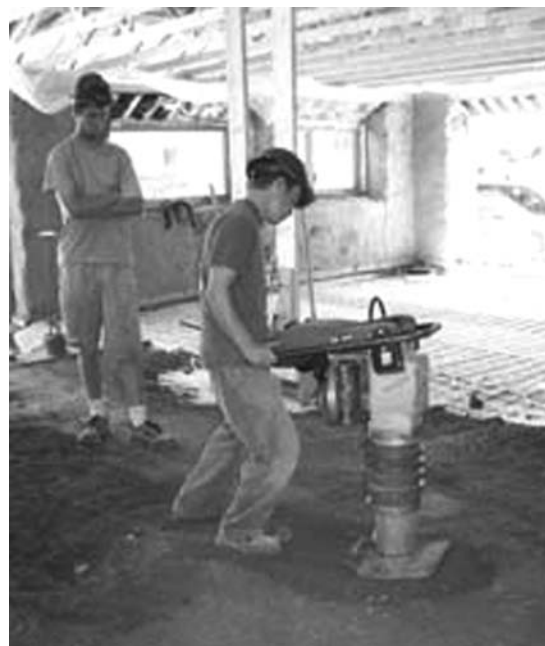
FIGURE 6. Laying and tamping earthen floor.

The earthen floor was constructed by first laying and tamping local soil as shown in Figure 6. The soil was then overlaid with a variety of finishes. Much of the floor was finished with earthen clay, similar to that used on the exterior walls. A mixture of earth, sand, and chopped straw was used. In some areas 5% Portland cement was added to the mixture to speed the curing time. The earthen floor was given a mosaic pattern to control where drying cracks occurred. Once the floor had cured the cracks were filled with grout. The earthen floor was tinted terracotta and coated with linseed oil and wax as a finish. Other floor finishes included tile and limestone.

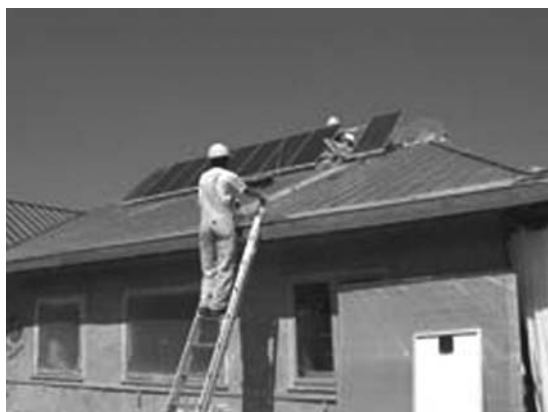
FIGURE 7. Installation of photovoltaic modules.

The electrical system is based around a 1kW grid-intertied photovoltaic (PV) array shown in Figure 7. The system consists of ten 100-watt modules, which are connected to the Province of Ontario's Hydro One power grid, eliminating the need for batteries. Any excess energy produced by the array is fed into the power grid. The energy is then "returned" to the building at times when the PV array does not produce enough energy, such as on cloudy days. The 4C's are then only billed for the net energy being consumed off of Hydro One's grid.

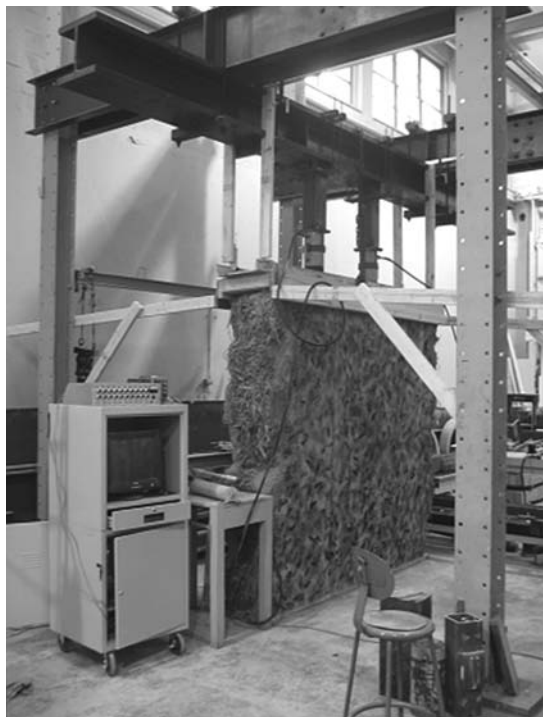
FIGURE 8. Experimental setup.

clay, masonry sand, and water. The final wall is shown in Figure 8.

A loading apparatus was designed specifically for testing of the full-scale wall. The apparatus consisted of two 1000 kN hydraulic rams, which were fixed to a loading frame and located directly over the wall specimen. The rams were controlled by two hydraulic hand pumps. The load was applied from the rams onto a steel channel section, which was located on top of the wall box beam, as shown in Figure 9. This section acted to distribute the load evenly across the top of the wall. Timber bracing was constructed for the top of the wall to ensure the deformation of the wall was purely vertical at the top surface of the wall. This was done to mimic the bracing a roof structure would provide for a typical wall section. The bracing can be seen in Figure 8, and the vertical deflection of the wall can be seen quite clearly in Figure 9.

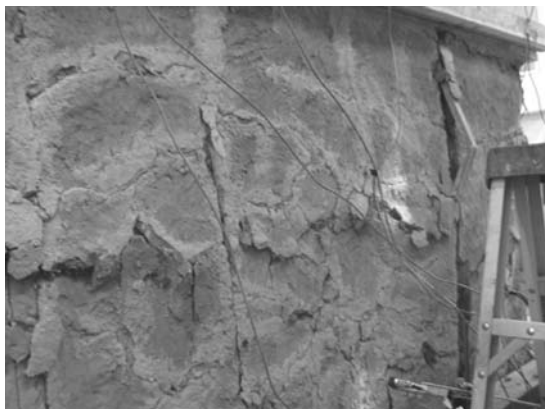
FIGURE 11. Failure cracking of wall.

The wall was loaded to failure and was observed to undergo a significant amount of cracking as it failed. Figure 11 shows the cracking that occurred in the wall as it failed during the experiment. Note that the lighter sections on the wall represent locations where shrinkage cracks had been repaired. It can be seen that much of the cracking initiated at these locations. Despite the observed cracking, there was little debonding of the hemp fibre from the earthen plaster.

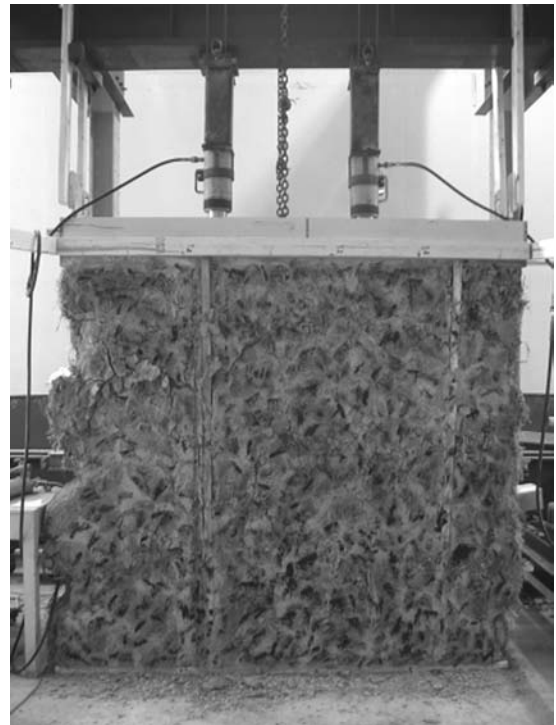
FIGURE 12. Overall failed wall.

An overall view of the failed wall is given in Figure 12, which also shows how the 1-inch \times 2-inch wood slats buckled within the wall, causing significant cracking around their location.

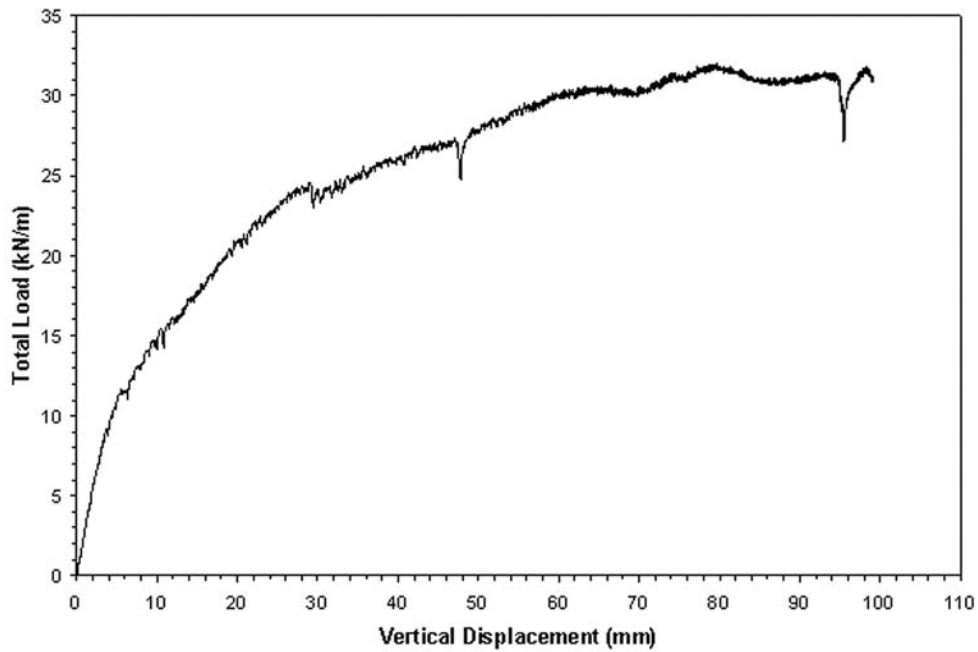
FIGURE 13. Load displacement response for plastered straw bale wall.

The load-vertical deflection response was the most critical result from the experimentation. Specifically, the maximum load was required to be in excess of 23.5 kN/m. Figure 13 gives the load-deflection diagram for the wall. The total load applied was divided by the wall length of 2060 mm, which was the

Figure 13 indicates that the maximum load obtained was approximately 32 kN/m, which far exceeds the required 23.5 kN/m. The wall had exhibited significant cracking at this point, but continued to resist load. The first visible cracking was observed to occur at a load of 12 kN/m, which can be seen as a change in the slope of the curve shown in Figure 13.

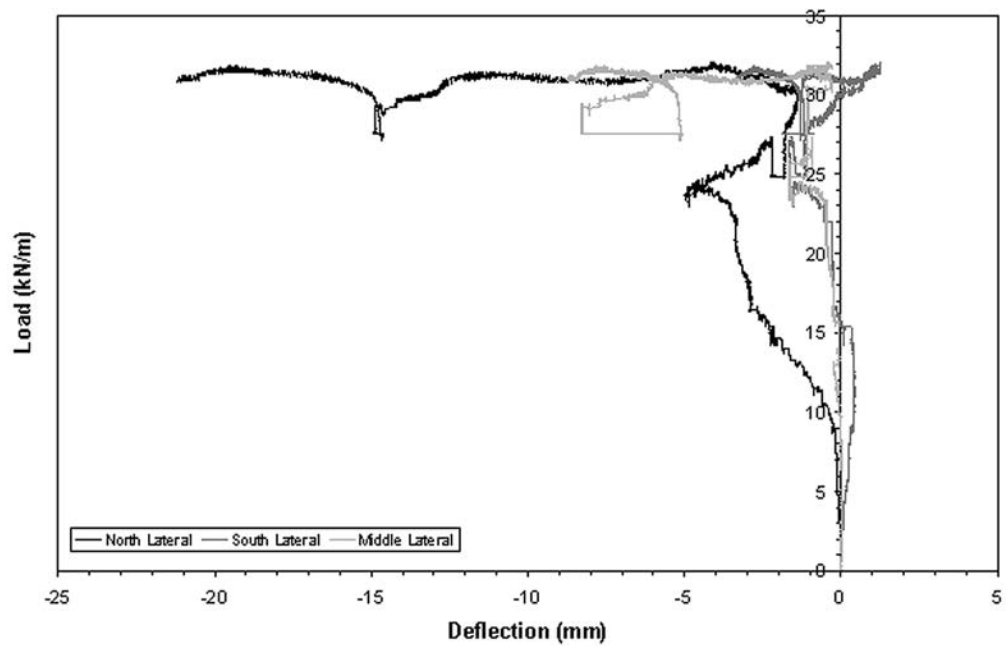
FIGURE 14. Lateral load-displacement response for plastered straw bale wall.

The load-lateral displacement response is given in Figure 14. It can be seen that the lateral displacements are very minimal for the majority of the experiment. For loads less than about 30 kN/m, the displacements remain less than about 5 mm. Once 30 kN/m has been reached and plaster cracking becomes significant, the displacements increase to a maximum of nearly 25 mm at the conclusion of the experiment.

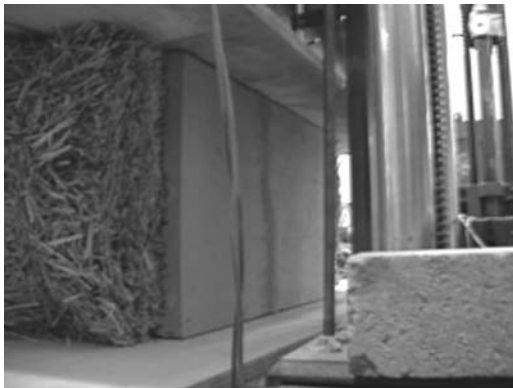
FIGURE 15. Earthen-plastered bale ready for testing.

single-plastered bales were prepared and tested in compression. An example of one of these bales, prior to testing, is shown in Figure 15.

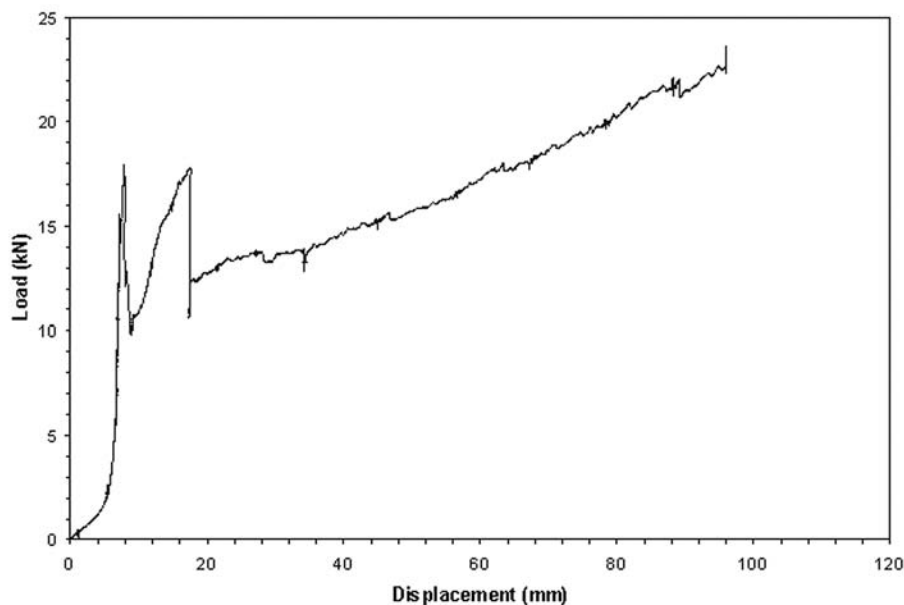
FIGURE 16. Load-displacement response of earthen-plastered straw bale.

Figure 16 shows the load-deflection behaviour for a typical earth-plastered straw bale. The behaviour is linear up to the point of failure except a small portion up to 2 kN load. This represents the initial compression of some of the straw that had bulged above the height of the plaster skins. Once failure was initiated at about 18 kN, severe cracking was noted in the bale as the load dropped significantly to approximately 10 kN. Following this, the bale continued to carry increasing load, but also underwent significant cracking and damage to the plaster skins. This portion of the curve represents the transfer of load from the failing plaster skins to the straw. Under enough deformation, the plaster skins would cease to carry load, and all, or very nearly all, of the load would be taken by the straw.

All three plastered bales tested were observed to reach an ultimate load of approximately 30 kN/m. This value is smaller than was obtained for the full-scale wall, which is likely a result of a slightly thicker

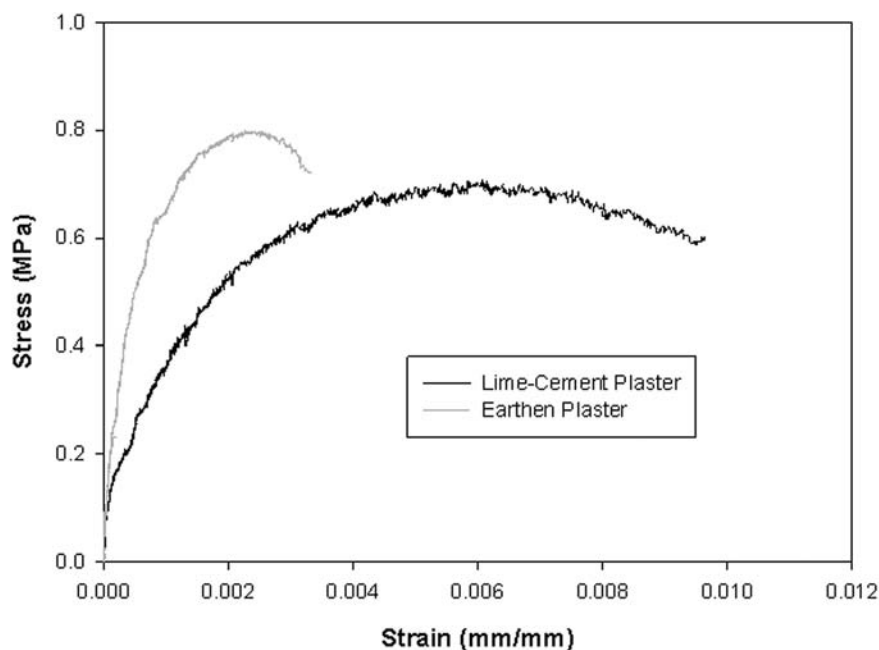
FIGURE 18. Stress-strain relationships for lime-cement and earthen plasters.

Figure 18 compares the stress-strain response of a lime-cement and earthen plaster with similar ultimate strength (f'_c) values. The response of the earthen plaster is similar to that for the lime-cement plaster and concrete. However, for approximately the same f'_c , the ultimate strain of the earthen plaster was much lower.
