GREEN ROOFING IN INDIANA: CASE STUDIES AND DESIGN NOTES

Anne Altor, PhD, PWS¹

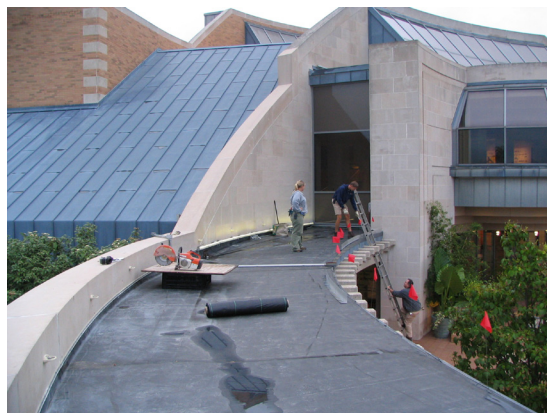
FIGURE 1. Installing waterproofing membrane and flashing on west arbor arm for Minnetrista green roof, September 2008. Photo credit: Minnetrista.

ate a walkway around the perimeter of the green roof plantings. Wool fleece was placed onto the concrete deck to protect the new waterproofing membrane, and two additional layers of 60-mil, non-adhered EPDM waterproofing membrane were placed over the fleece, in May 2008. The membrane was continued part way up the west limestone sidewall. Modules, buckets of gravel ballast, extra planting mix, and weed fabric were staged on the ground below the roof, and pallets were raised with a front-loader to deliver the 3' × 1' modules to the roof. The rectangular modules did not precisely fit the curved roof, so additional planting mix and *Sedum* were placed on top of weed fabric between gaps in modules. No leak test was performed on the membrane, but no leaking was observed in the months before the green roof was installed. Insulation was not included because the roof covers an outdoor walkway.

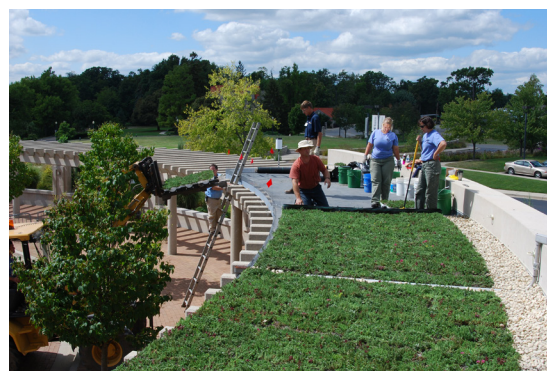
FIGURE 2. Installing ballast and green roof modules on west arbor arm, Minnetrista, September 2008. Photo credit: Minnetrista.

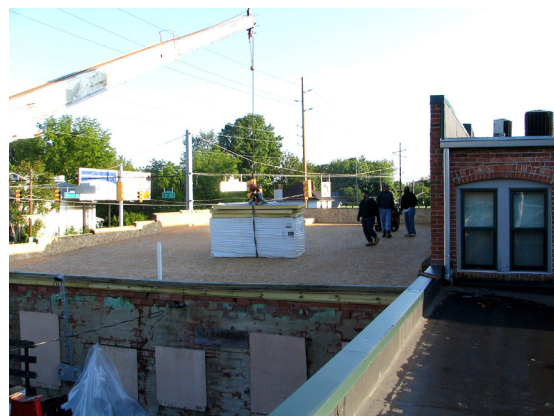
FIGURE 3. Replacement of roof deck, Moonblock Building, May 2007. Photo credit: John H. Boner Community Center.

A crew of volunteers including professional trades and members of the Englewood CDC removed the old roofing materials down to the deck, and installed the second interior truss system. The new roof assembly was then installed on top of the original deck. The AVRS green roof was installed in June 2007. Trays were arranged on the roof and a drip-irrigation system was installed through all the trays. Growing media was brought up by cranes in "Supersacks," and the trays were filled by hand-raking the media across the roof. *Sedum* plugs were planted by hand 6" on center. The LiveRoof® modules were installed in September 2007, with pavers separating green roof areas.

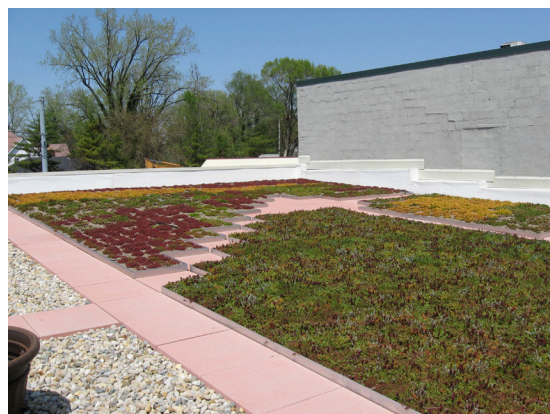
FIGURE 4. Moonblock AVRS (top) and LiveRoof (bottom) green roof areas, April 2008. Photo credit: John H. Boner Community Center.

Very few maintenance activities were carried out on the Moonblock green roof over the first few years. The LiveRoof® modules have maintained approximately 75% plant cover. Vegetation has been slow to develop in the AVRS area, with substantial bare patches remaining three years after installation. However, the maintenance procedures recommended for successful development of the

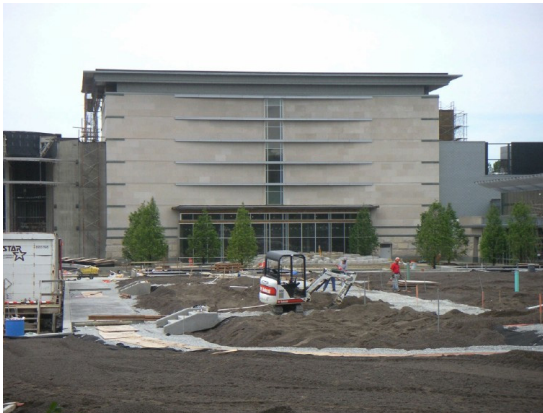
FIGURE 5. Installation of IMA green roof growing medium, March 2004. Photo credit: Indianapolis Museum of Art.

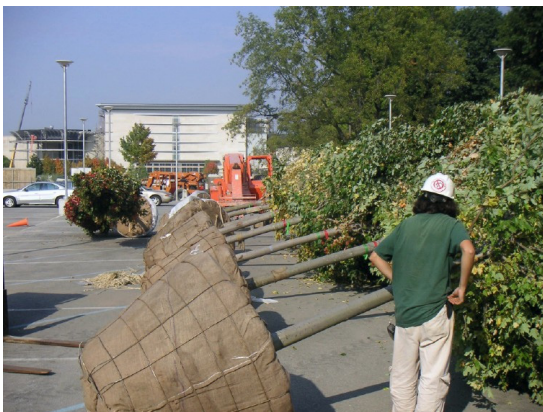
FIGURE 6. Red maples to be installed on IMA green roof. Photo credit: Indianapolis Museum of Art.

The root systems of the red maples have demonstrated robust, shallow growth in the porous growing media. Fertilizer was initially added to the irrigation water but was found to quickly percolate below the root zone in the deep media, so nutrient addition was discontinued. Excessive alkalinity has been an issue, with pH reaching 8.0 across the top six inches of the roof. The alkalinity is generated from the limestone supporting the sidewalks and from the irrigation water, which comes from a limestone aquifer. Red maples prefer acidic soils, and some of the trees on the IMA green roof have demonstrated chlorosis (leaf yellowing) that is typical for this species when pH is too high. Some of the perennials on the green roof have also shown stunted growth.

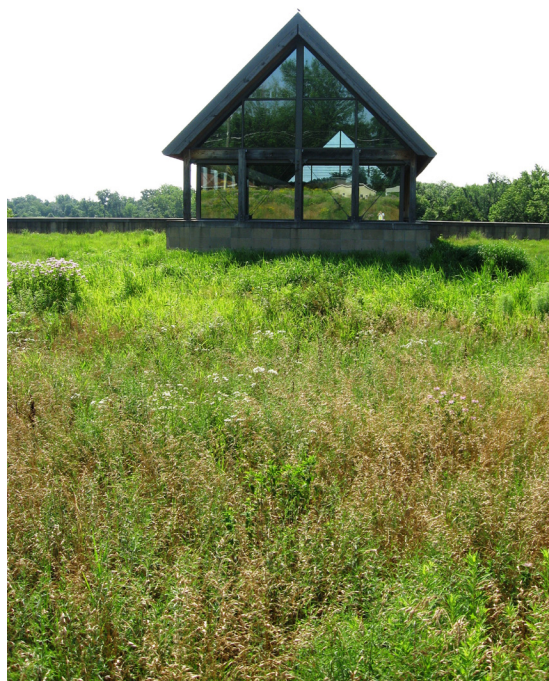
FIGURE 7. Oaklyn Library green roof around LightBridge Clerestory, and adjacent native meadow, June 2010. Photo credit: Pam Locker, Oaklyn Branch Library.

The Oaklyn Library green roof is a 14-inch deep intensive system. The design represented a collaborative effort between the Evansville Vanderburgh Public Library, architecture firm Veazey Parrott Durkin & Shoulders, landscape architect Storrow Kinsella Assoc., and Roofscapes, Inc. Architect William Brown is credited with developing the overall concept for the site, and Charlie Miller with conceiving the green roof design. The roof deck consists of a lightweight composite of steel and concrete. The roof’s waterproofing membrane is hot air welded fiber-reinforced 80-mil PVC (Sarnafil G-476), on top of which was placed an additional protective PVC membrane. The waterproofing membranes were extended up and over the parapet walls to minimize the potential for leaking, and “containment strips” were used to compartmentalize the roof for flood tests and to facilitate finding and repairing any future leaks. The green roof was designed as a two-layer system that mimics shallow soil (eight inches of growing medium) over bedrock (six inches of granular drainage media). The media making

up both layers were tested according to FLL (1995) standards, and provide approximately 4.75 inches of stormwater storage under fully drained conditions.

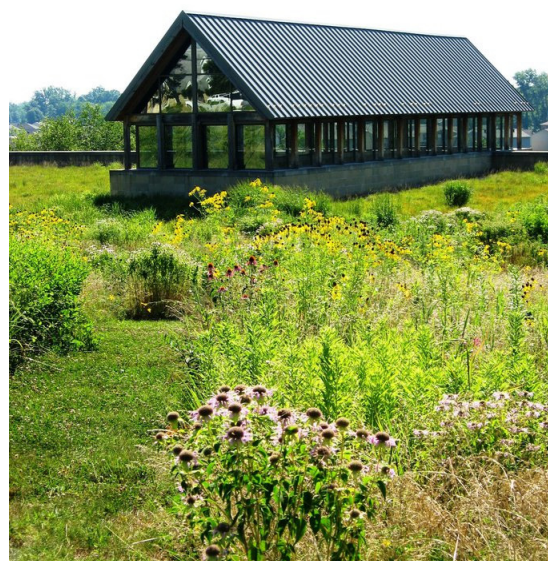
FIGURE 8. Another view of Oaklyn Library green roof, LightBridge Clerestory and adjacent native meadow, July 2010. Photo credit: Pam Locker, Oaklyn Branch Library.

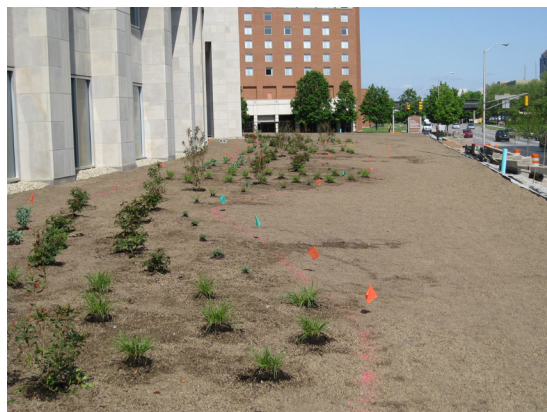
FIGURE 9. Clarian Cancer Center south green roof after planting, May 2008. Photo credit: Becker Landscape Contractors, Inc.

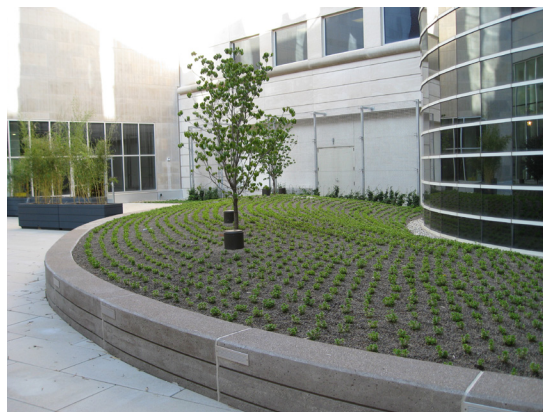
FIGURE 10. Clarian Cancer Center west green roof after planting, June 2008. Photo credit: Becker Landscape Contractors, Inc.

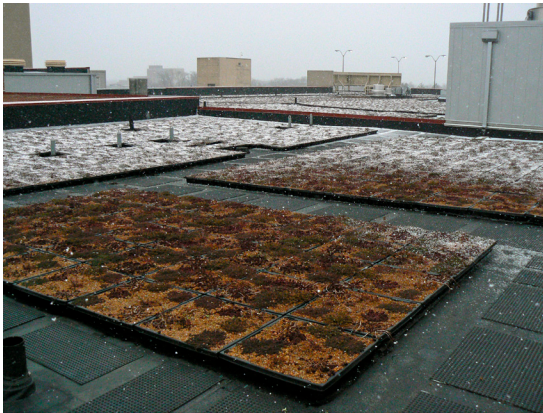
FIGURE 11. BMH green roof and walkways, January 2010. Areas not covered by snow are located near heat vents. Photo credit: Anne Altor.

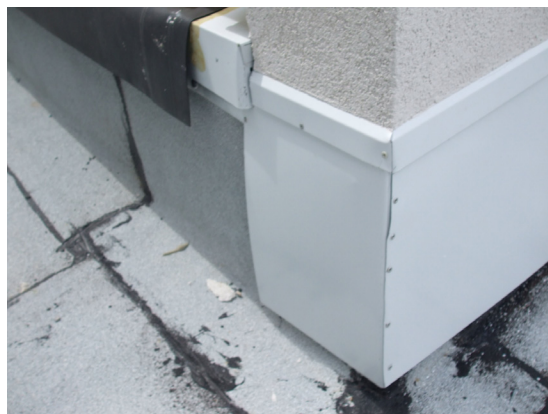
FIGURE 12. 3Mass waterproofing installation: bitumen membrane carried up parapet wall, with extra layer of EPDM before finishing with coping. April 2009. Photo credit: AAA Roofing.

sive planting areas located over structural members, and a rooftop patio area. The inverted roof assembly consists of a concrete deck, a heat-welded, 2-ply Soprema Sopralene Flam 250 modified bitumen waterproofing membrane carried up over the roof's parapet walls, and four inches of Styrofoam insulation on top of the membrane. An additional EPDM membrane was placed over the parapet walls, which were then capped with aluminum coping. Disposable insulation was placed on the membrane to protect it during the months before the green roof was installed. Before the permanent insulation and green roof were installed, a 24-hour flood test was performed by the waterproofing installer (AAA Roofing).

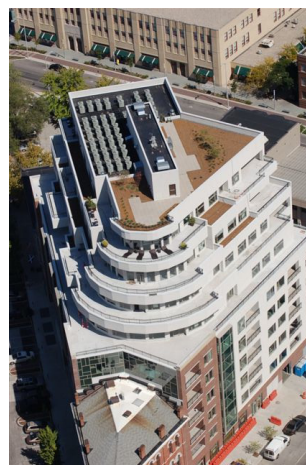
FIGURE 13. 3Mass green roof after planting, August 2009. Photo credit: AAA Roofing.

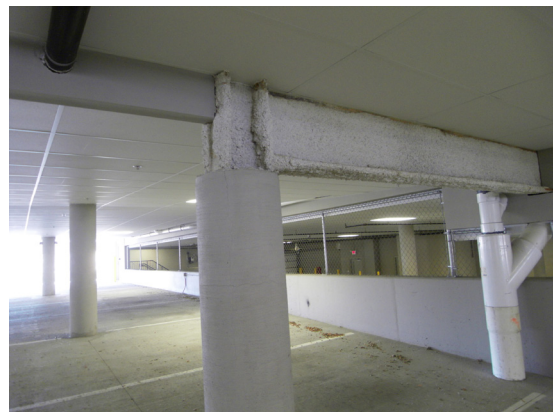
FIGURE 14. Support posts for green roof and fountain, Maxwell Courtyards parking garage, August 2010. Photo credit: LederPro Consulting.

tural engineer generally performs the assessment, which involves evaluating the roof materials, slab, beams, columns, trusses, or other reinforcements. If the existing loading capacity is inadequate to support a green roof, reinforcement of the roof may be an option. Reinforcement can include addition of truss systems or other supports to reduce span, addition of reinforced composites or bonded steel to concrete roof decks, and post-tensioning (Alkhrdaji 2004; Cuono and Bates 2010). New buildings incorporating green roofs are designed at the outset to support the extra weight. Approximate increases in dead load contributed by green roofs range from 14–35 lb/ft² for extensive roofs, and between 60–200 lb/ft² for intensive green roofs (Dunnett and Kingsbury 2008). Intensive green roof areas or other landscape features on the roof are often located over structural members where the loading capacity is highest. For example, the fountain in the middle of the Maxwell green roof is located over pillar supports in the parking garage below.

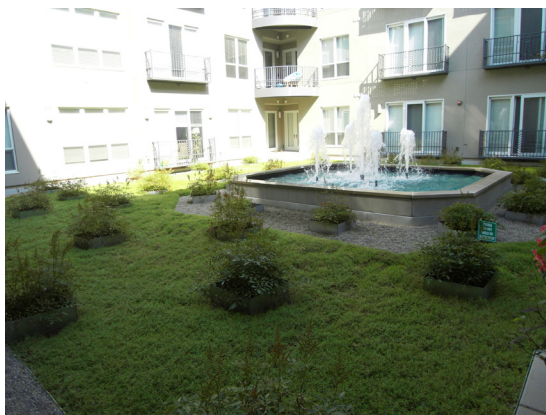
FIGURE 15. Maxwell Courtyards green roof and fountain, August 2010. Photo credit: LederPro Consulting.

a crane in the building's confined urban area, and all green roof materials were carried by hand to the second floor where they were placed on rollers and moved to the courtyard. The green roof was watered and slow-release Osmocote fertilizer was applied

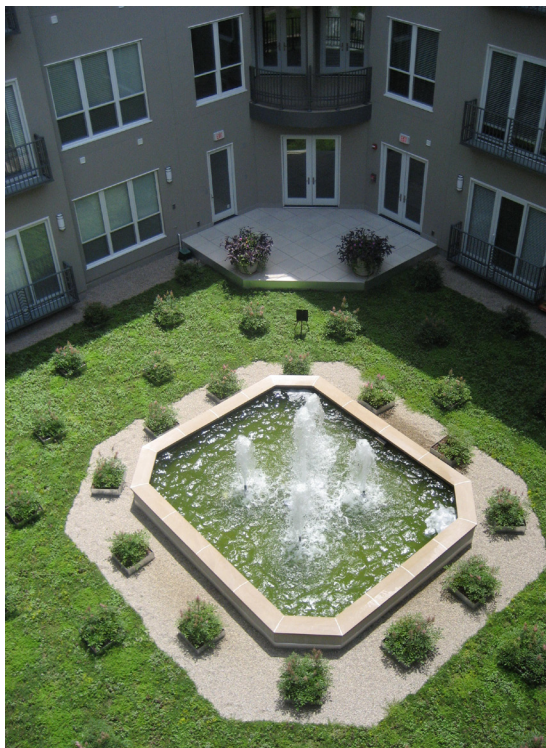
FIGURE 16. Maxwell Courtyards green roof and fountain, June 2009. Photo credit: LederPro Consulting.
