# THE GREENEST BUILDING (IS THE ONE THAT YOU DON'T BUILD!)

## Effective Techniques for Sustainable Adaptive Reuse/Renovation

Barbara J. Thornton, AIA, LEED AP<sup>1</sup>

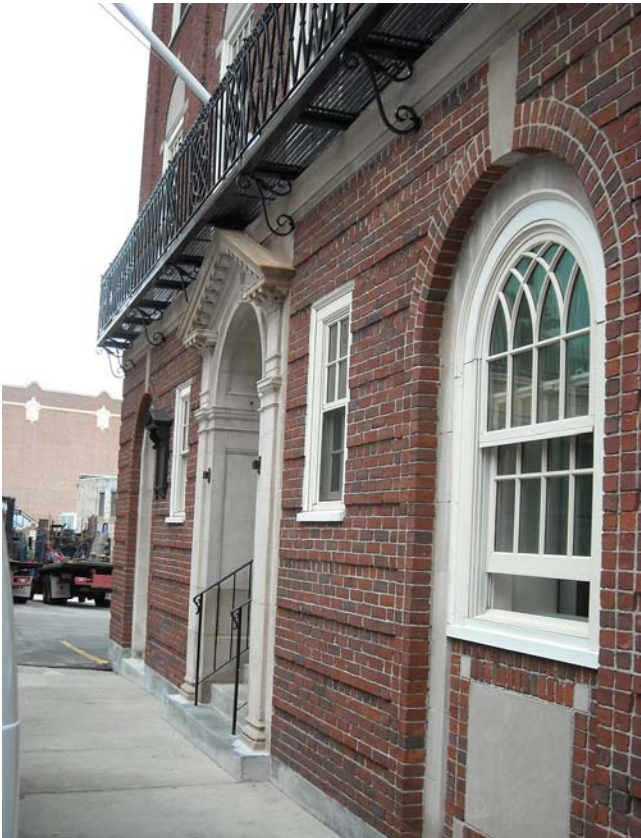
**FIGURE 1.** Historic façade salvaged.

- At Johnson & Wales University in Providence, an historic bank building adapted to offices and student services returns to its historic façade (Fig. 1).

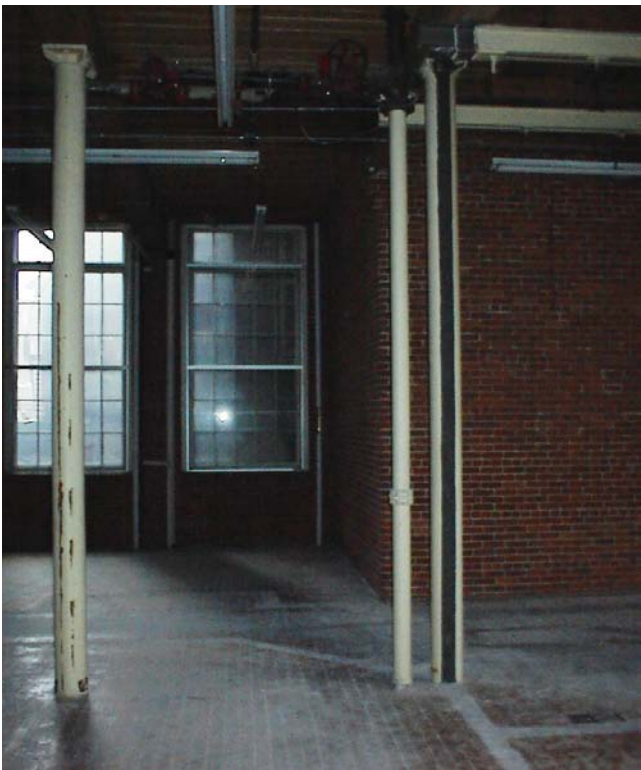
**FIGURE 2.** Downtown factory before.

**FIGURE 3.** Factory reused as Center for Entrepreneurship.

- Next door, a prior factory building is converted to contain an entrepreneurship center with graduate and faculty offices, classrooms (Fig. 2 and 3).
- Down the street, an 1840s convent reused as student dorms and an intercultural center is restored to maintain its historic exterior (Fig. 4).

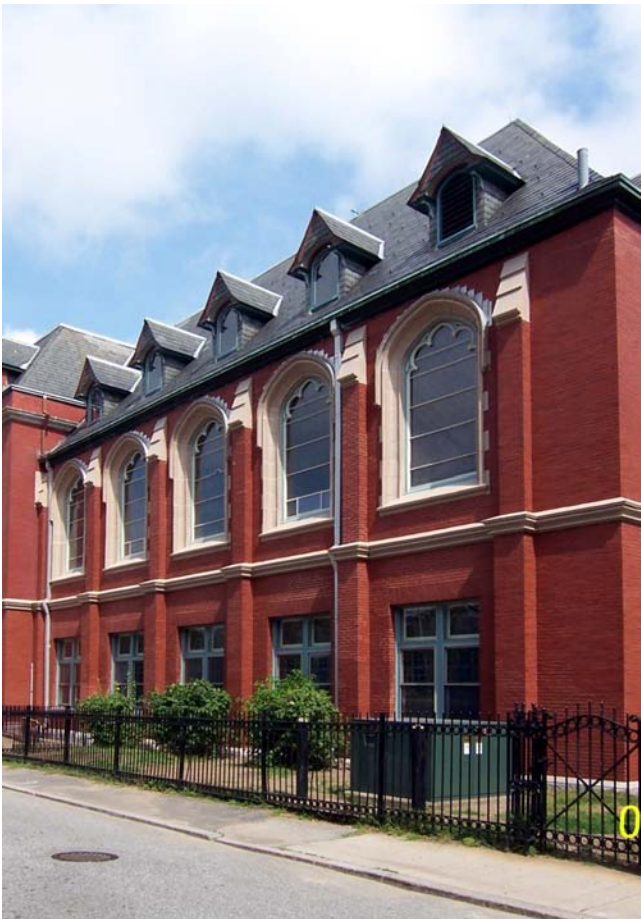
**FIGURE 4.** Historic chapel exterior preserved.

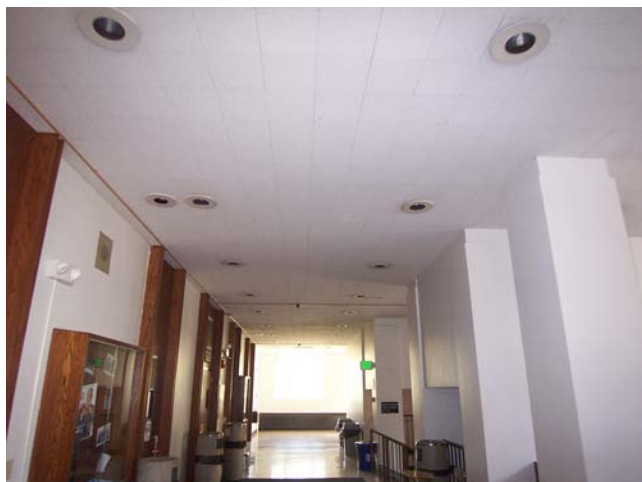
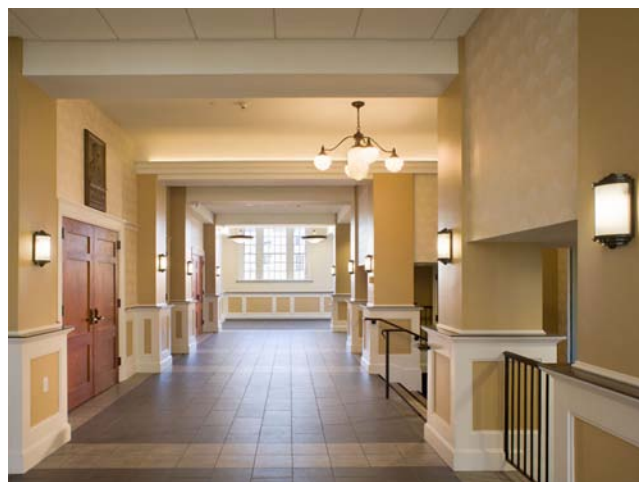
**FIGURE 5.** 1910 lobby with 1960 remodel.

**FIGURE 6.** 1910 lobby restored.

- At the University of Rhode Island, a granite 1910 building, originally the college library/lecture hall, is now a major performing venue and large lecture site with faculty offices (Fig. 5 and 6).

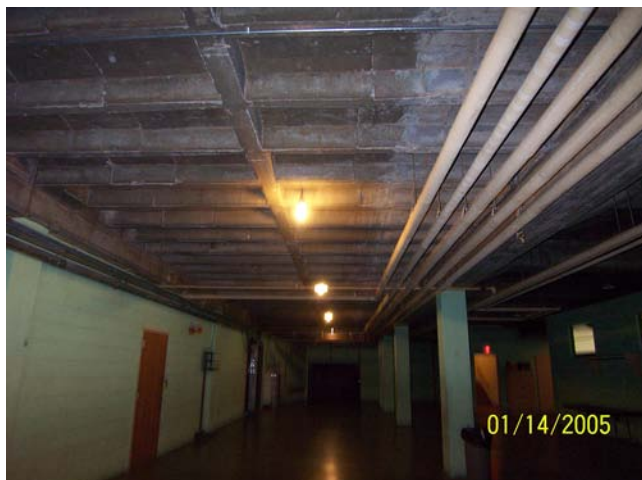
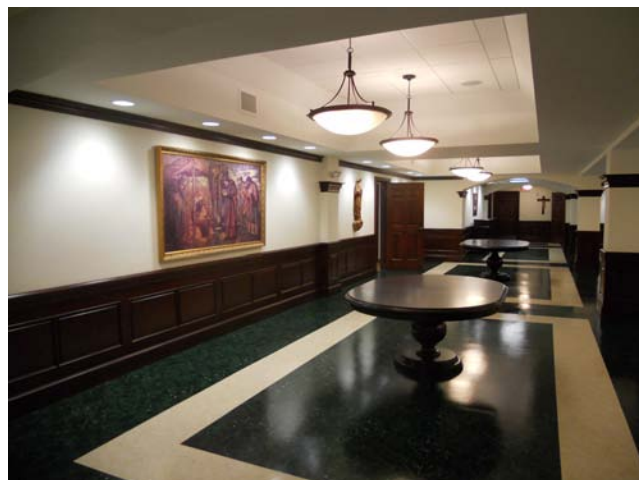
**FIGURE 7.** Church basement before.

**FIGURE 8.** Church basement after.

- An empty Church basement at St. Augustine's in Providence transformed to provide a parish hall space without new exterior construction costs or land purchase (Fig. 7 and 8).

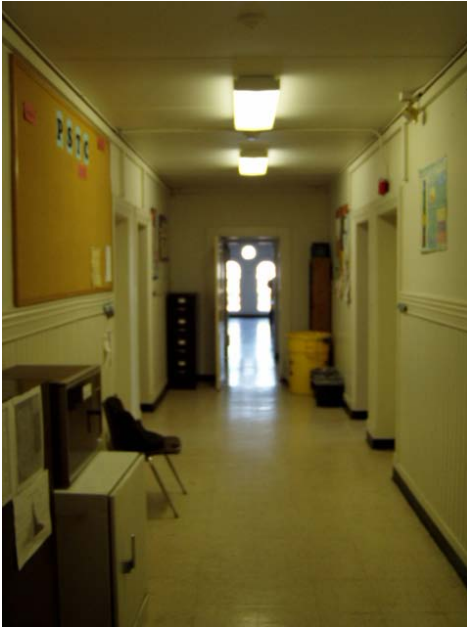
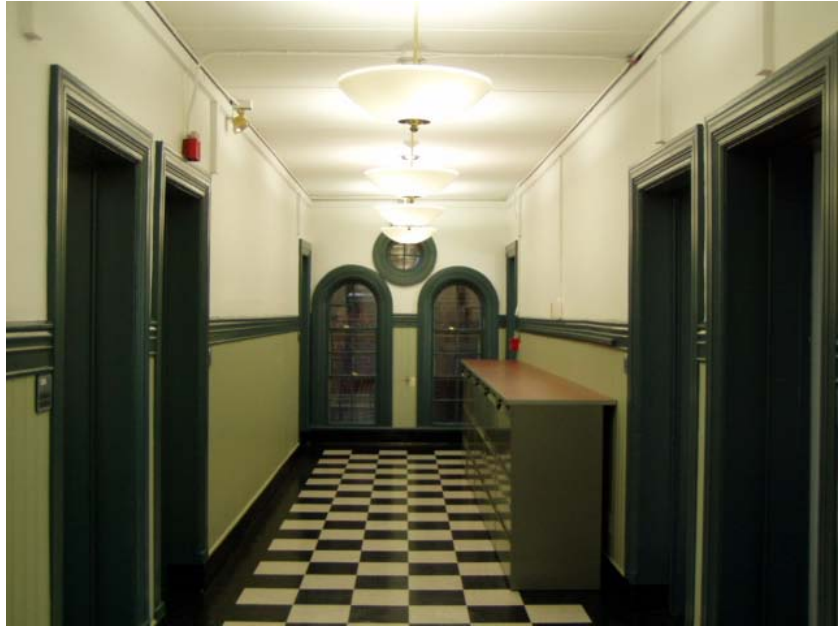
**FIGURE 9.** College dorm as offices before.

**FIGURE 10.** Period interior works well after.

- At Brown University, an 1890s dormitory college has been recast floor-by-floor for departmental headquarters and research offices (Fig. 9 and 10).
- A textile mill in Pawtucket with tenant renovations to provide research offices and work space for 12 psychologists associated with local universities (Fig. 11 and 12).

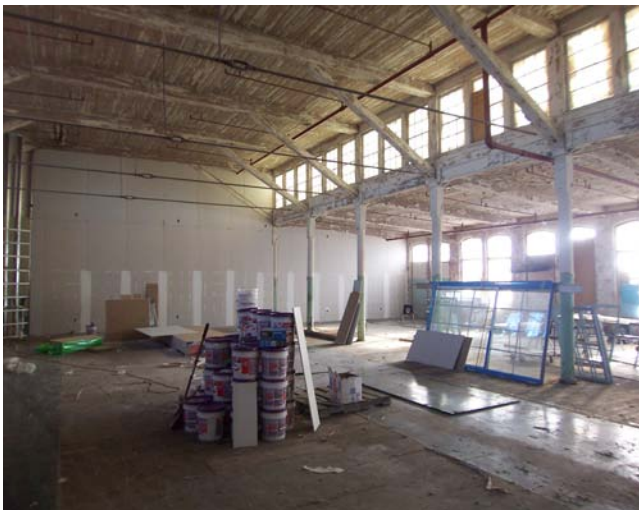
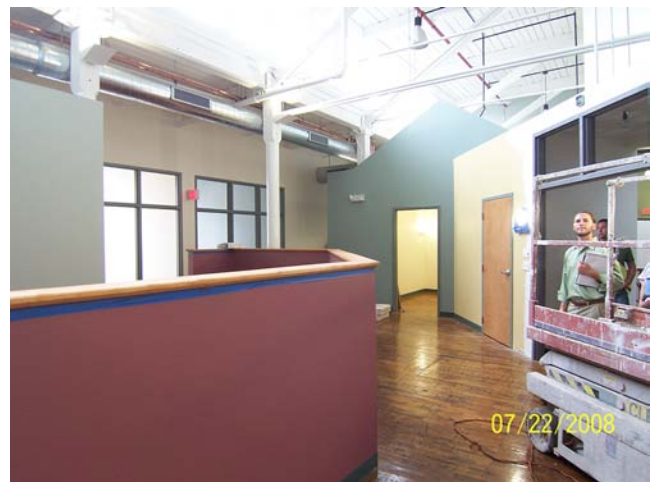
**FIGURE 11.** Mill building monitor before.

**FIGURE 12.** Adds light to interior after, even with perimeter office requirements.

Daylighting was often a key practical component of older structures, particularly the mill building so typical of New England. Such glazing can be restored, unblocked, returned to useful life, or augmented with 21st century technologies. At a recent mill project, the upper monitor sidewall windows were upgraded to insulated units allowing the interior spaces to benefit from the original designer's intent to bring exterior light all the way into the center of the factory floor (Fig. 11 and 12). Sometimes the original daylighting design is in conflict with new use programs of private perimeter offices—14' high windows can overwhelm a 10' wide office space. Here is one solution (Fig. 15)—without impacting the original window, an acoustic cloud was floated 24" off the exterior wall to reduce perceived height and very real echo from hard existing surfaces. French doors, sidelights, and transoms allowed light transfer to interior corridors and research carrels. Many readers are also familiar with a traditional renovation dilemma—an antique central skylight backlit with electric bulbs once the leaky roof opening is covered. Now it is possible to backlight with the real thing; reflective tube light wells can deliver sunlight to these obscured locations from up to 20 feet away.

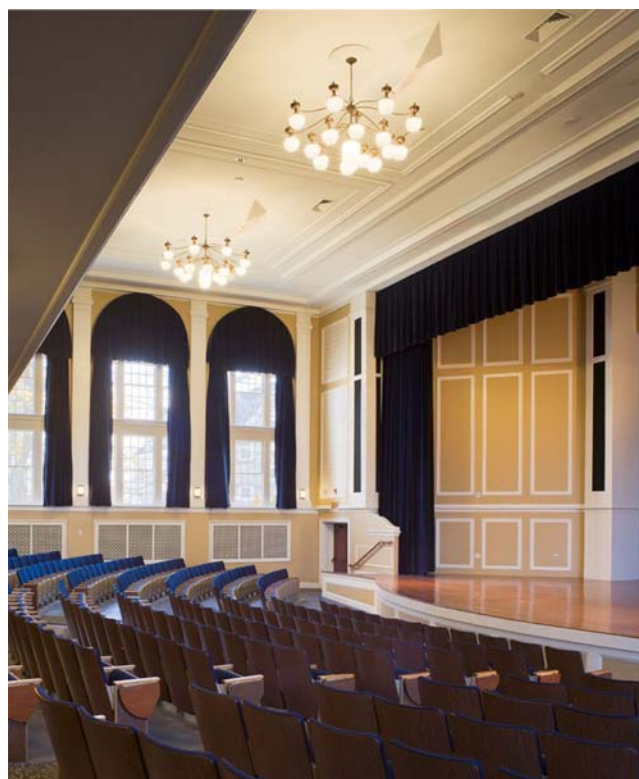
**FIGURE 13.** Deco chandeliers replaced wagonwheels of can lights.

Progress in lighting allows retrofit and custom fixture designs for historic venues that can satisfy both energy-efficiency and aesthetics. At URI, we replaced 1960s can lights with custom warm-fluorescent chandeliers of deco/arts and crafts lineage more appropriate to this 1910 granite edifice. The new sconces in the building maintain an early deco theatre theme, still meet energy and ADA requirements, and were amended only slightly from stock fixtures (Fig. 13 and 14). Where new codes mandated new types of lighting for this renovation, such as performance lighting for safety path visibility, advanced LED technologies were employed to install low-profile carpet runner edge and stair nosing applications in an incredibly energy-efficient system.

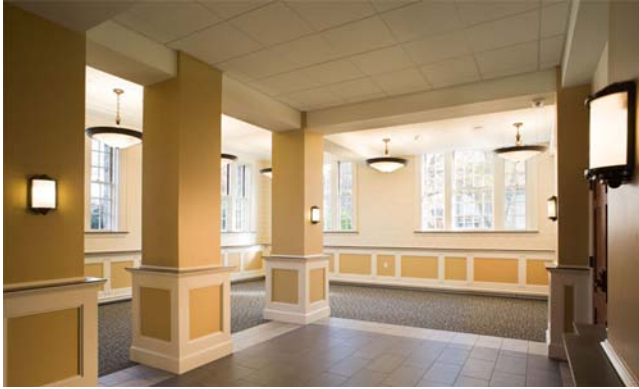
**FIGURE 14.** Theatre Sconces, MDF millwork, Corian sills.

intrinsically very "green." Linoleum, for example, is a natural replacement now for its own prior "improved" replacement, vinyl composition tile. This older flooring is new again, made of post-industrial sawdust and linseed oil but reinforced with recycled glass fiber backing as tile in wonderful colors. Improvements on older materials also abound without sacrificing aesthetics. Carpets would have been wool (and can be again on a large enough budget), but recycled and recyclable nylon and polypropylene also serve well. Millwork once done in mahogany can now be replicated in low-VOC, non-formaldehyde MDF. Slate sills and thresholds can become recycled-content solid acrylic, and wallpaper can be used that is both rapidly renewable, flame-retardant, and breathable to help those historic walls (Fig. 14).

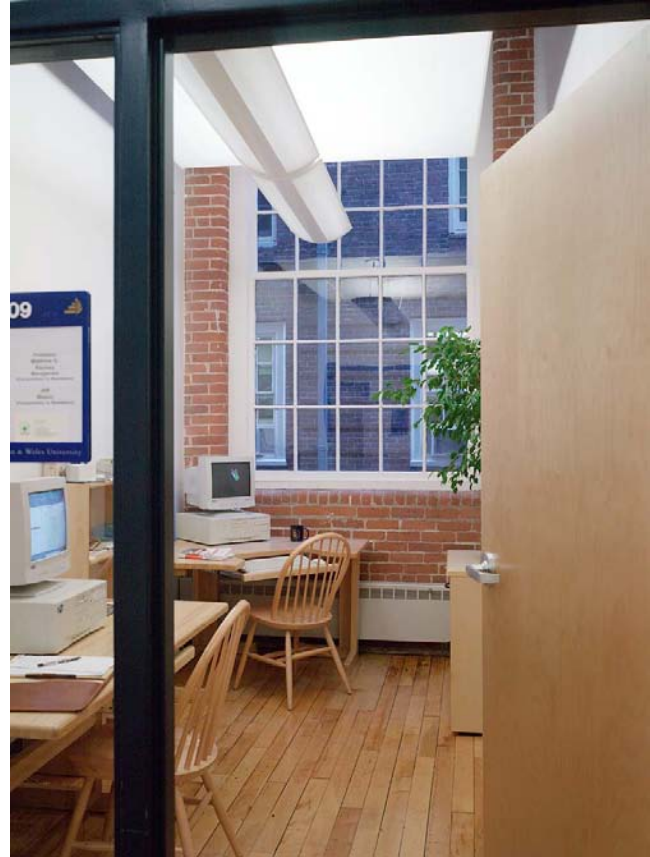
**FIGURE 15.** Office with acoustic cloud.
